## FAILURE MECHANISM OF THE FURYO DAIICHI BRIDGE IN THE 2016 KUMAMOTO EARTHQUAKE

In the Kumamoto Earthquake that occurred in western Japan in 2016, the Furyo Daiichi Bridge, a 60 m-long overbridge, collapsed onto the busy Kyushu Expressway. The bridge, constructed in 1974, had a skew angle at one end of the superstructure. To confine displacements in the perpendicular direction, displacement confining devices were installed at the abutment on the skewed side of the superstructure. The two piers located on the dividing strips were rocking piers. The rocking piers had pivot bearings at both the upper and lower ends of the columns. The pivot bearings were incorporated to provide a rotating function and a vertical load support function.

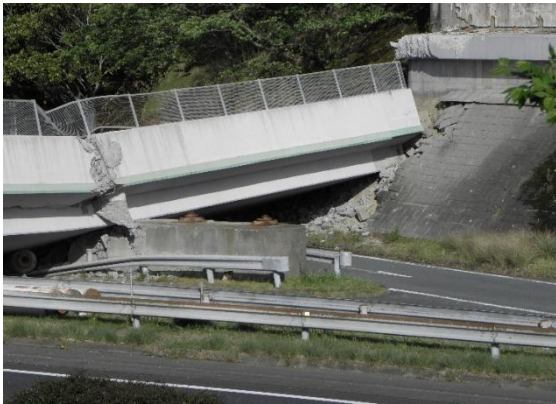
Photo 1 shows the collapsed portion of the bridge near Abutment A1. Photo 2 shows the damage to the displacement confining device. Fig. 1 gives a plan view of the Furyo Daiichi Bridge before and after the earthquake.

Photo 1 Collapsed bridge near Abutment A1

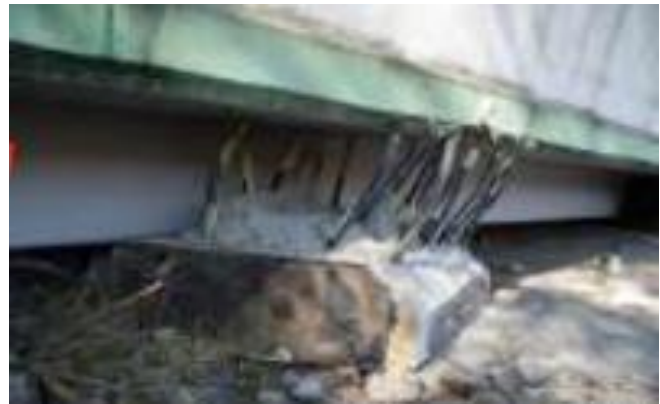
As shown in Fig. 1, the bridge was displaced to the north about 5 m at Abutment A1 and about 3 m at Abutment A2. It is considered that the skewed superstructure made a rotating movement to the north and collided against the displacement confining device. A punching shear failure occurred at the connection area of the confining device and the bridge seat, forcing the device and the superstructure to fall off, as seen in Photo 2. Unlike Abutment A1, a displacement confining device was not installed at Abutment A2 as there was no skew angle at that position. Considering the fact that the rocking piers are vulnerable to movements, we can point out that the displacement confining devices of this bridge were not sufficient to resist large movements in the axial and perpendicular directions.

This bridge suffered unordinary damage, namely, a punching shear failure occurred at the connection area of the displacement confining device and the bridge seat, as seen in Photo 2. To evaluate the behavior of the connection area, we derived two different punching shear resistances of the area and compared them with the design seismic force. For this calculation, two typical shear stress values specified in Japan's Bridge Specifications were used <sup>[1]</sup>.

Photo 2 Damage to the displacement confining device

- 4) Considering from this failure mechanism, the effective improvement measures are to increase the punching shear resistance of the device-bridge seat connection area and to increase the number of devices to be installed.

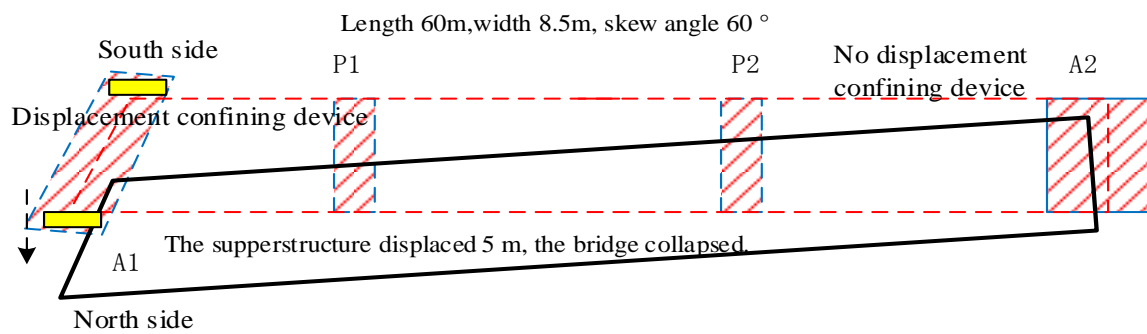
Fig. 1 Plan view of the Furo Daiichi Bridge before and after the earthquake.

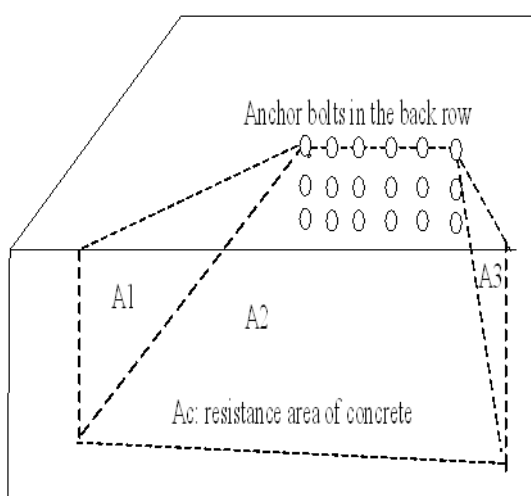
The total resisting area of concrete is  $4,242,000\text{mm}^2$  from  $A_c = A_1 + A_2 + A_3$  in Fig. 2.

Fig. 2 Planes of punching shear failure

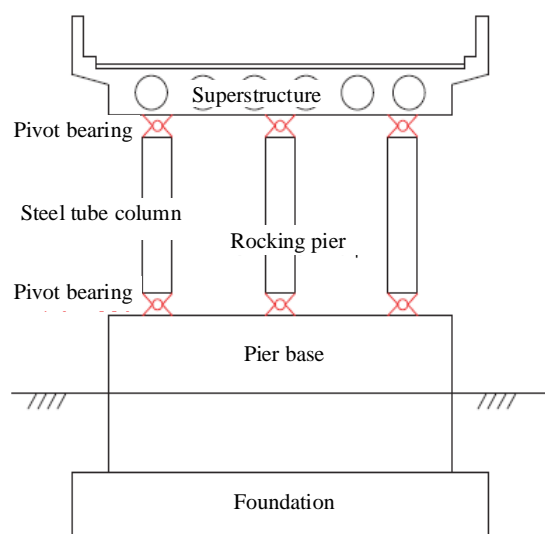
The rocking pier shown in Fig. 3 is 245 cm in height. The allowable displacement of the rocking pier is obtained by Eq. (5).

If 0.06 (rad) is adopted as the allowable rotation of pivot bearings based on the experiment conducted at the Railway Technical Research Institute, the rocking pier will fail when it is displaced 14.7 cm by reaching the rotation limit of the pivot bearing 0.06 (rad) [2].

Fig. 3 Cross sectional view of the rocking pier

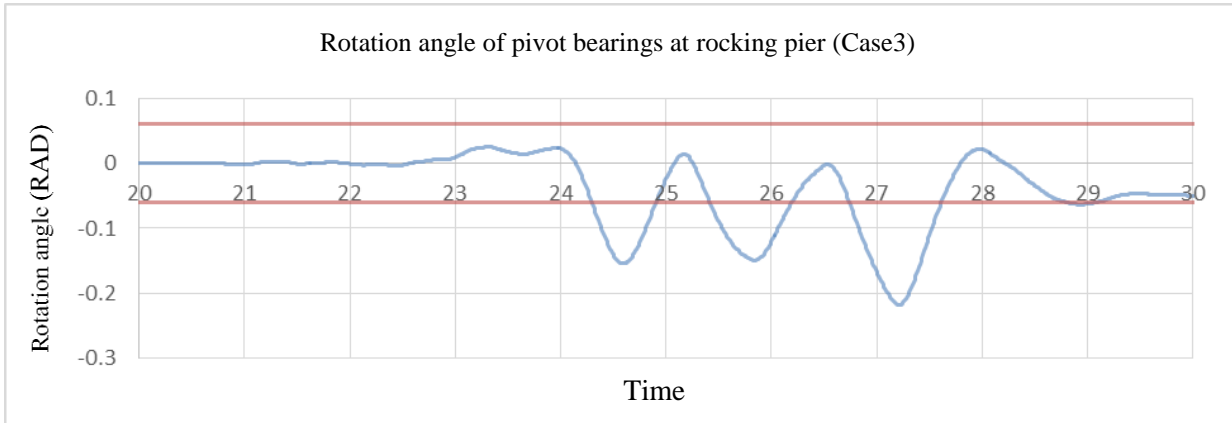
The analysis results of Case 3 (basic case) are explained here. Fig. 6 shows the time history response of the rotation of the pivot bearings installed at the upper and lower ends of Pier P2. The horizontal and vertical axes show the elapsed time and the rotation angle of the pivot bearings, respectively. The two parallel lines in Fig. 6 indicate the rotation angle 0.06 (rad) which is the rotation limit of the pivot bearings. The figure shows that the rotation angle of the pivot bearings exceeded the rotation limit 0.06 (rad) at 24.30 (sec). The figure also shows that the pivot bearings rotated to the obtuse angle side (south side) as well before the failure. Fig. 7 depicts the displacement of the entire bridge structure at 24.30 (sec) when the pivot bearings failed and the bridge collapsed. It is also the time when a large waveform appeared for the first time in the recorded waveform chart.

Fig. 6 Time history response of pivot bearings at rocking pier P2 (Case3)

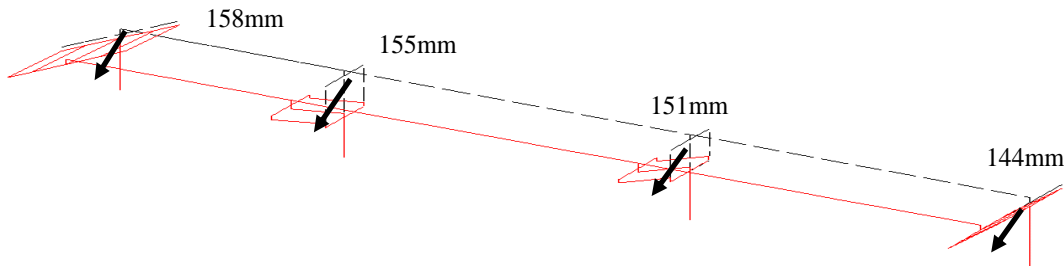
Fig. 7 Displacement of the entire bridge at 24.30 (sec) when pivot bearings failed (Case3)

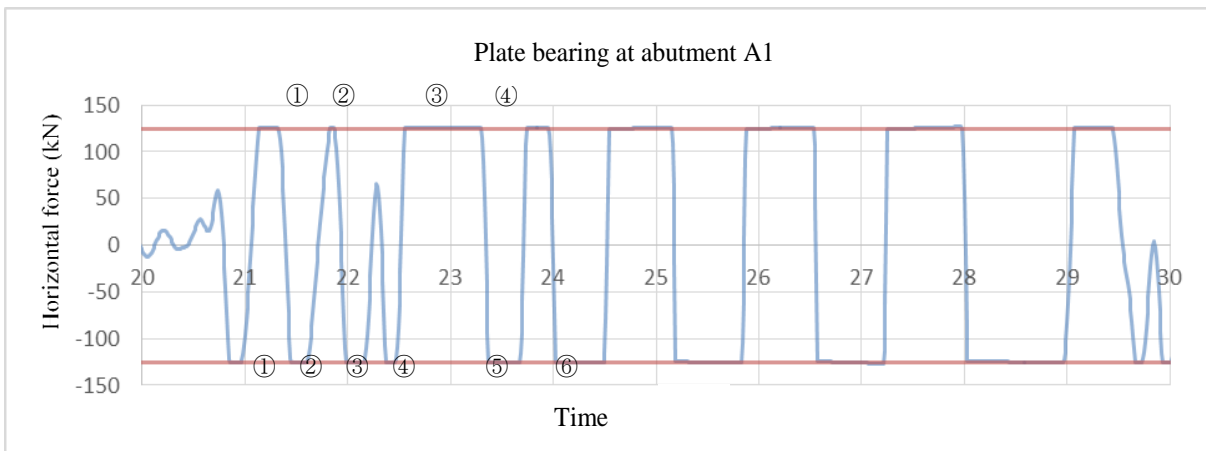
Fig. 8 indicates that the plate bearings at Abutment A1 collided six times to the north and four times to the south, including small collisions, before the collapse of the bridge. Fig. 9 shows that the plate bearings at Abutment A2 collided three times to the north and four times to the south before the collapse of the bridge. On the other hand, the displacement confining device on the north side at Abutment A1 was damaged at 24.28 (sec) and fell off almost immediately with the bridge. Fig.10 shows the displacement of the piers P1 and P2 at 24.30 (sec). Fig.11 shows the displacement of the girders at Abutment A1 and Abutment A2 at 24.30 sec.

Fig. 8 Time history response of the plate bearing at abutment A1 (Case3)

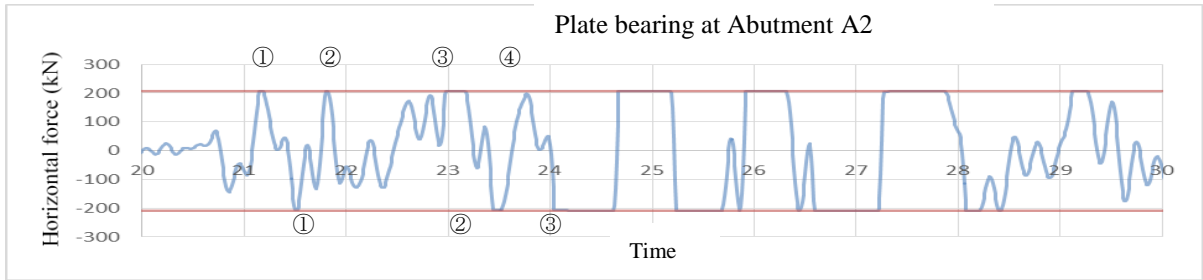
Fig. 9 Time history response of the plate bearing at Abutment A2 (Case3)

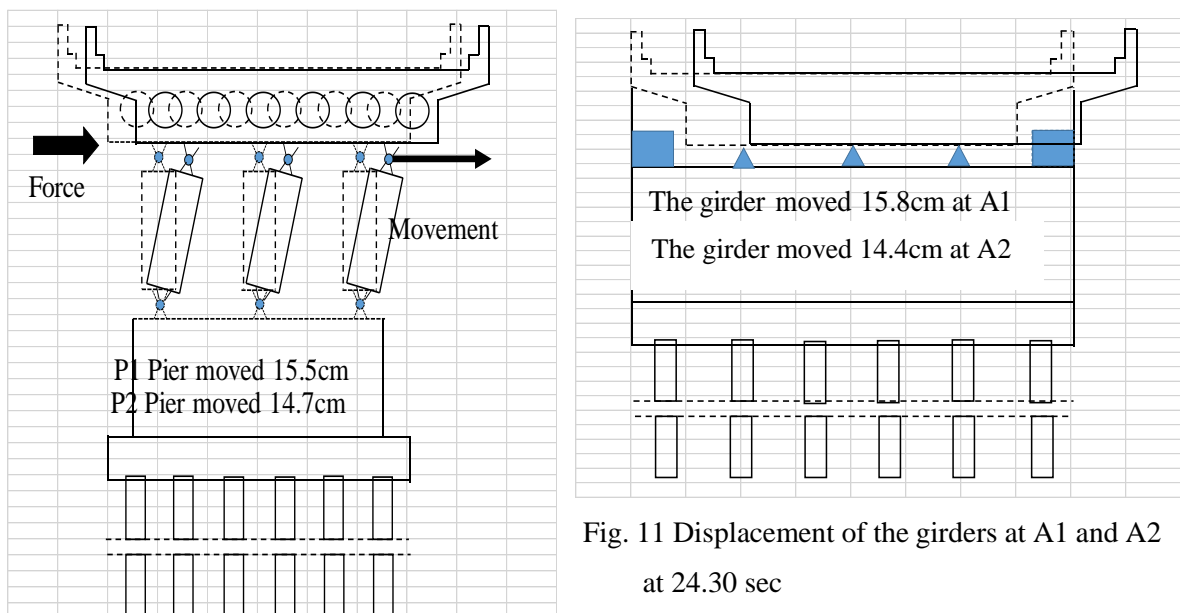
Fig. 10 Displacement of Piers P1 and P2  
 at 24.30 sec

Fig. 11 Displacement of the girders at A1 and A2  
 at 24.30 sec

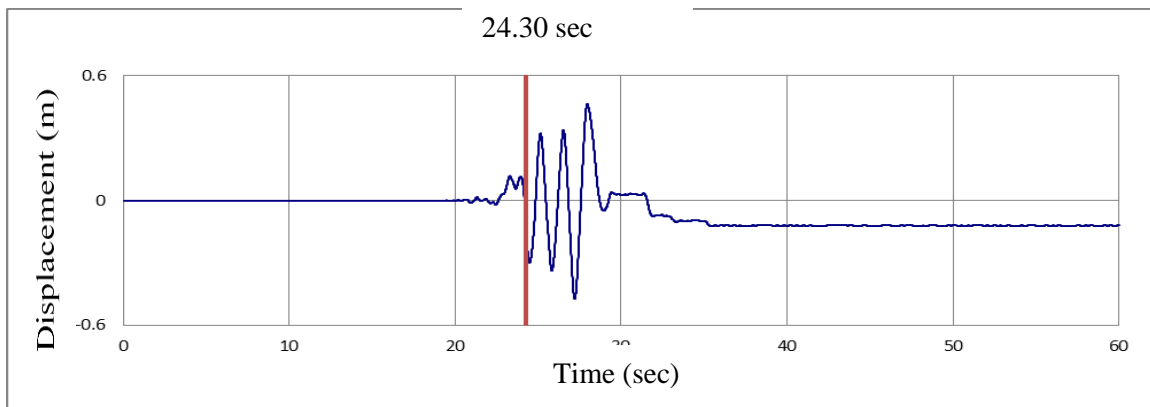
Fig. 12 describes the time history response of the end portion of the superstructure at Abutment A1 under seismic forces. The horizontal and vertical axes show the elapsed time and the horizontal displacement in the perpendicular direction, respectively. The horizontal displacement moved back and forth before the bridge collapse time of 24.30 sec. At 24.30 sec, the displacement at Abutment A1 was 158 mm and the displacement at Abutment A2 was 144mm, as shown in Fig. 7 and 11. The end portion of the superstructure was moved to the north significantly due to the effect of not only the rotational motion but also the large acting force to the north. This suggests that a displacement confining device with sufficient strength should be installed on both sides of the main girder at both abutments without regard to whether there is a skew angle or not.

Fig.12 Time history response of the girder at Abutment A1(Case3)

- 3) The superstructure is often moved back and forth in the perpendicular direction when subjected to seismic forces. Therefore, as the improvement measures for this type of bridge we propose to increase the punching shear resistance of the connection area of a displacement confining device and the bridge seat, and to increase the installation of displacement confining devices to all four positions, on both sides of the main girder at both abutments.
