FAILURE MECHANISM OF THE FURYO DAIICHI BRIDGE IN THE 2016 KUMAMOTO EARTHQUAKE

Kosa Kenji,

Kyushu Institute of Technology

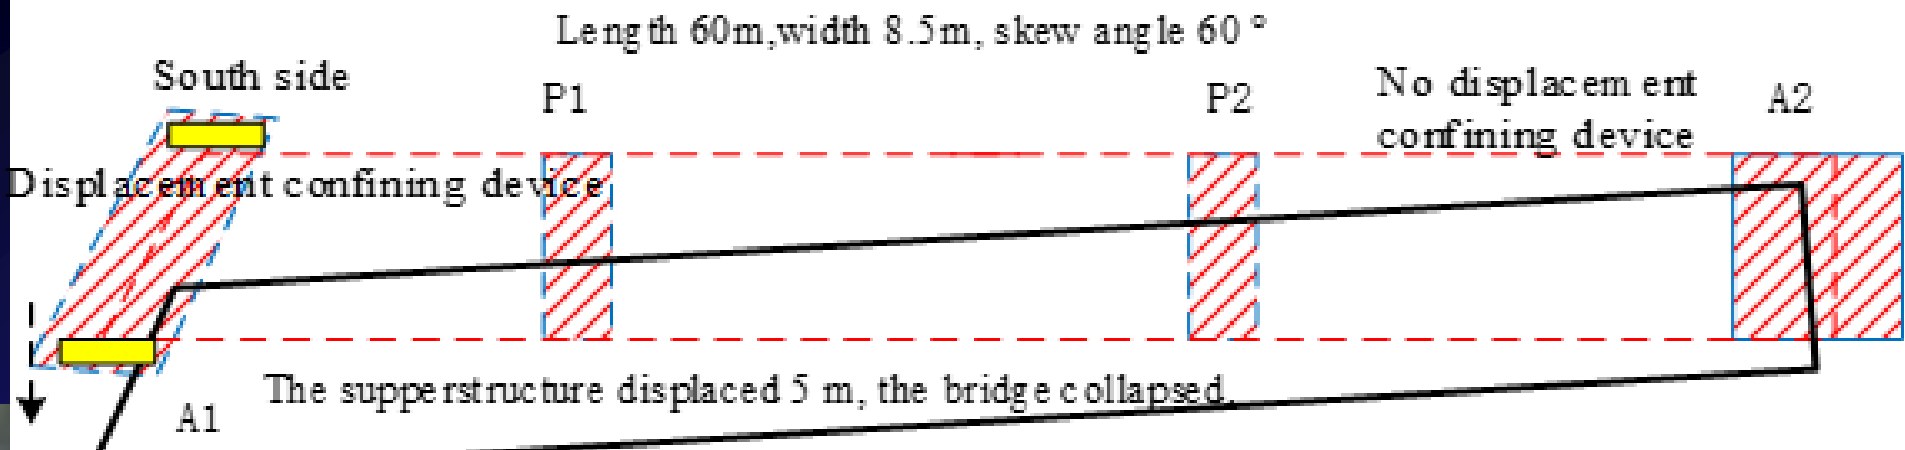
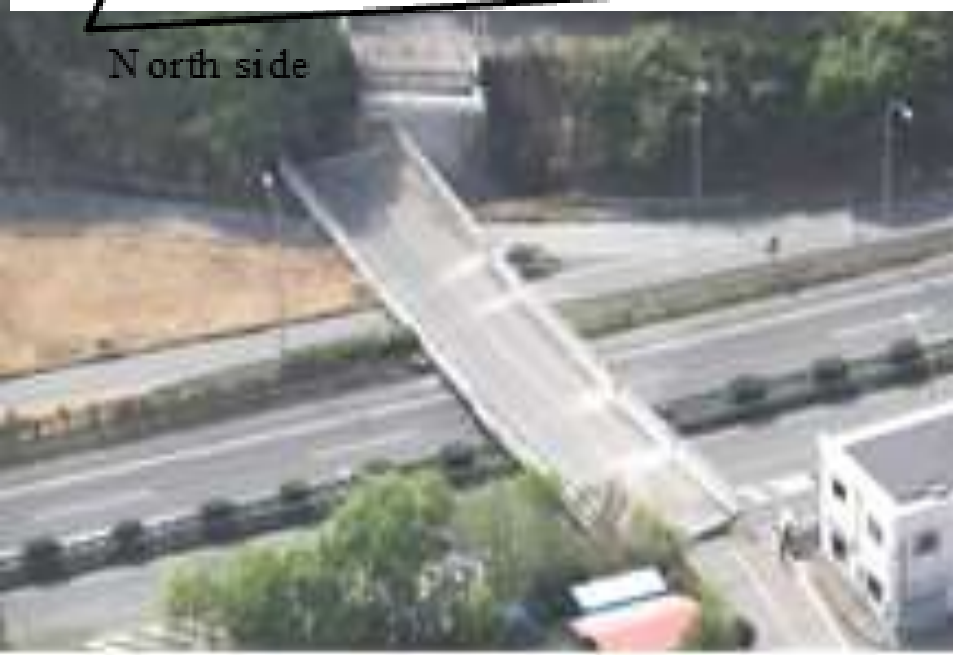
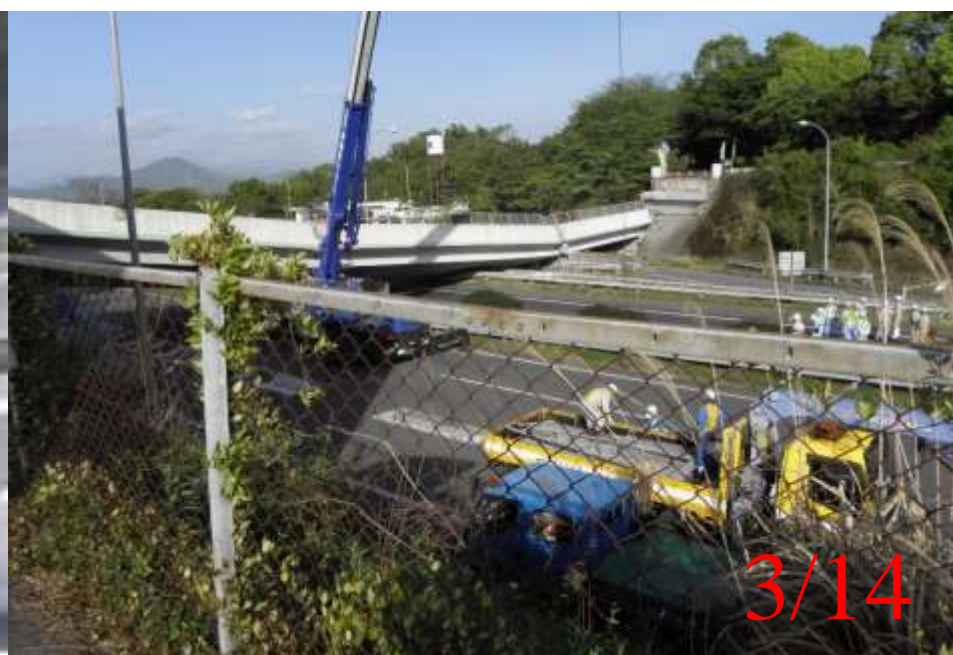
1. Furo Daiichi was an overbridge crossing over the Kyushu Expressway.
2. The bridge collapsed onto the expressway due to a large displacement to the perpendicular direction.

- 1.Span length 60m, and P1,P2 rocking piers
- 2.Supperstructure displaced 5m,bridge collapsed.

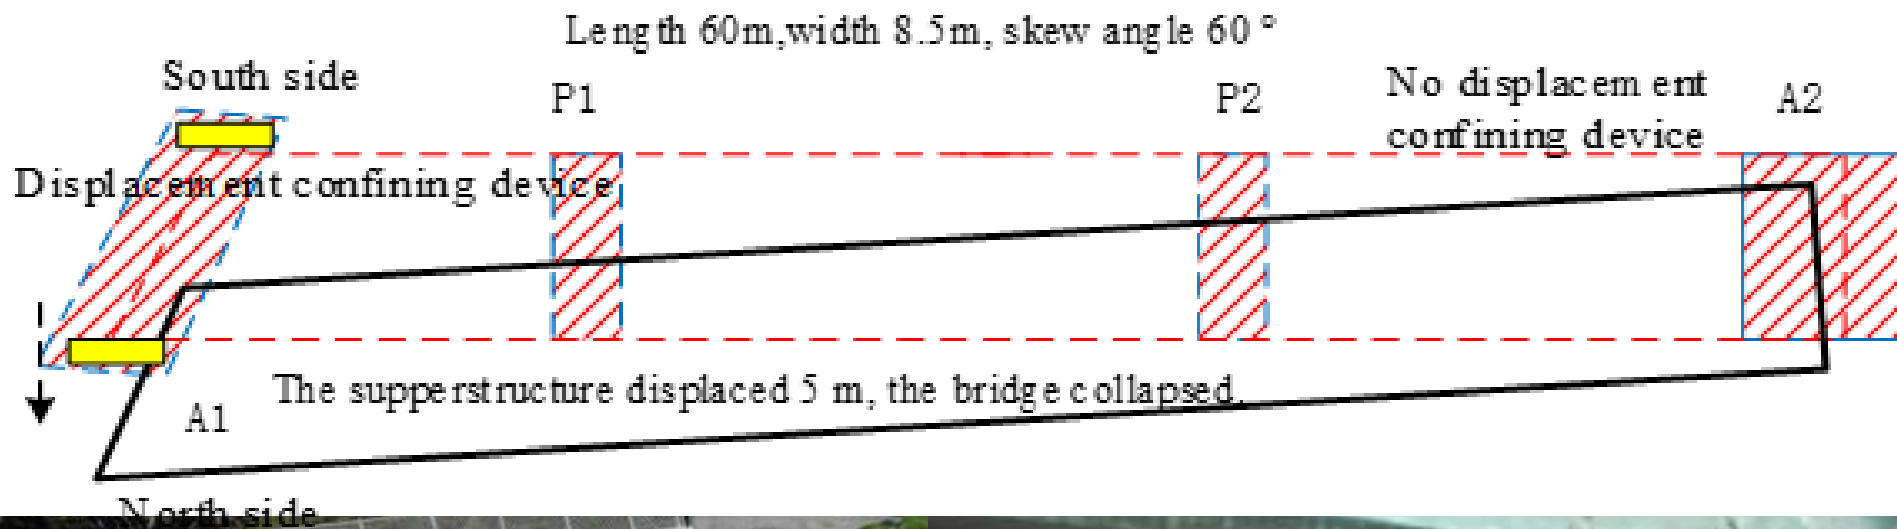
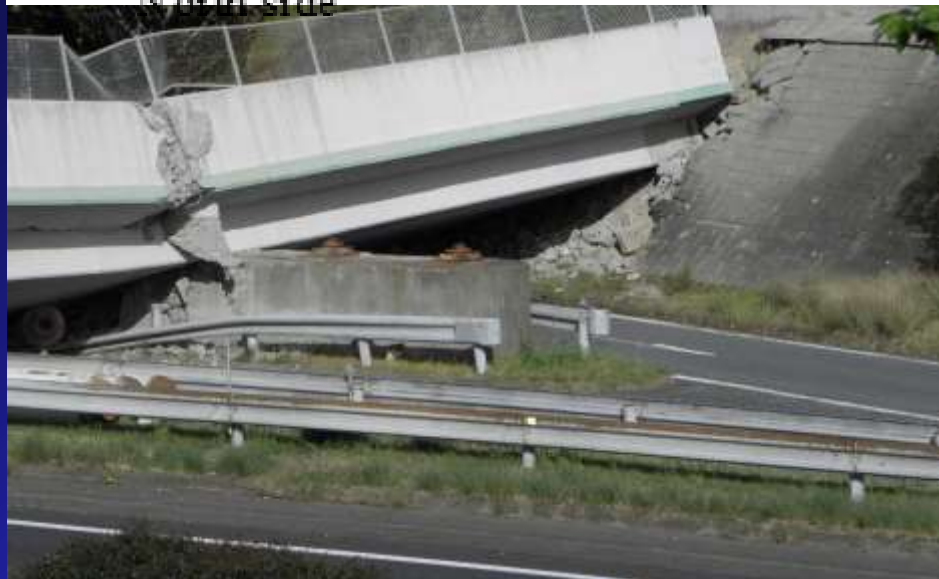
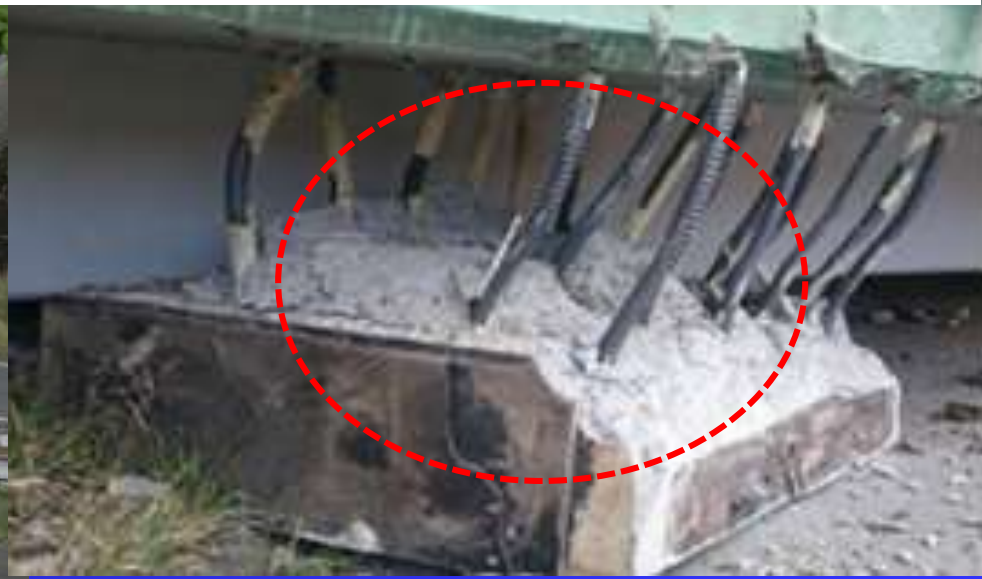
1. Skewed superstructure collided against the displacement confining device.
2. A punching shear failure occurred at the connection.

1. When rocking piers were displaced 14.7cm (rotation of the pivot bearing 0.06rad), the bridge collapsed.

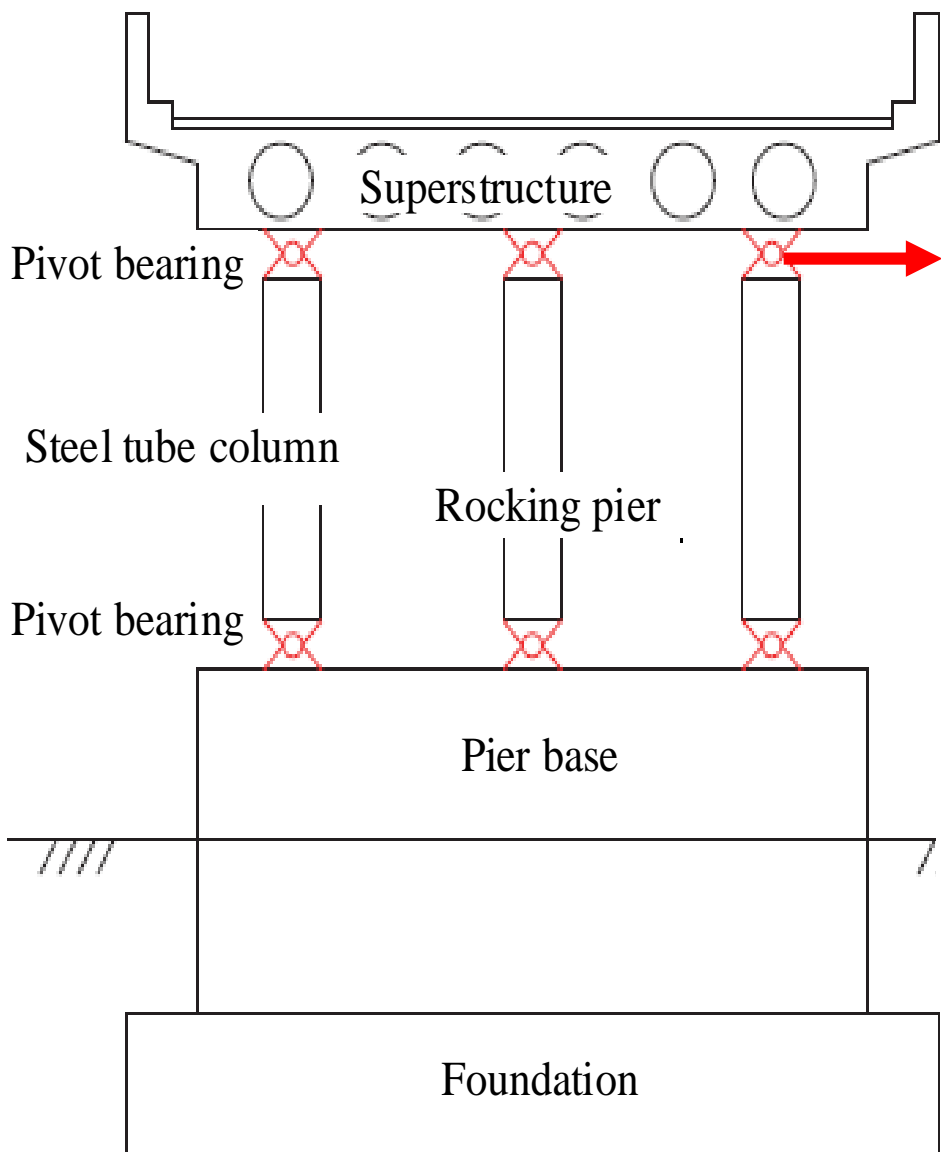
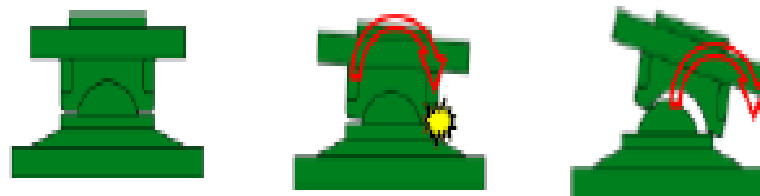
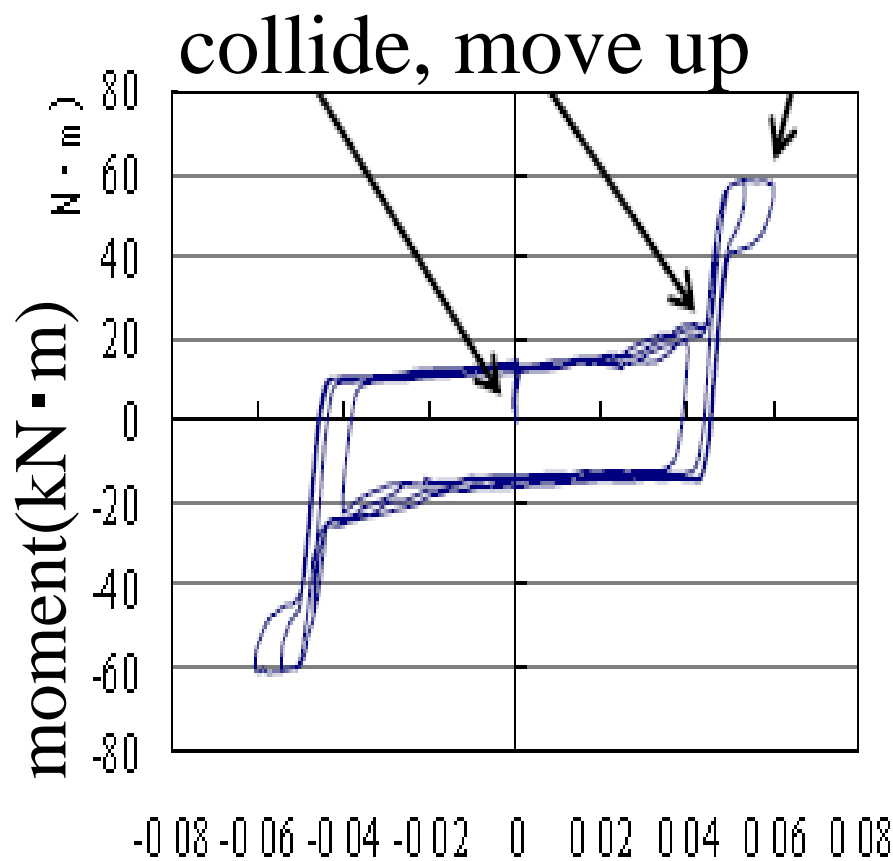
Rotation(rad) 5/14

I. Punching shear resistance

$$(\tau_c : 0.22\text{N/mm}^2)$$

$$1076\text{kN}(1.7R_d)$$

II. Design seismic force

$$= 3 \cdot k_h \cdot R_d = 1554\text{kN}$$

Resistance is smaller than force.

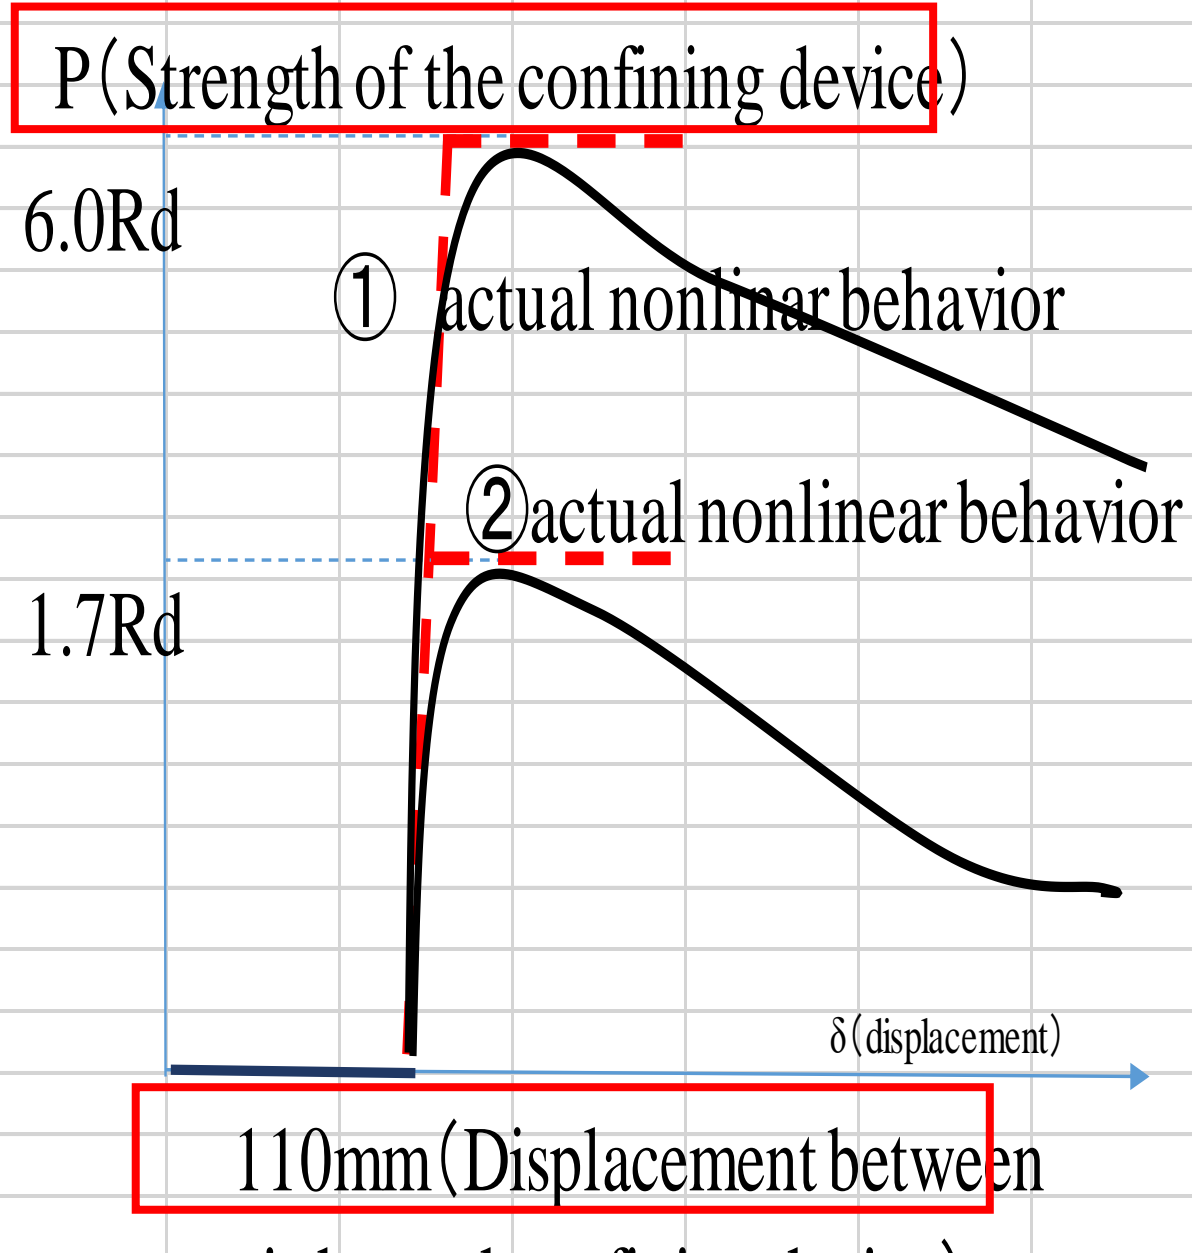
Fig. Resistance of confining device

- 1. Punching shear resistance is small.
- 2. 150mm: allowable displacement of girder
- 3. 110mm: clearance between girder and confining device.

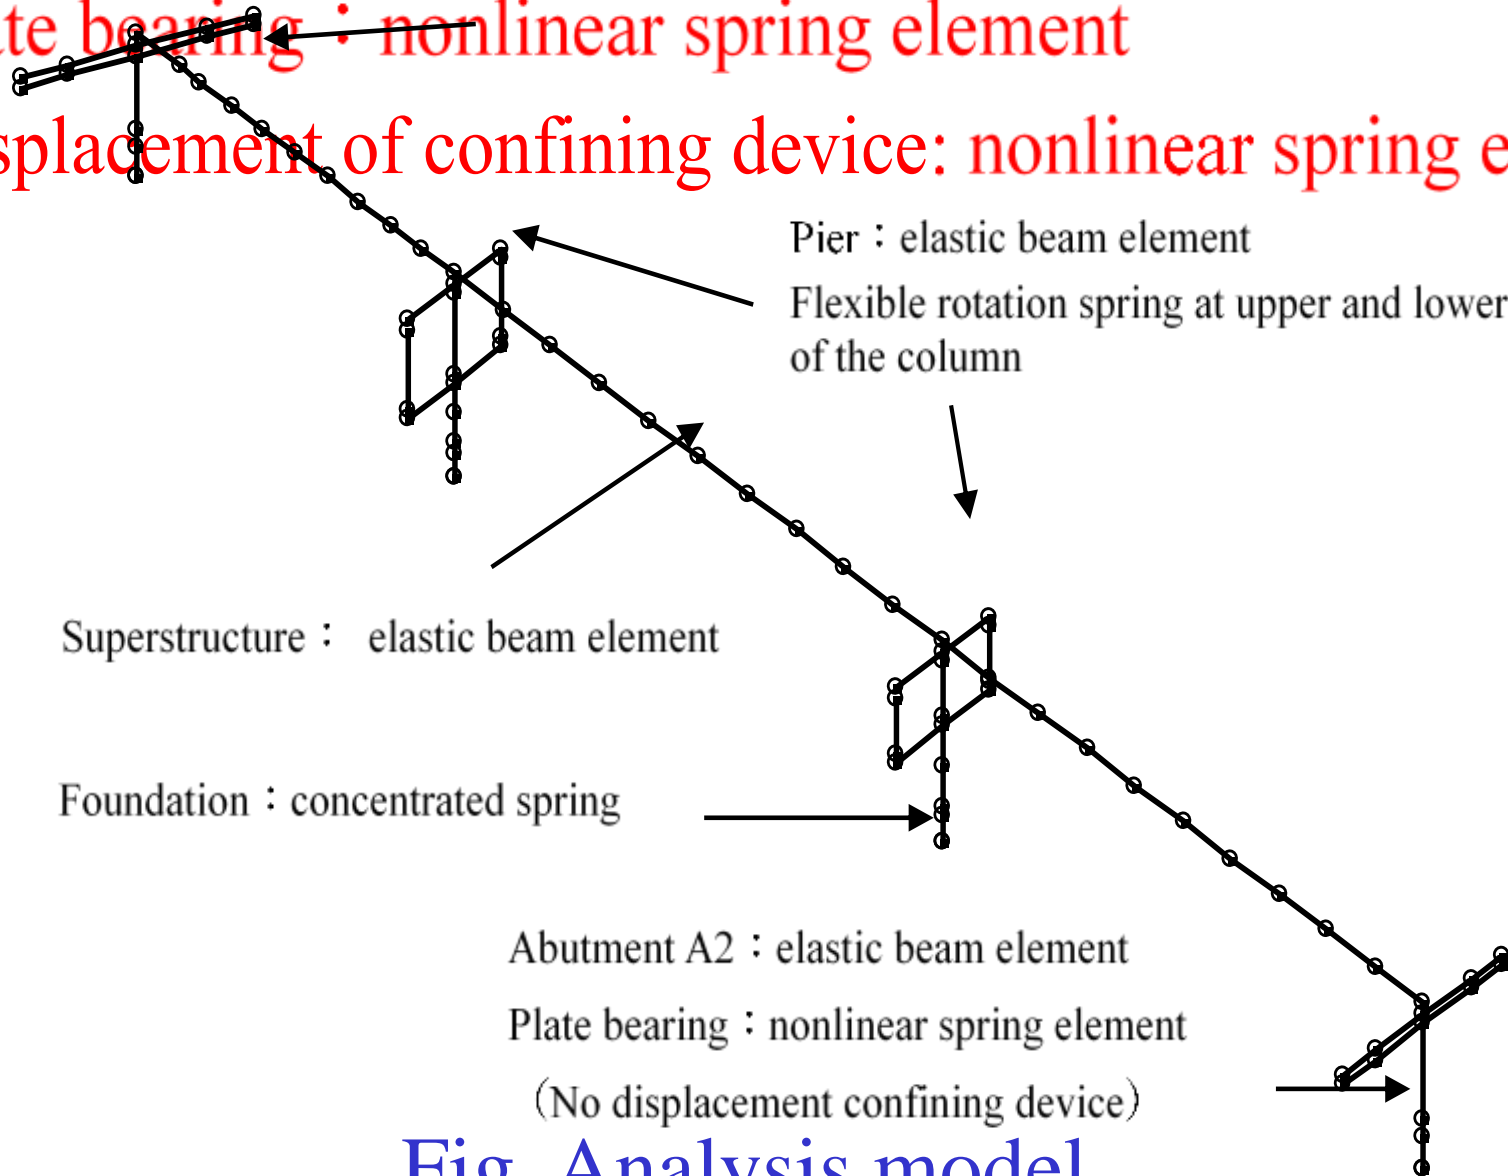
Fig. Analysis model

Abutment A1 : elastic beam element

Plate bearing : nonlinear spring element

Displacement of confining device: nonlinear spring element

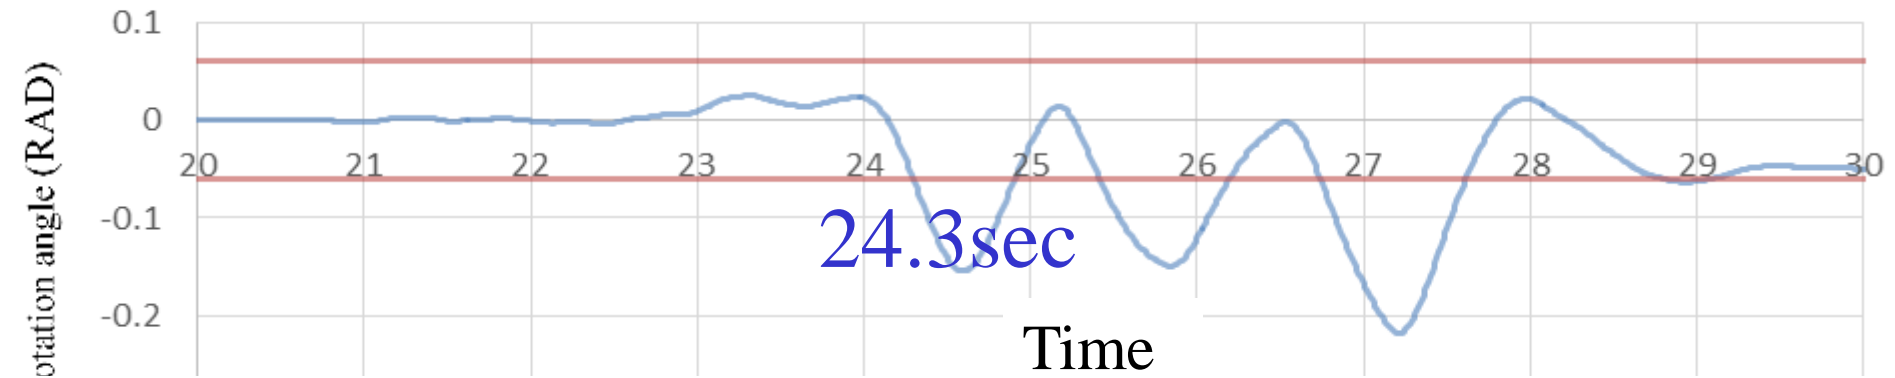
Fig. 6 Time history response of pivot bearing in Case3

Rotation angle of pivot bearing at rocking pier (Case3)

In case3, rotation of pivot exceeds 0.06 rad at 24.3 sec.

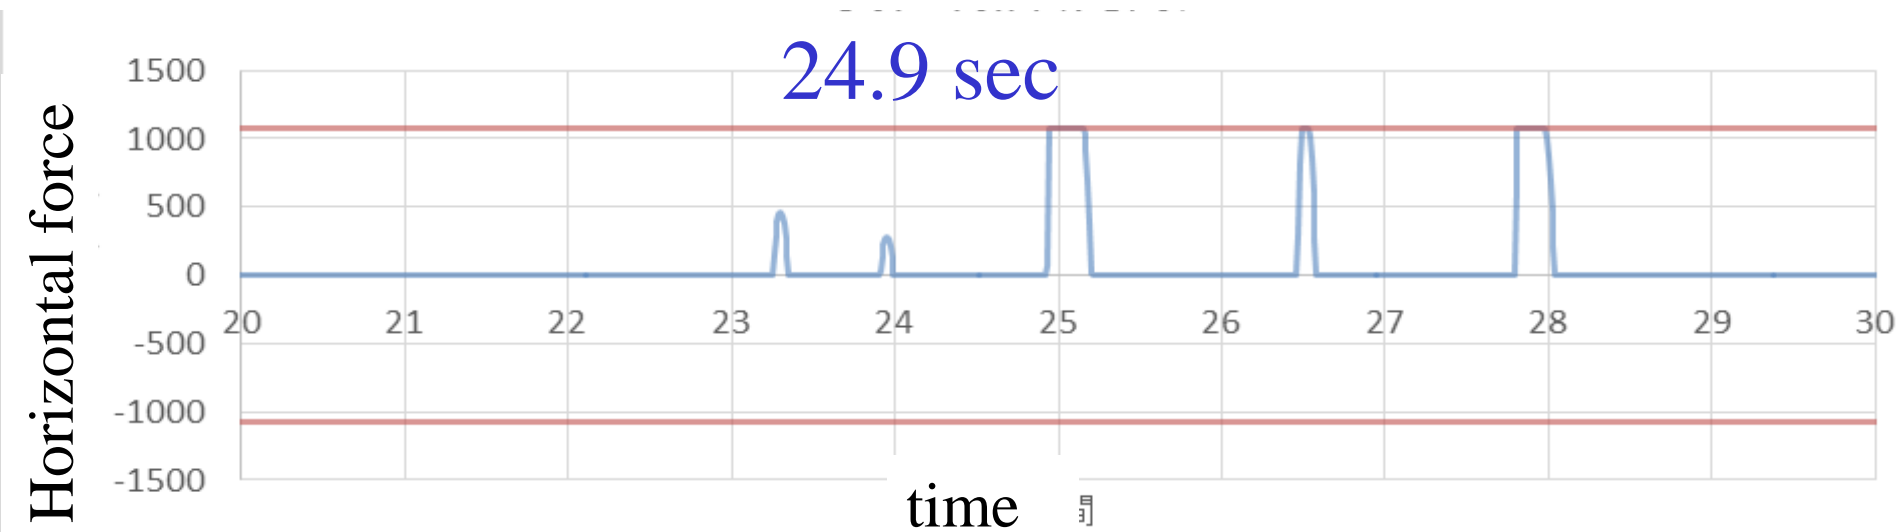
Fig. Time history of confining device on the south side.

Failure order of CASE3 :

③ confining device (north side) [24.28]

④ P2 pier pivot bearing [24.30], bridge collapse.

Actual damage: No damage confining device at the south side.

Analysis results showed the same damage.

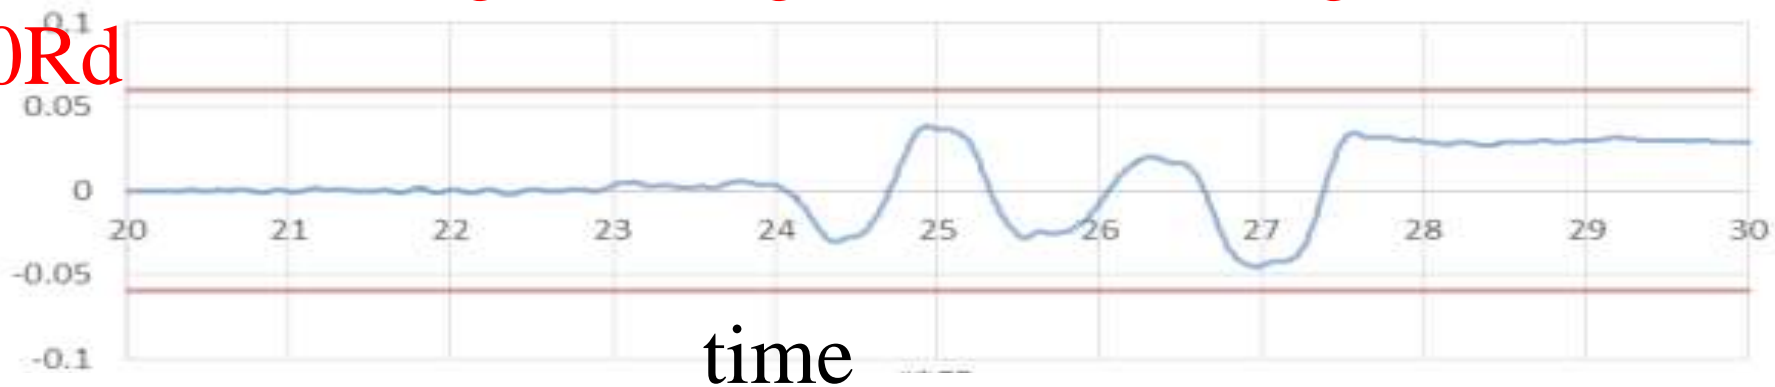
Fig. Time history response of pivot bearing at P2 (CASE2)

In case2, rotation is within 0.06rad.

1. The damage was caused not only by the rotation of the superstructure but also by the movement of the superstructure to the perpendicular direction due to seismic force.
2. As the improvement measures, We propose to increase the punching shear resistance of a confining device.

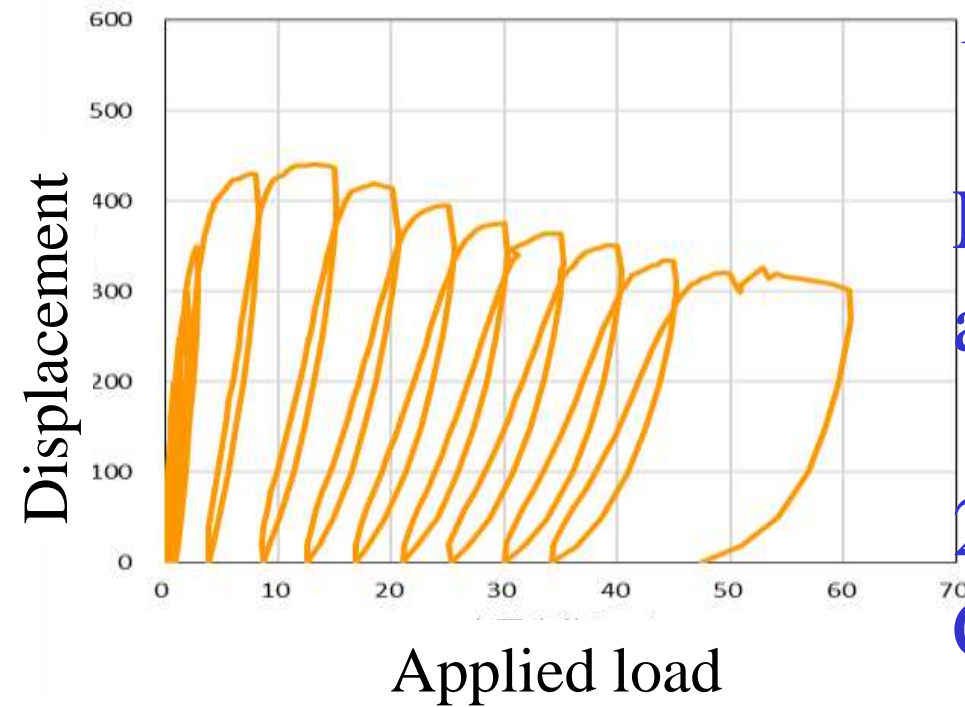
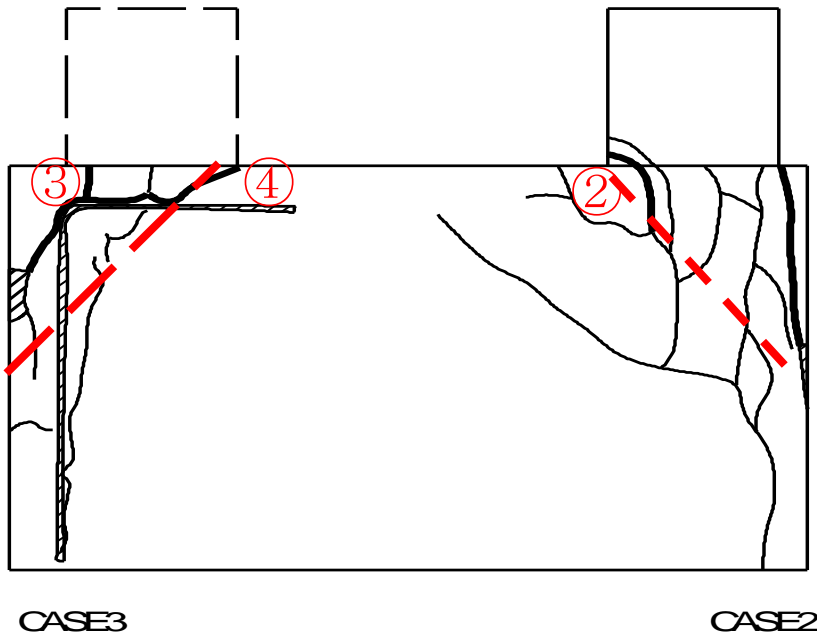
2. Fig. Ultimate Cracks at Cross section

Cracks starts from the anchor bolt position.

3. Results shows the good agreement with Road Specifications.
