Damage of Bridges due to kumamoto Earthquake

Kenji Kosa

Kyushu Institute of Technology

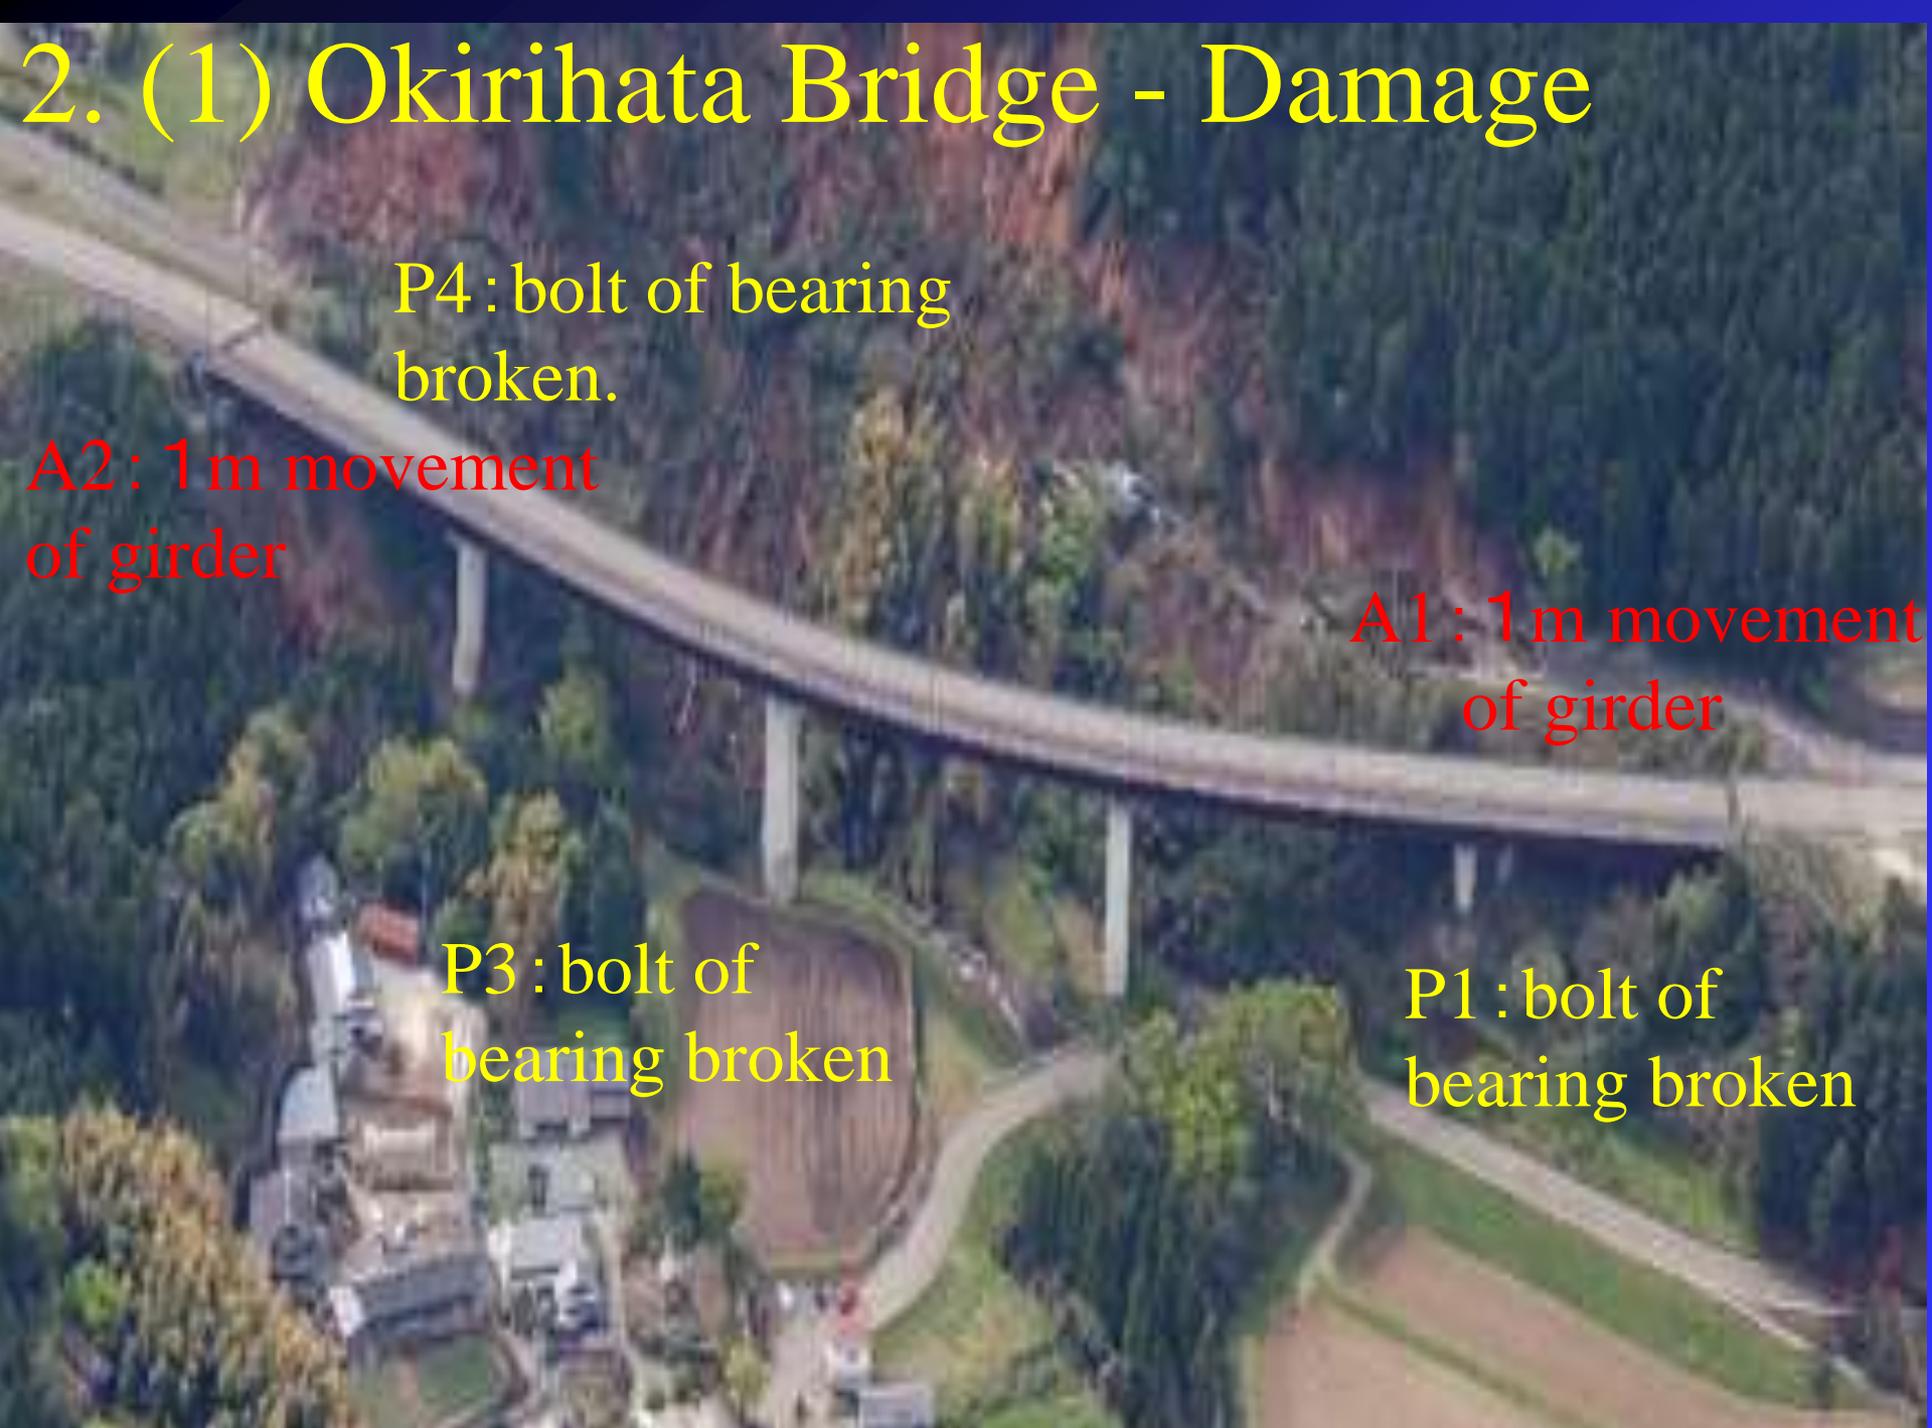
2. (1) Okirihata Bridge - Damage

P4 : bolt of bearing
broken.

A2 : 1 m movement
of girder

A1 : 1 m movement
of girder

P3 : bolt of
bearing broken

P1 : bolt of
bearing broken

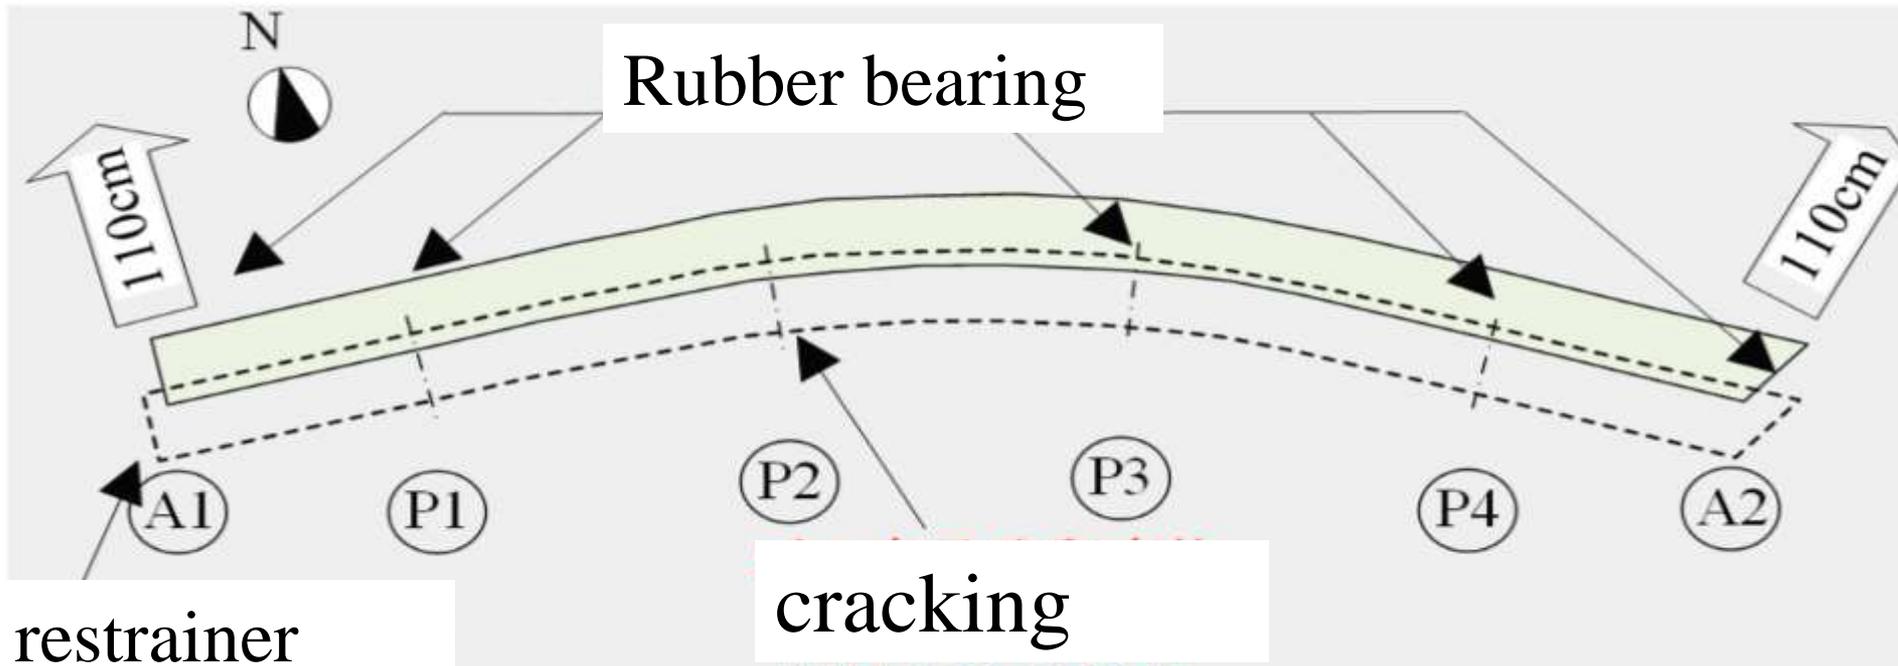
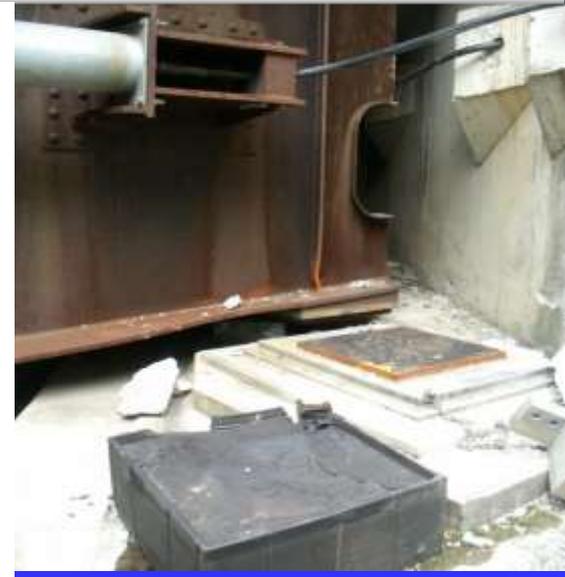
2. (2) Okirihata Bridge - Damage

1. At A1, A2, P1, P3, P4, rubber bearings were broken.
2. At P2, cracking occurred at the column.
3. At A1, PC cable restrainers were broken.

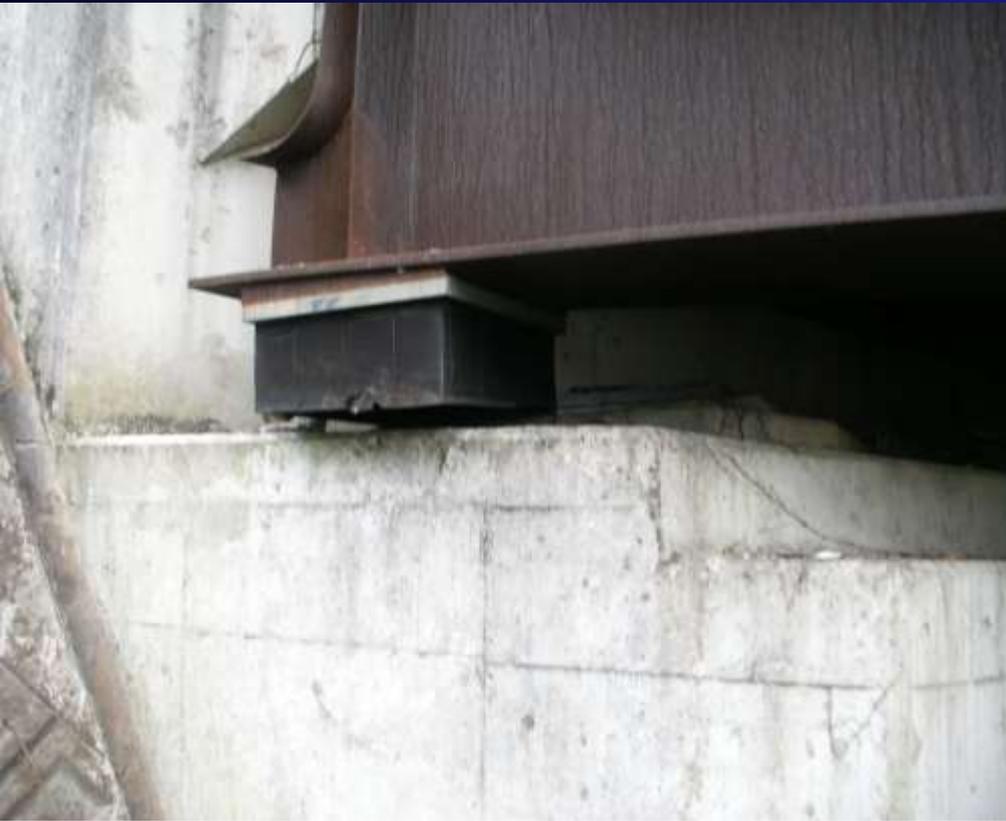
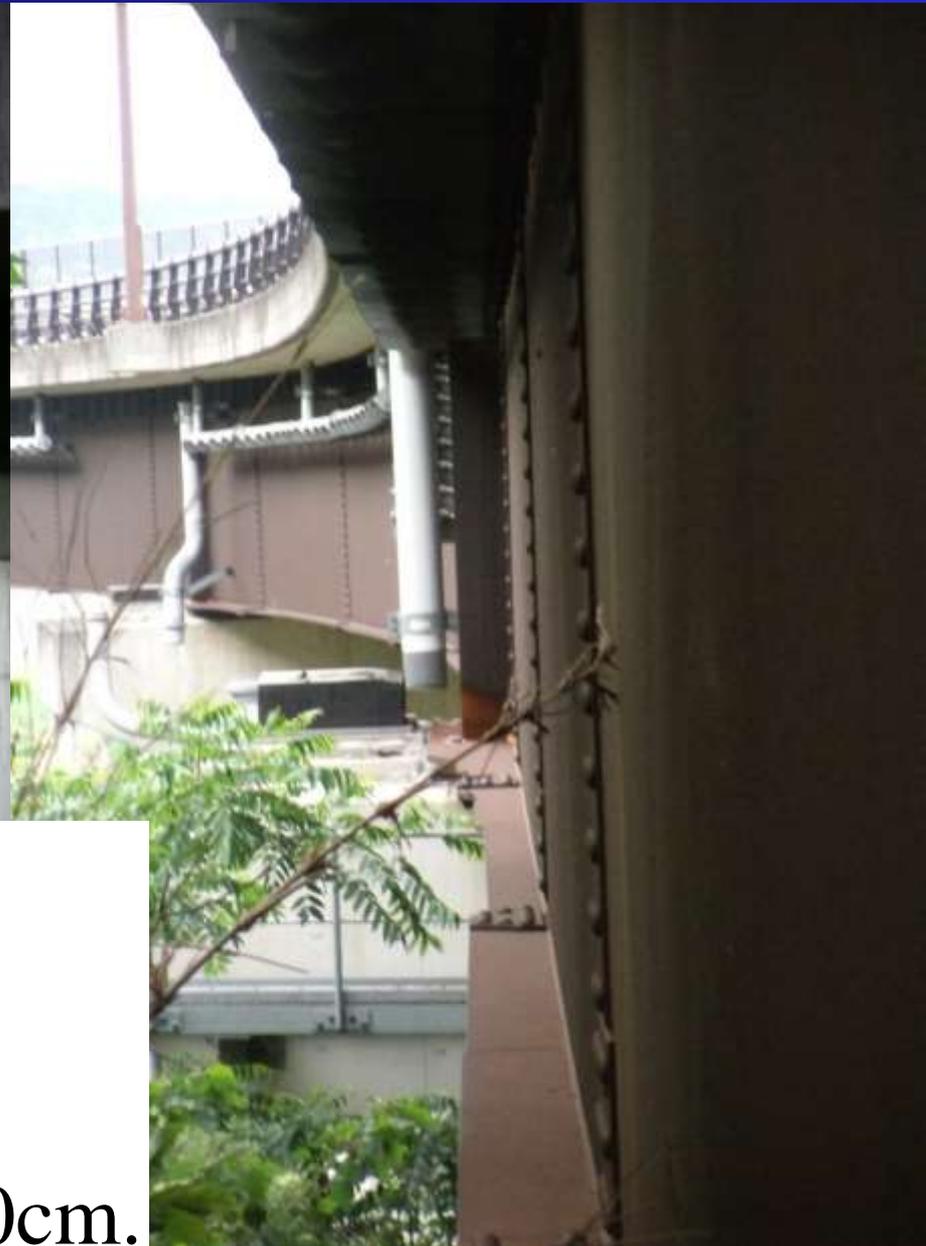
2. (3) Okirihata - Rubber Bearing

Rubber portion of rubber bearing was broken.

Main girder moved to the transverse direction about 30cm.

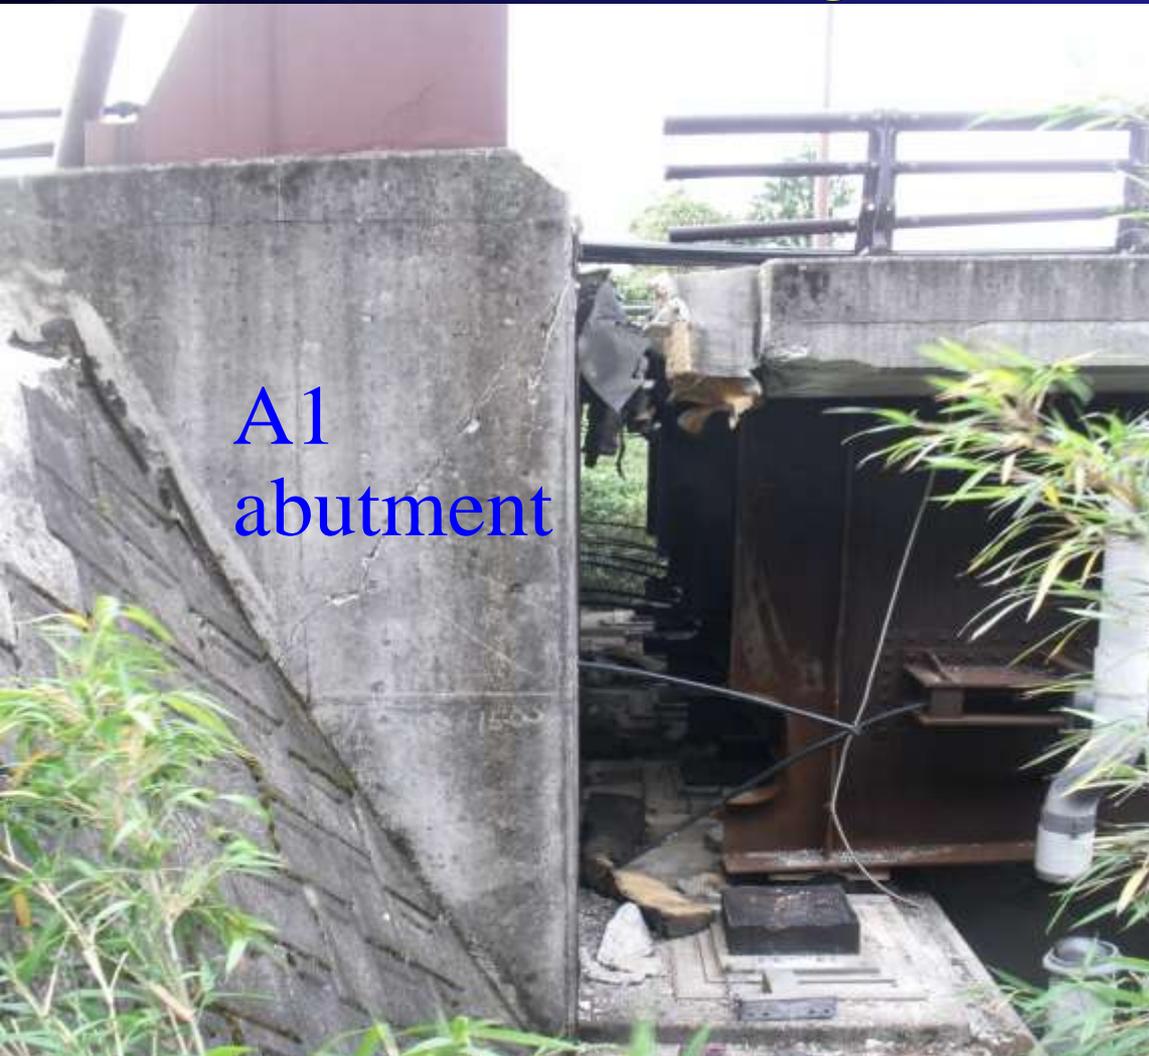
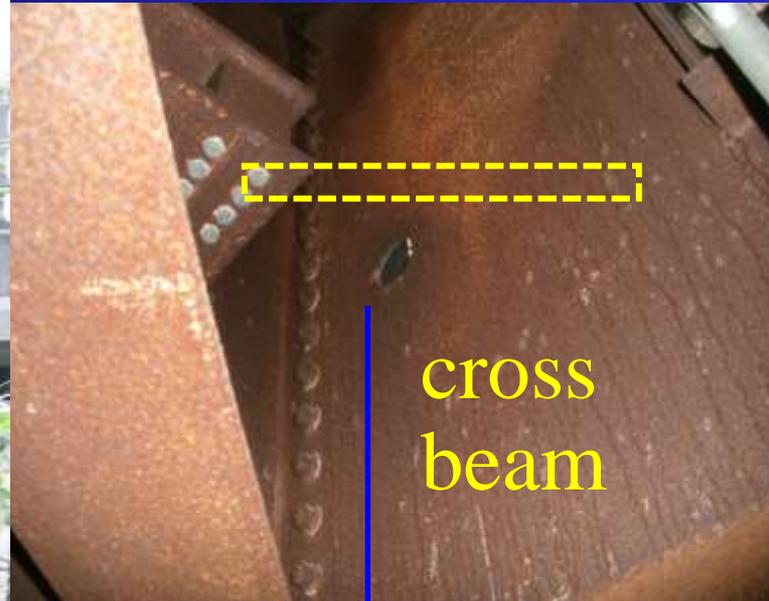
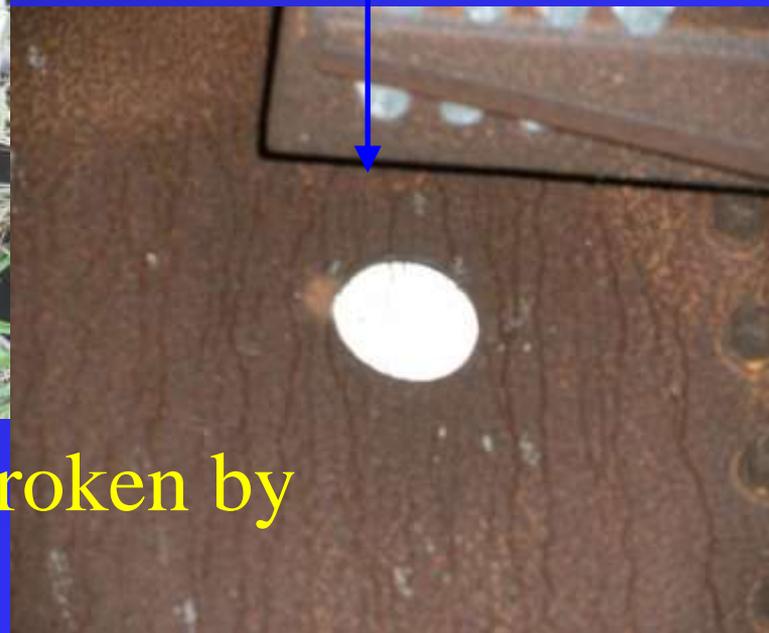
2. (4) Okirihata Bridge - cable restrainer

All (10) cable restrainers were broken by the movement of girder.

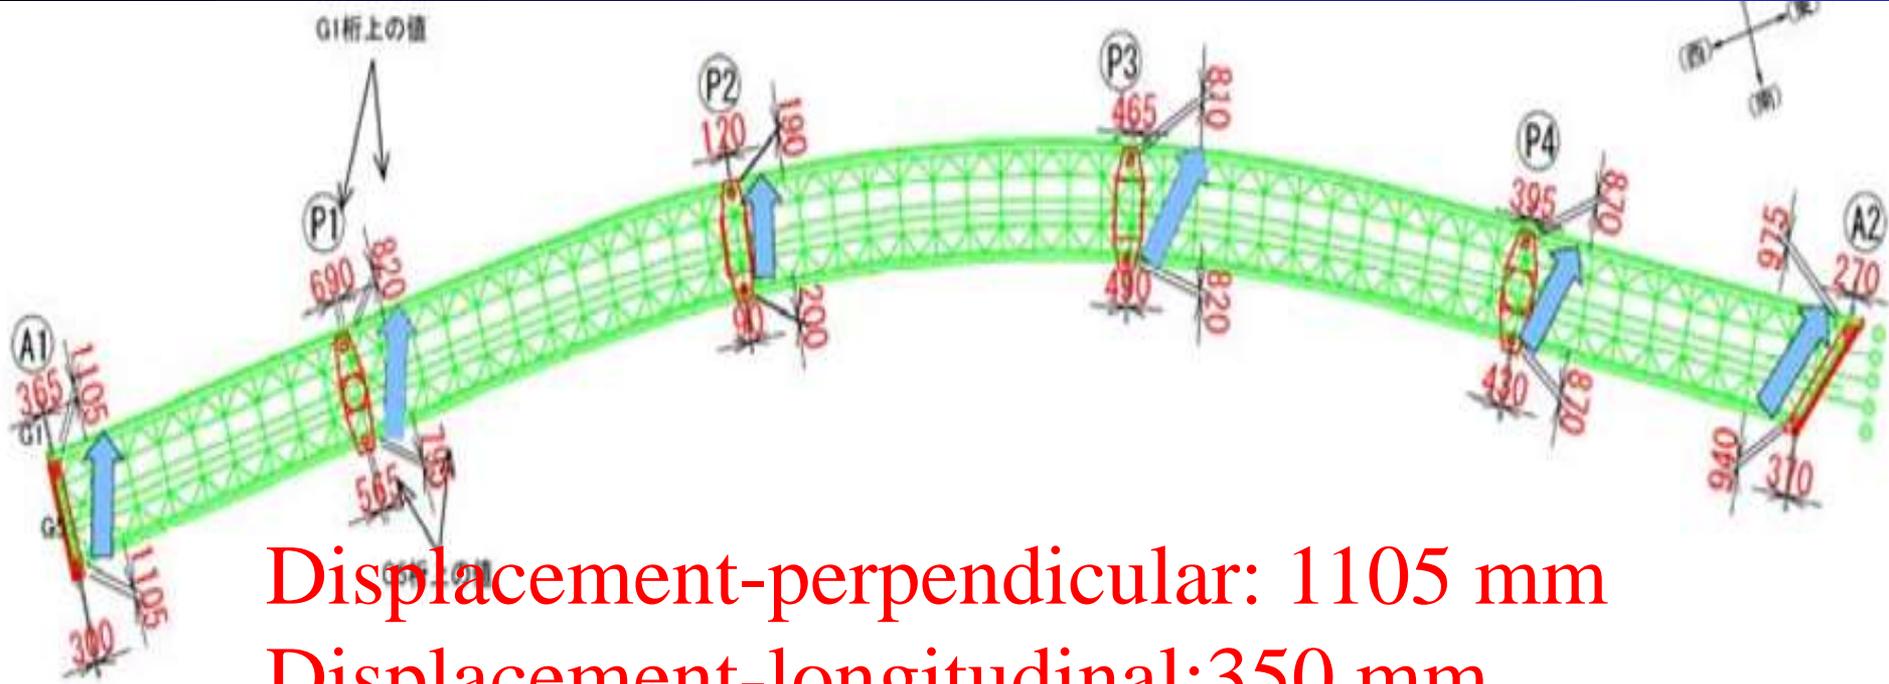
Displacement-perpendicular: 1105 mm

Displacement-longitudinal: 350 mm

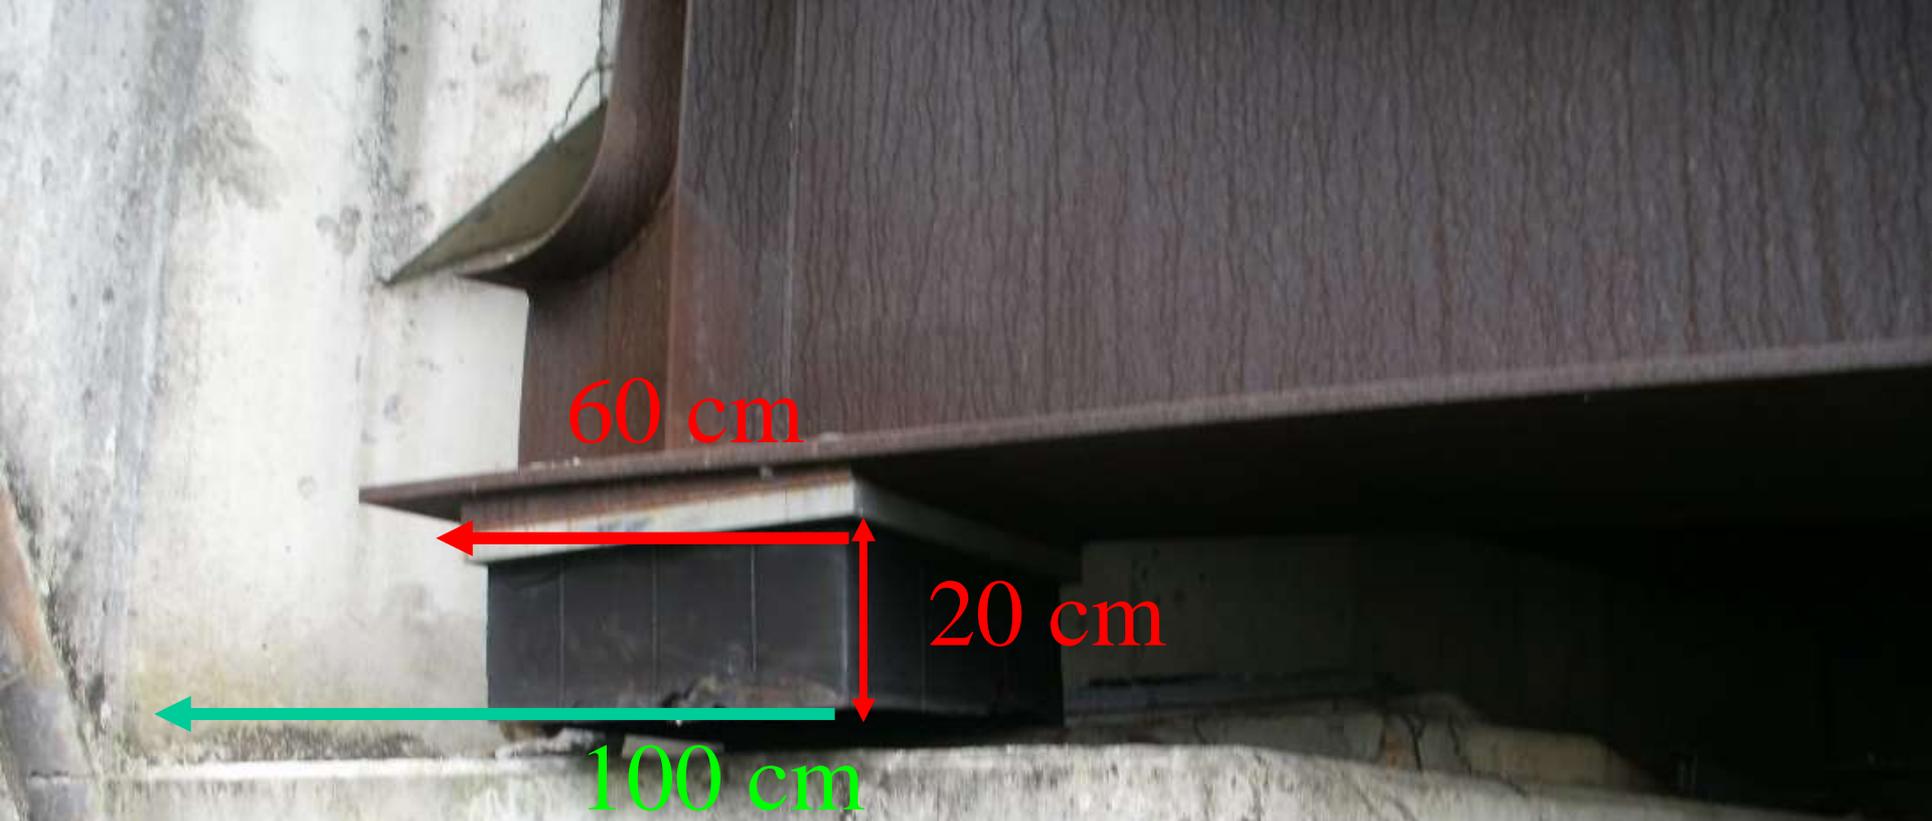
2. (5) Okirihata Bridge – Damage of Rubber Bearing

1. The Rubber portion was broken into two parts.

2. Displacement between upper rubber portion and lower rubber portion was measured.

3. About 1 m displacement was observed due to the movement at substructure.

4. Rubber bearing was weak for ground movement

Allowable displacement = $20 \cdot 300\% = 60\text{cm}$

Actual Displacement = 100cm

Rubber bearing was weak for ground movement

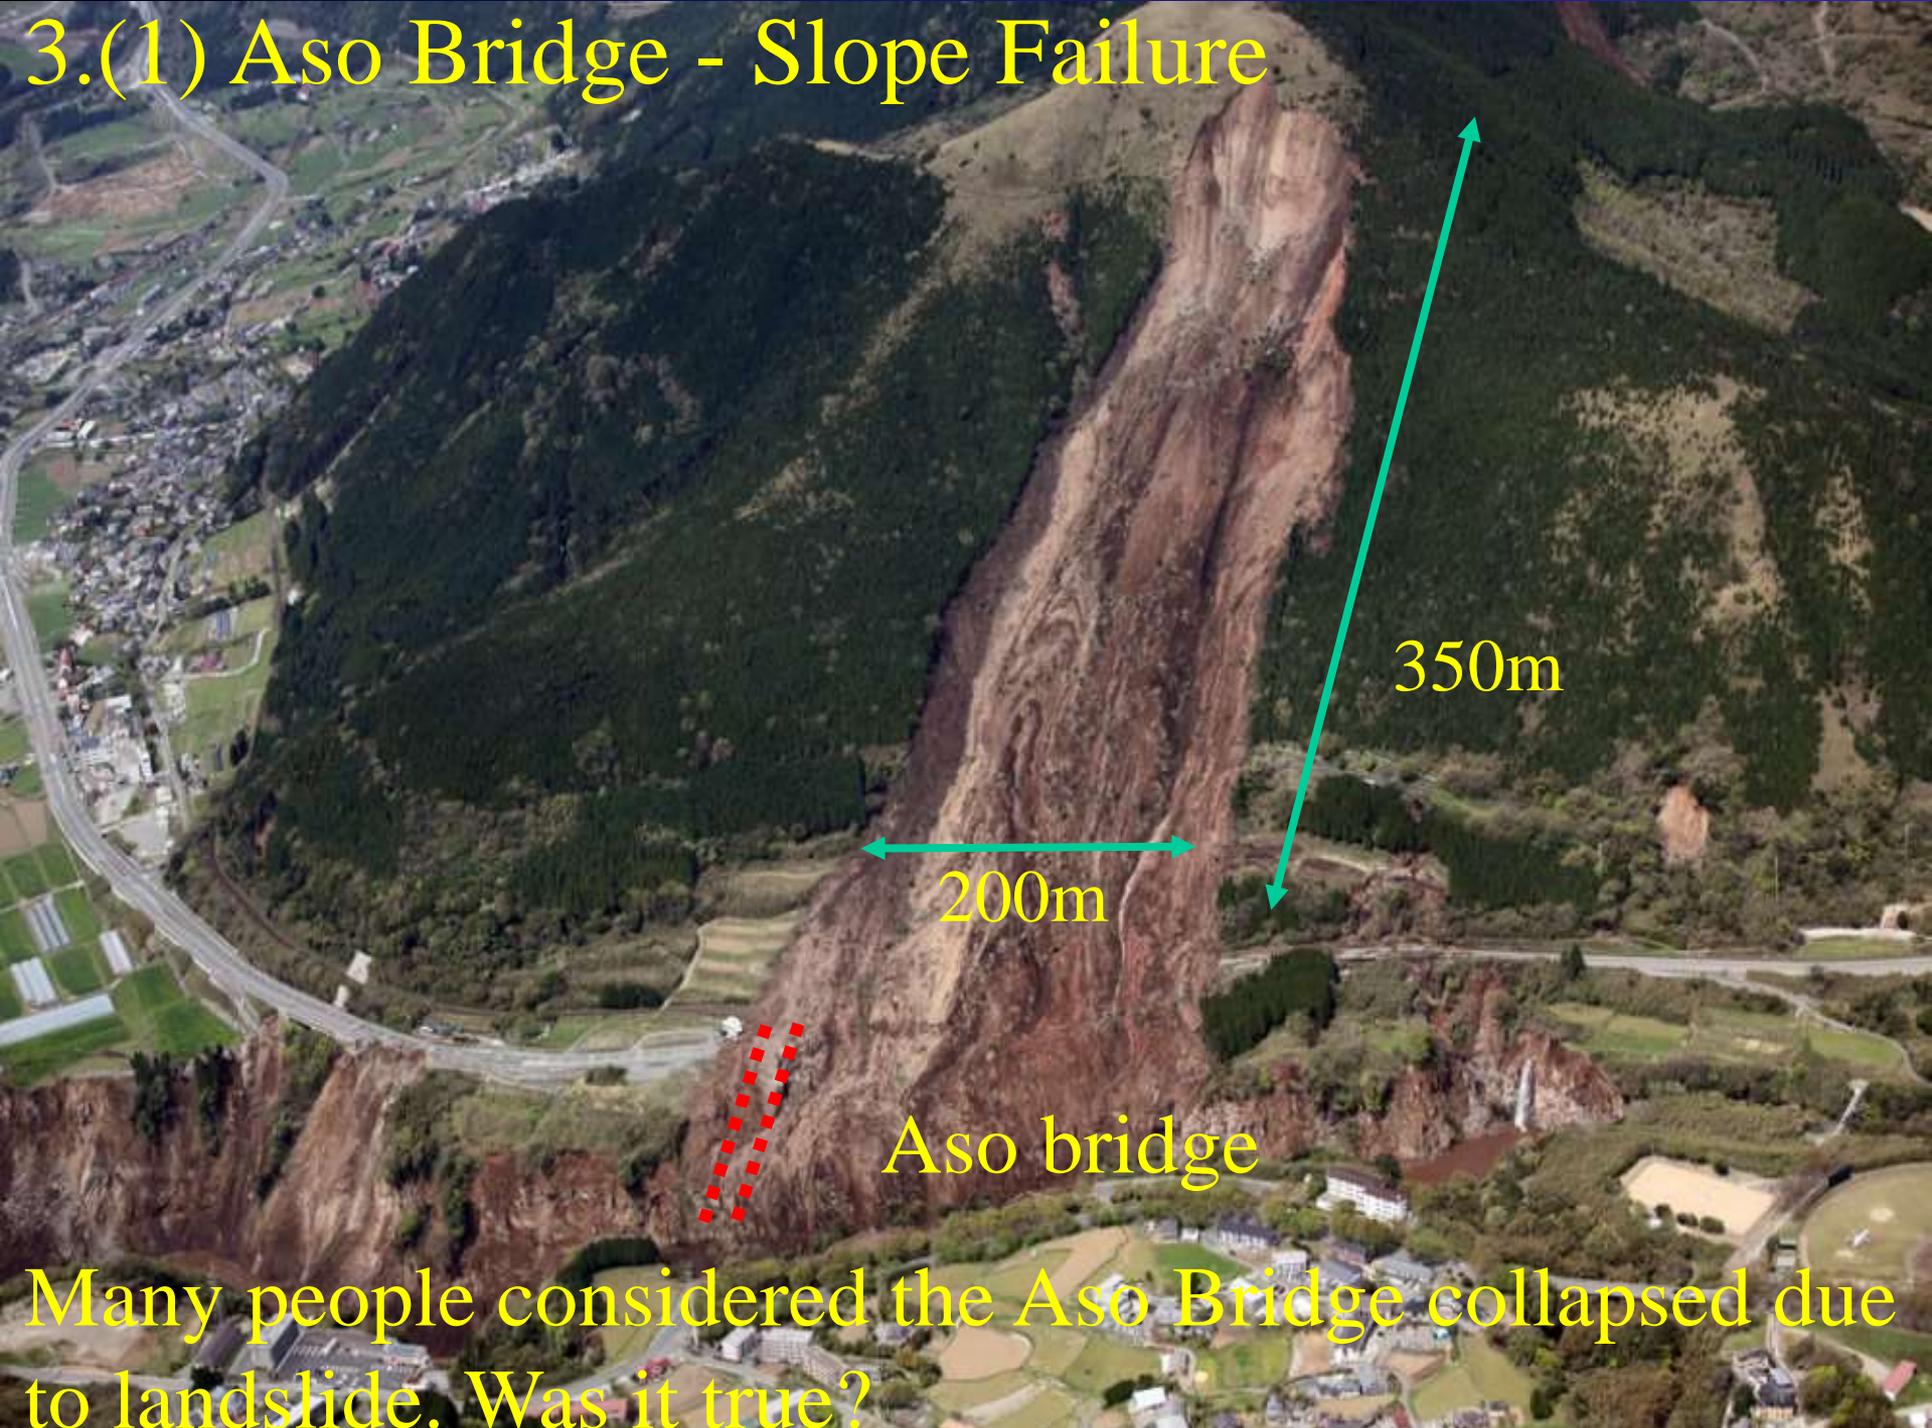
3.(1) Aso Bridge - Slope Failure

Many people considered the Aso Bridge collapsed due to landslide. Was it true?

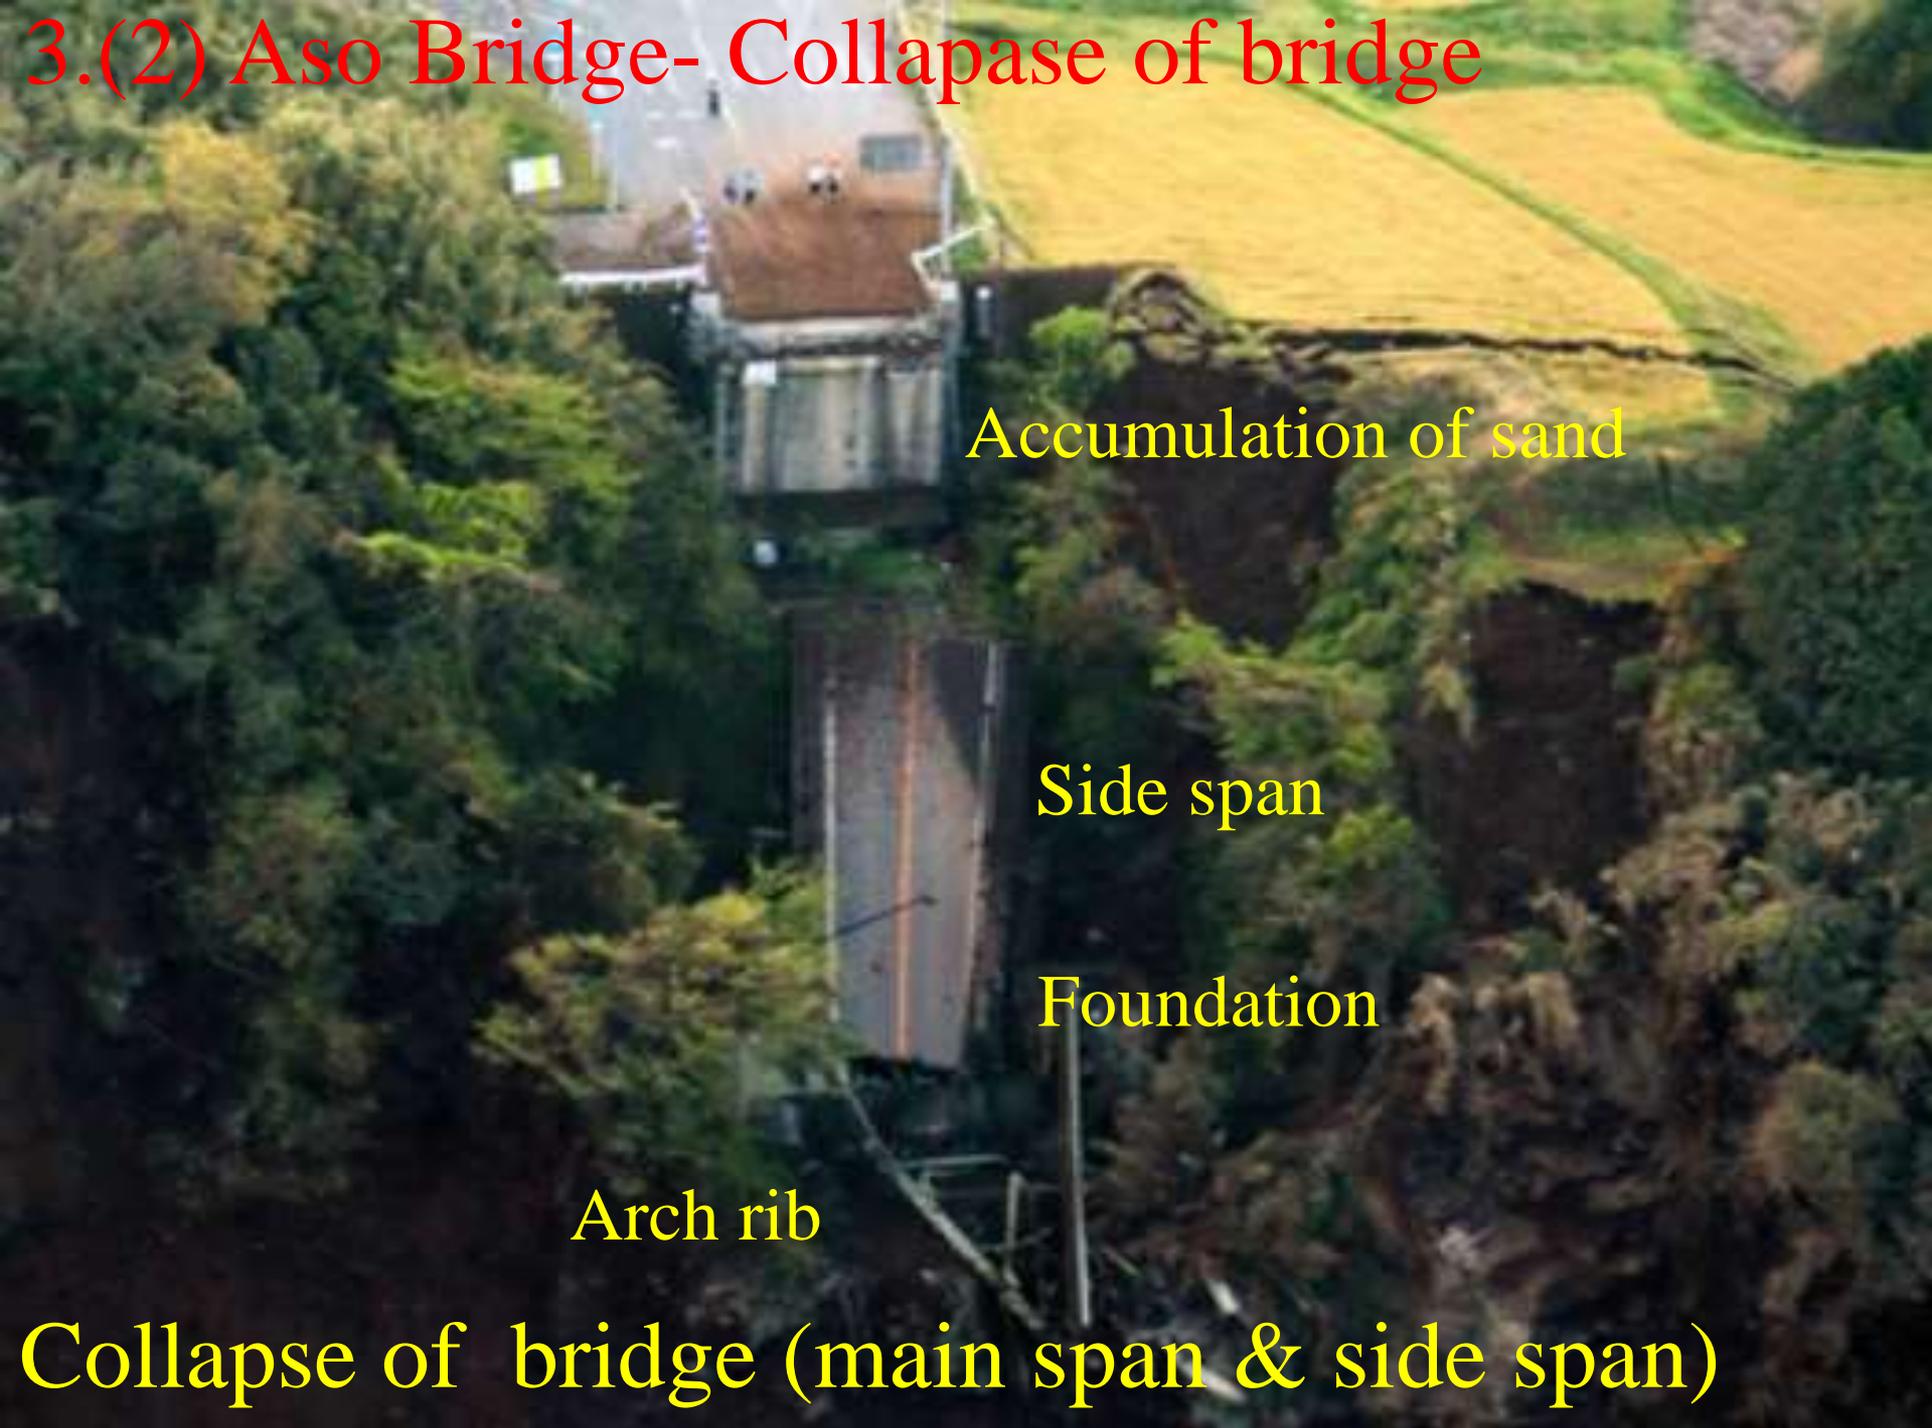
3.(2) Aso Bridge- Collapase of bridge

Collapse of bridge (main span & side span)

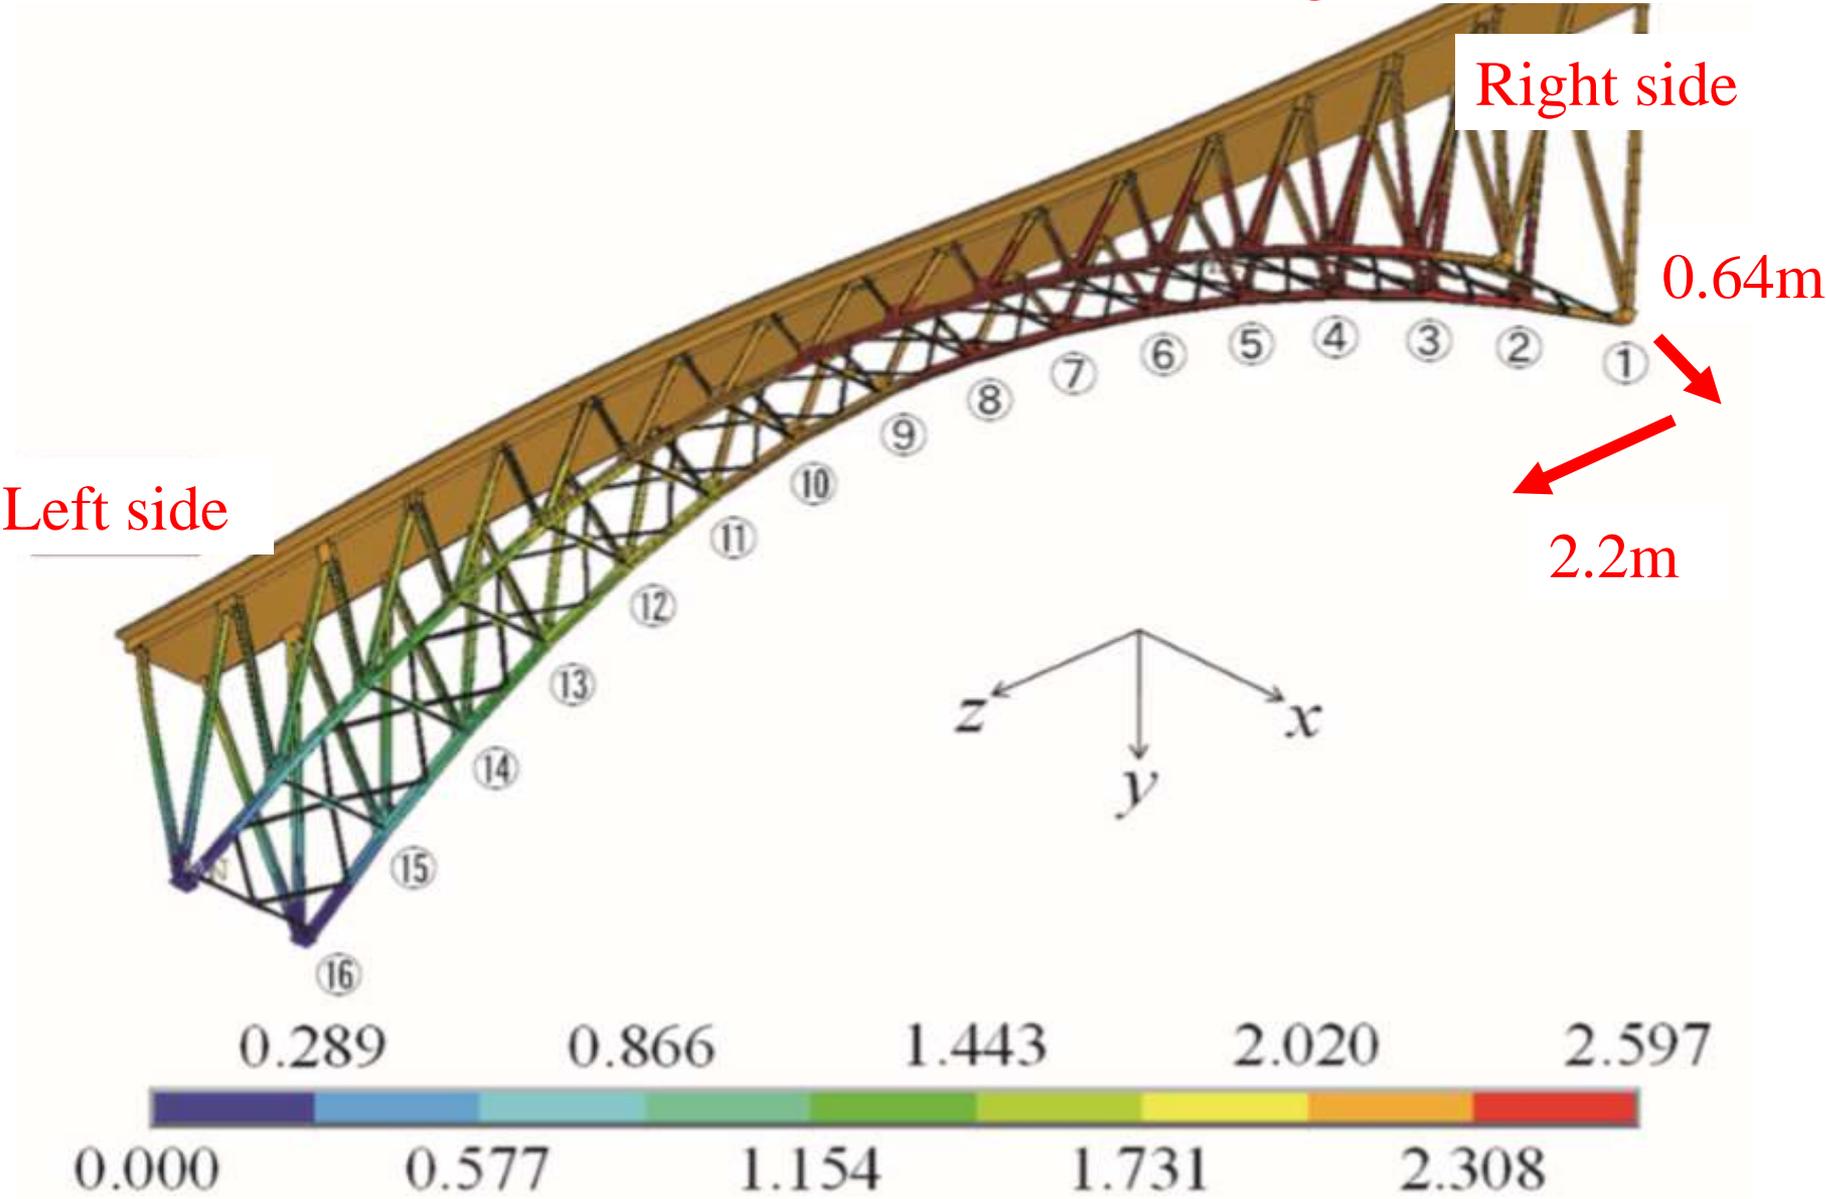
3.(7) Cause2 or 3: Displacement of abutment (2.2m) lead arch rib to the ultimate stage.^(che)

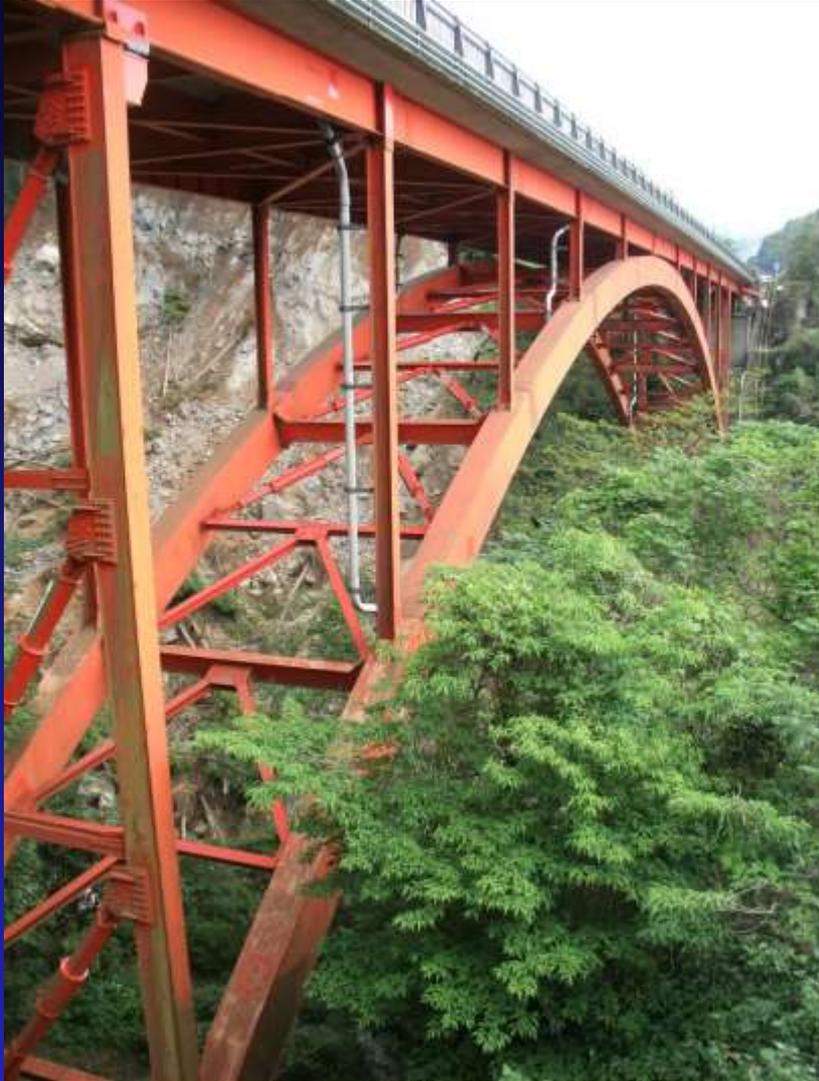
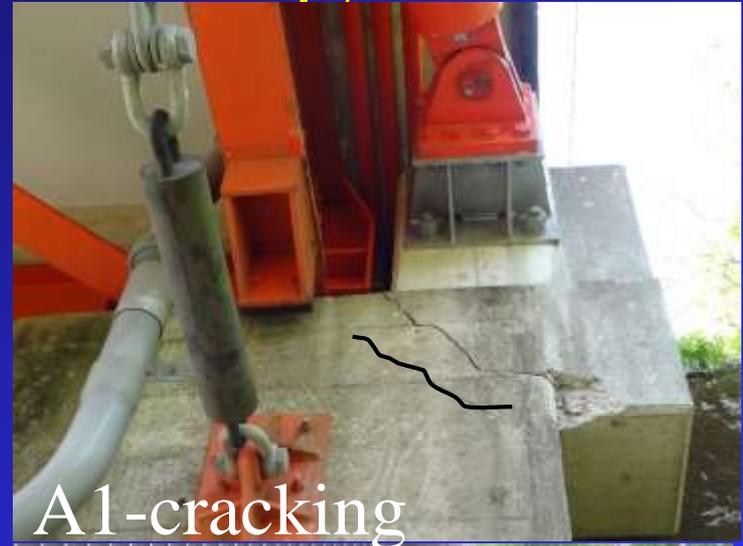
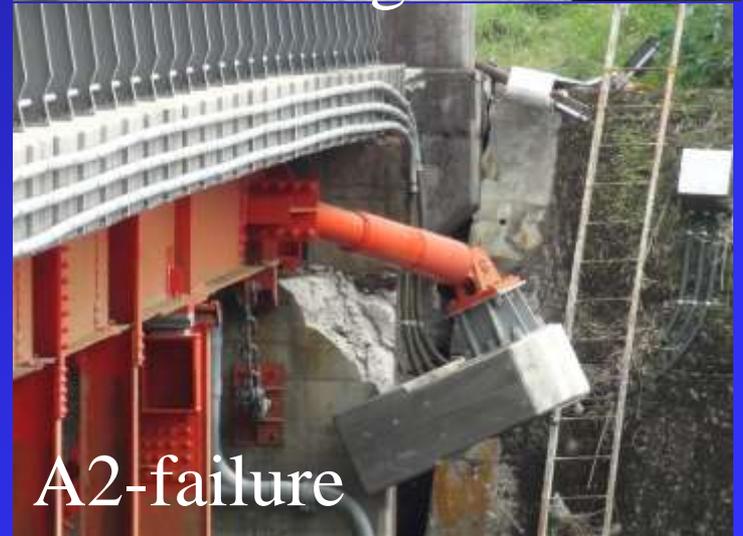
4. (1) Minami-aso Arch Bridge

Damper had been installed as retrofitting. Punching shear failure occurred between damper and abutment.

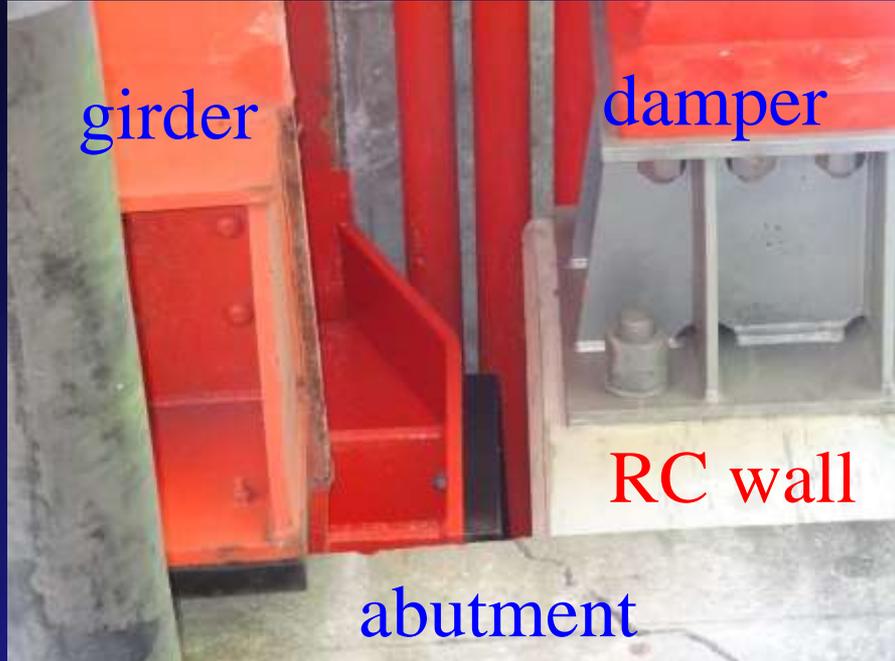
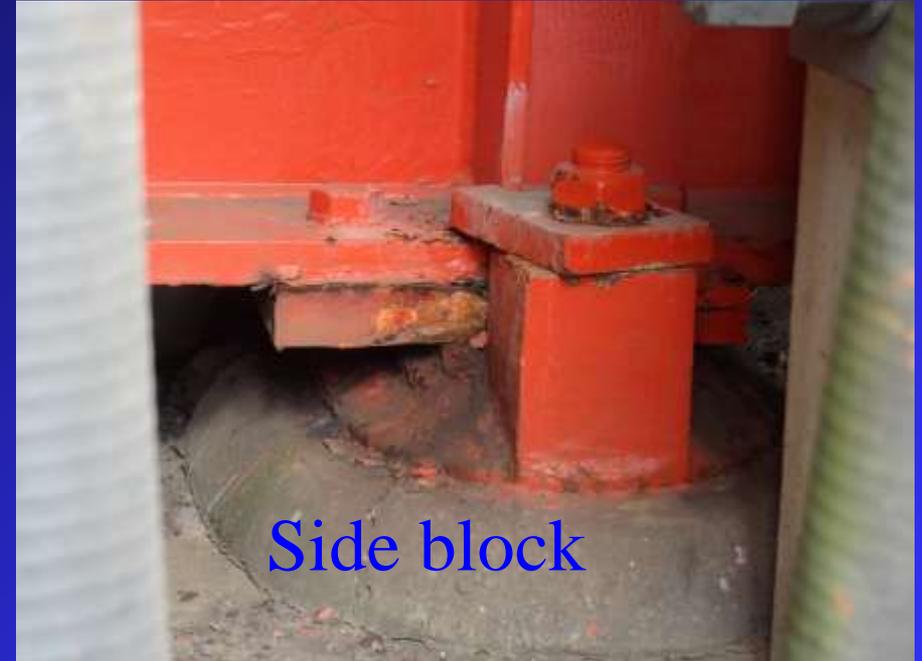
4. (2) Direction of movement

1. Side block was not damaged.
2. The girder beside the RC wall was not damaged, so the movement was not in the transverse direction.
3. Movement occurred in the longitudinal direction
