Damage of Bridges due to kumamoto Earthquake

Kenji Kosa

Kyushu Institute of Technology

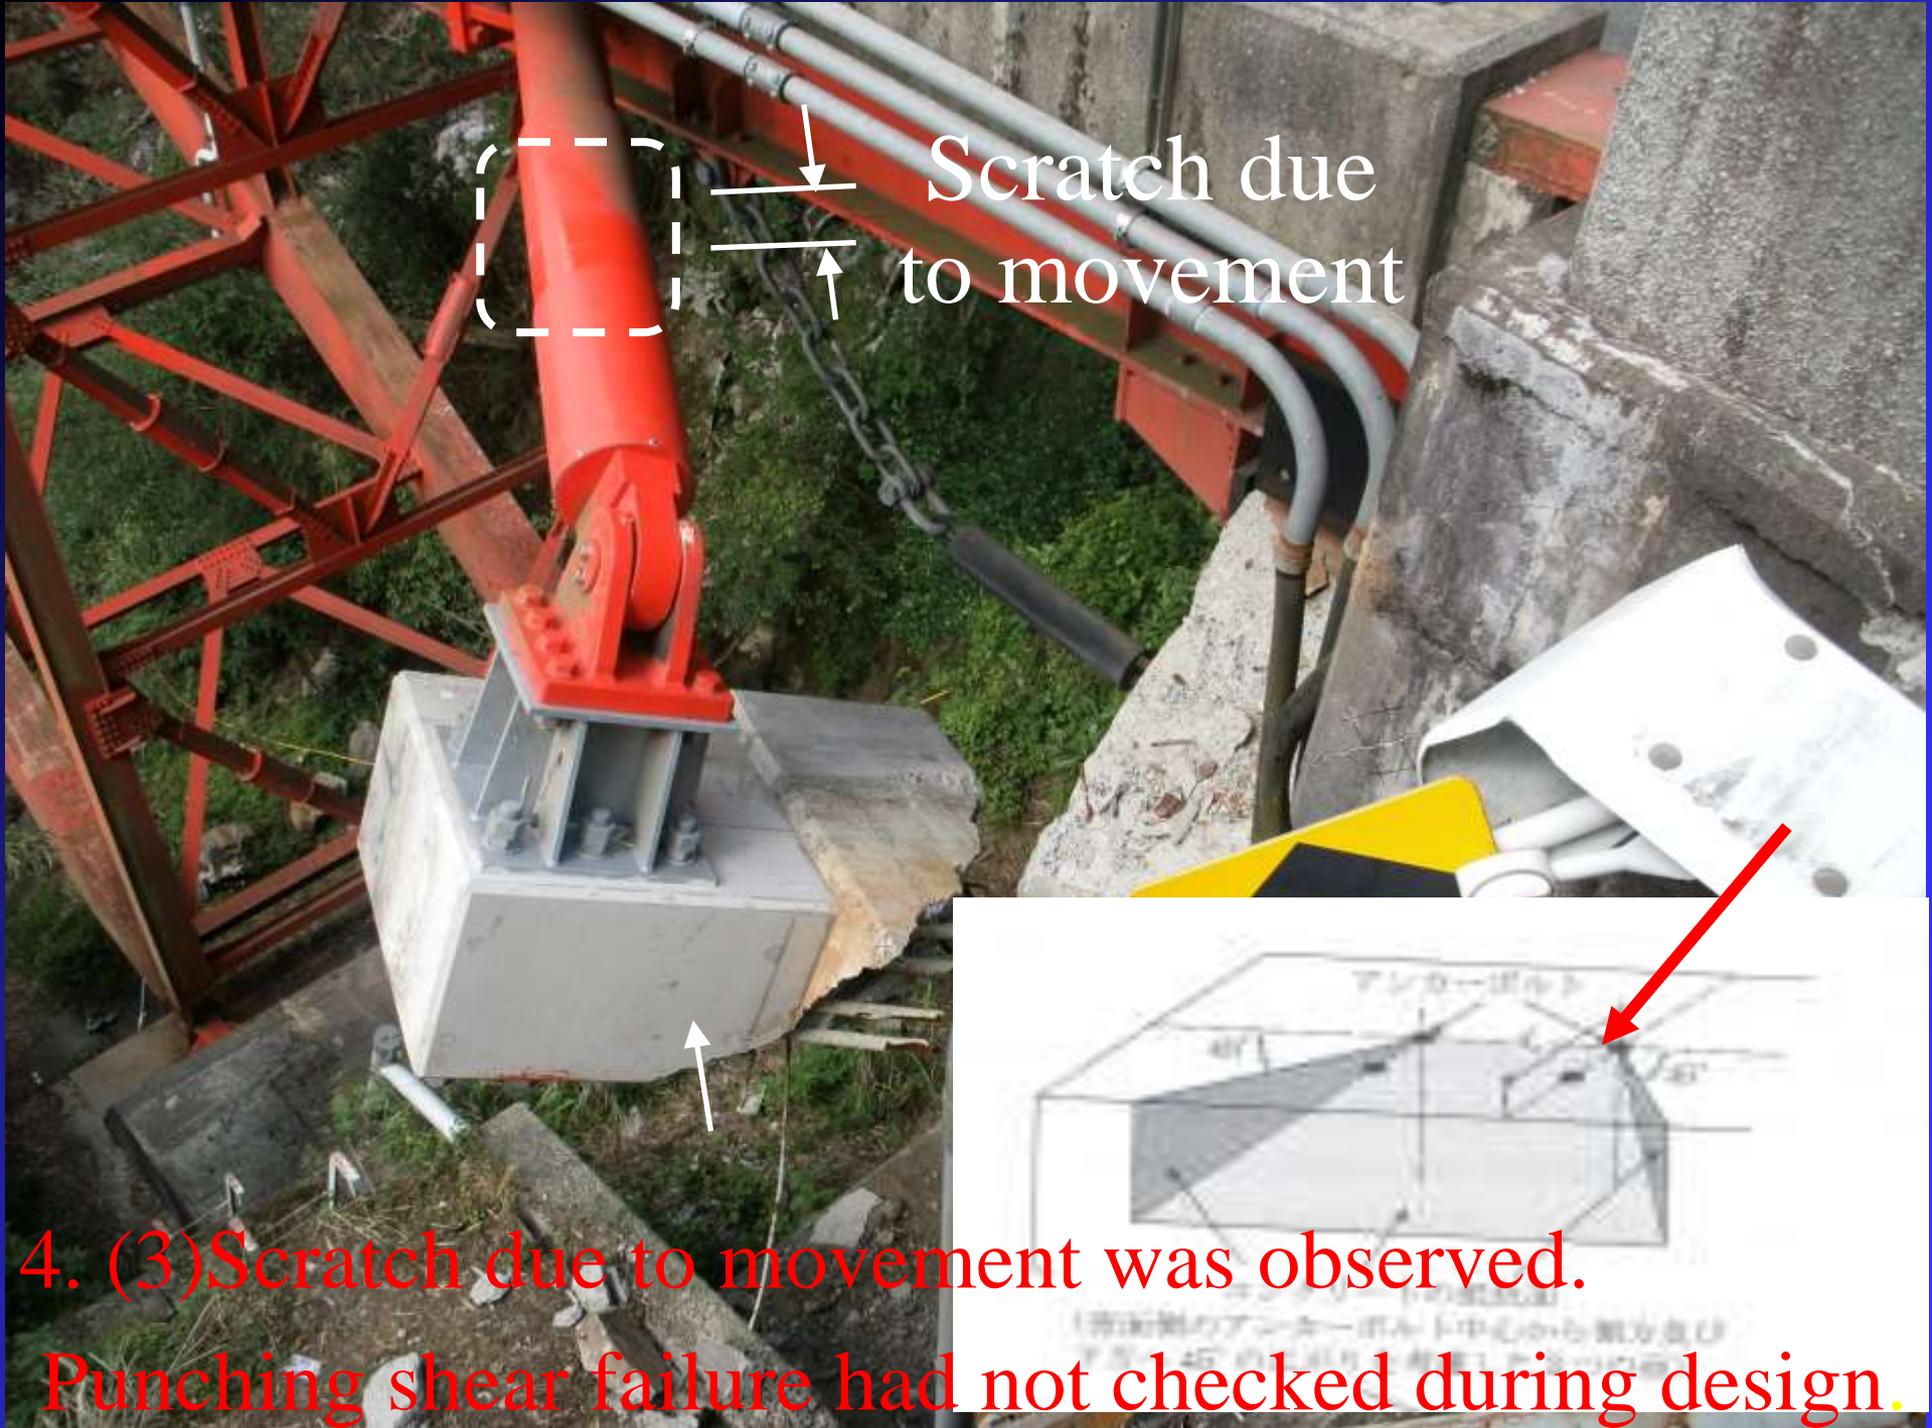
Scratch due
to movement

4. (3) Scratch due to movement was observed.
Punching shear failure had not checked during design.

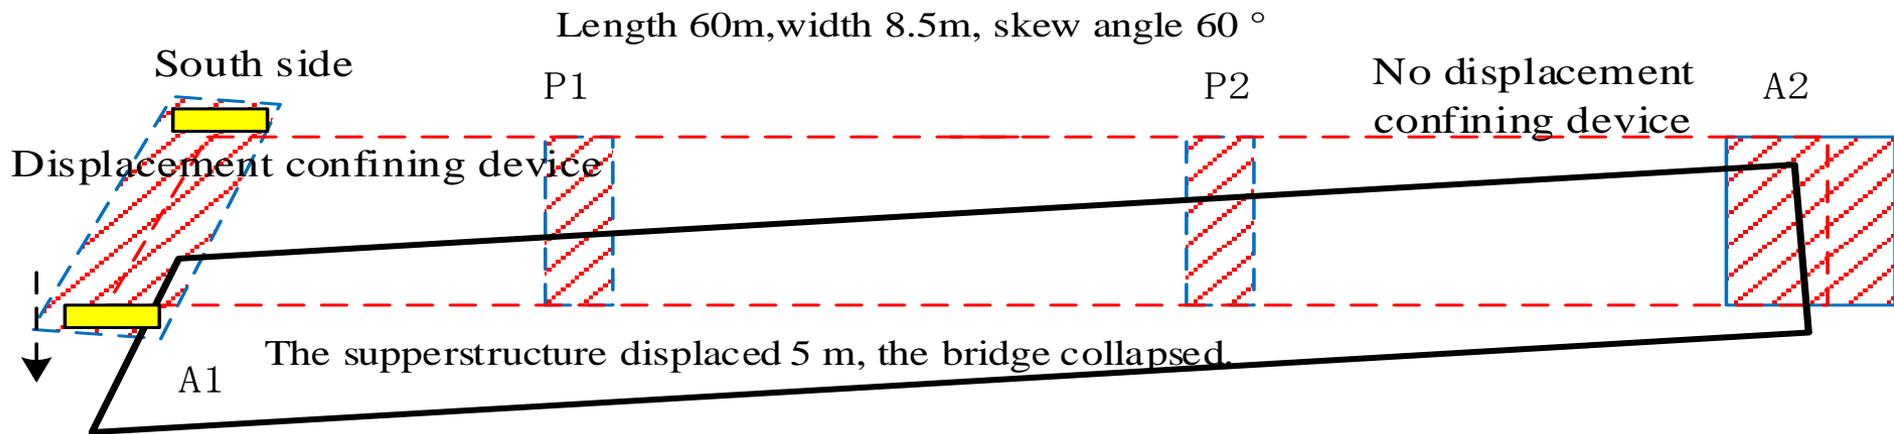
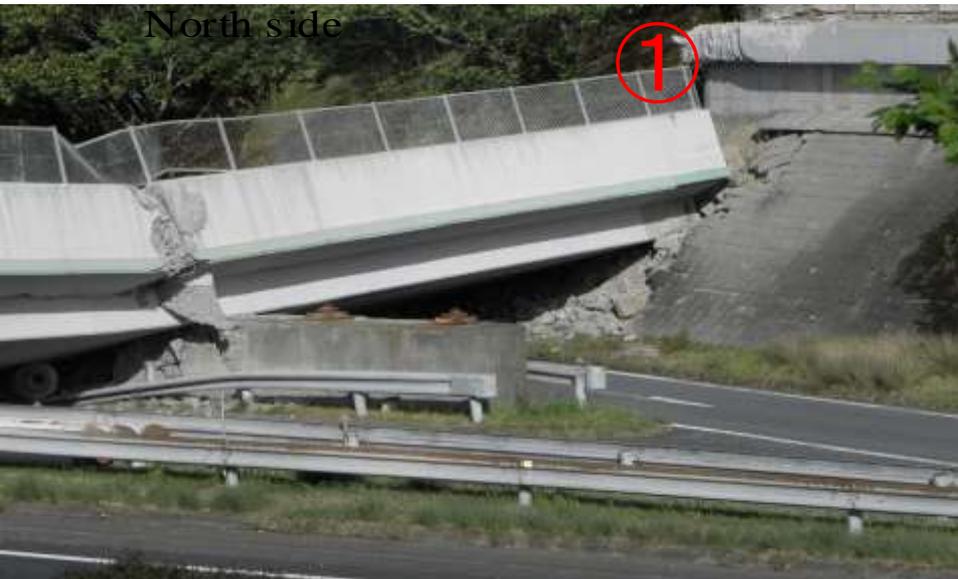
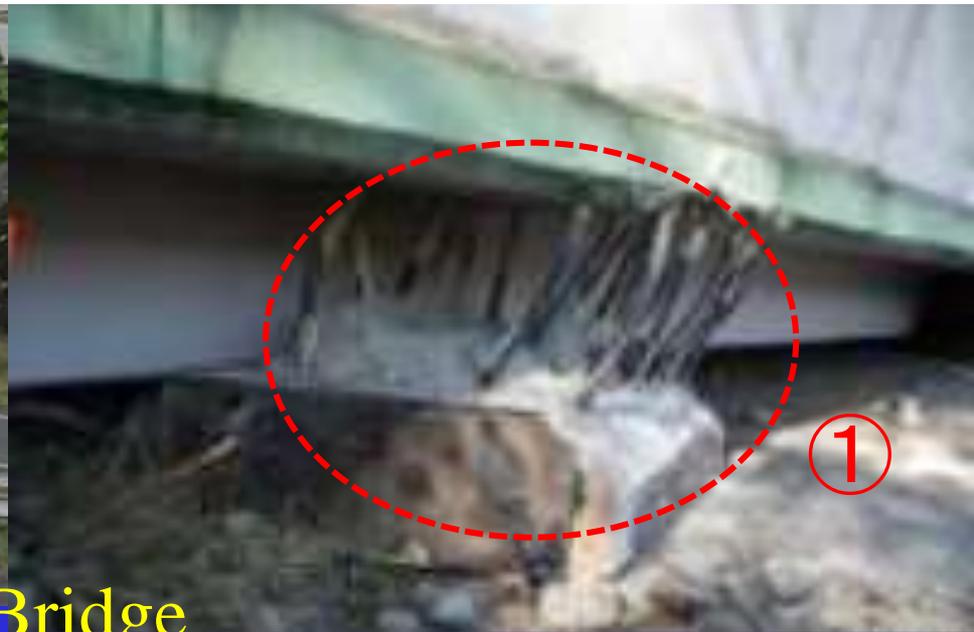
5.(4) Fuyo Daiichi Bridge in Kumamoto Earthquake
 Span length was 60m. P1 & P2 were rocking columns.
 Skew girder rotated and fell down.

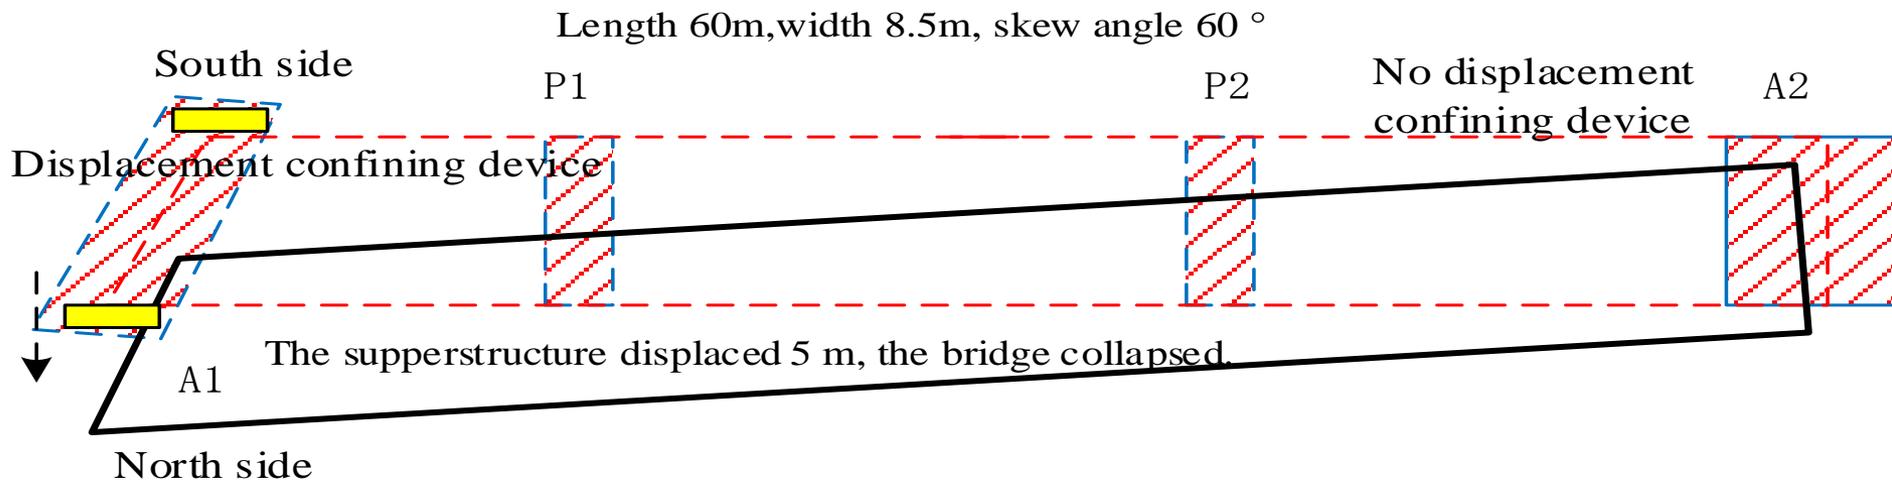
5. (5) Damage at Furo Daichi Bridge

1. The girder collided with the restrainers due to rotation.
2. Punching shear failure occurred at the connection of restrainer and abutment.

1. P1, P2 were rocking columns. There was not installed for longitudinal restrainers.

There was installed for transverse restrainers to protect rotation of girder.

$$F = 3kh \cdot R_d = 1554 \text{ kN}$$

3. Actual applied acceleration would be larger than $3kh$ (about $0.75G$).

4. Punching shear resistance = 1076 kN

5. Resistance is smaller than the acted force.

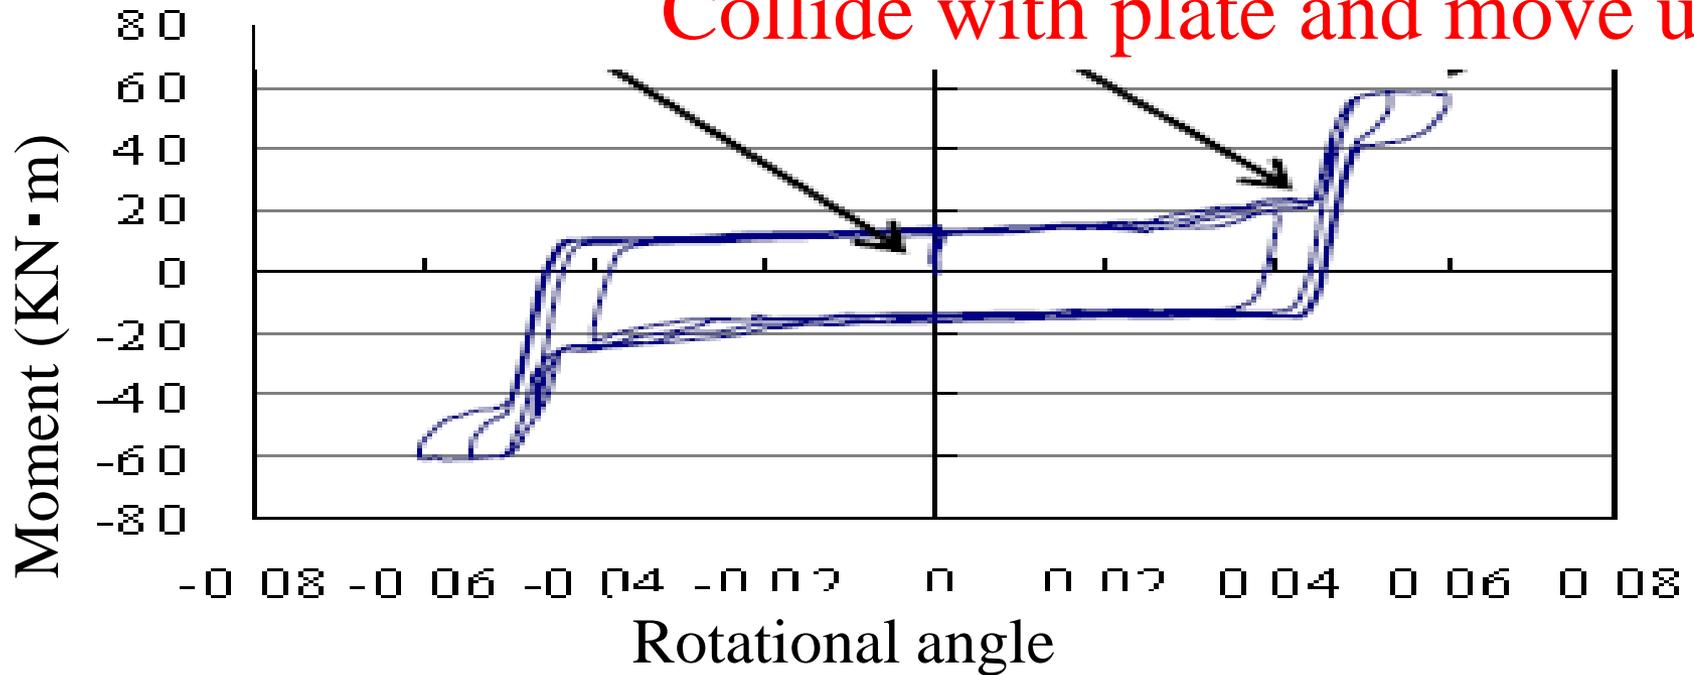
5.(7) Bearings were damaged due to large rotation.

Collide with plate and move up

5.(8)1. When rotational angle of column was 0.06rad, this value is the limit angle of pivot bearing.
2. As the restrainers were completely collapsed, the pivot bearings rotated over 0.06rad, and the bridge collapsed.

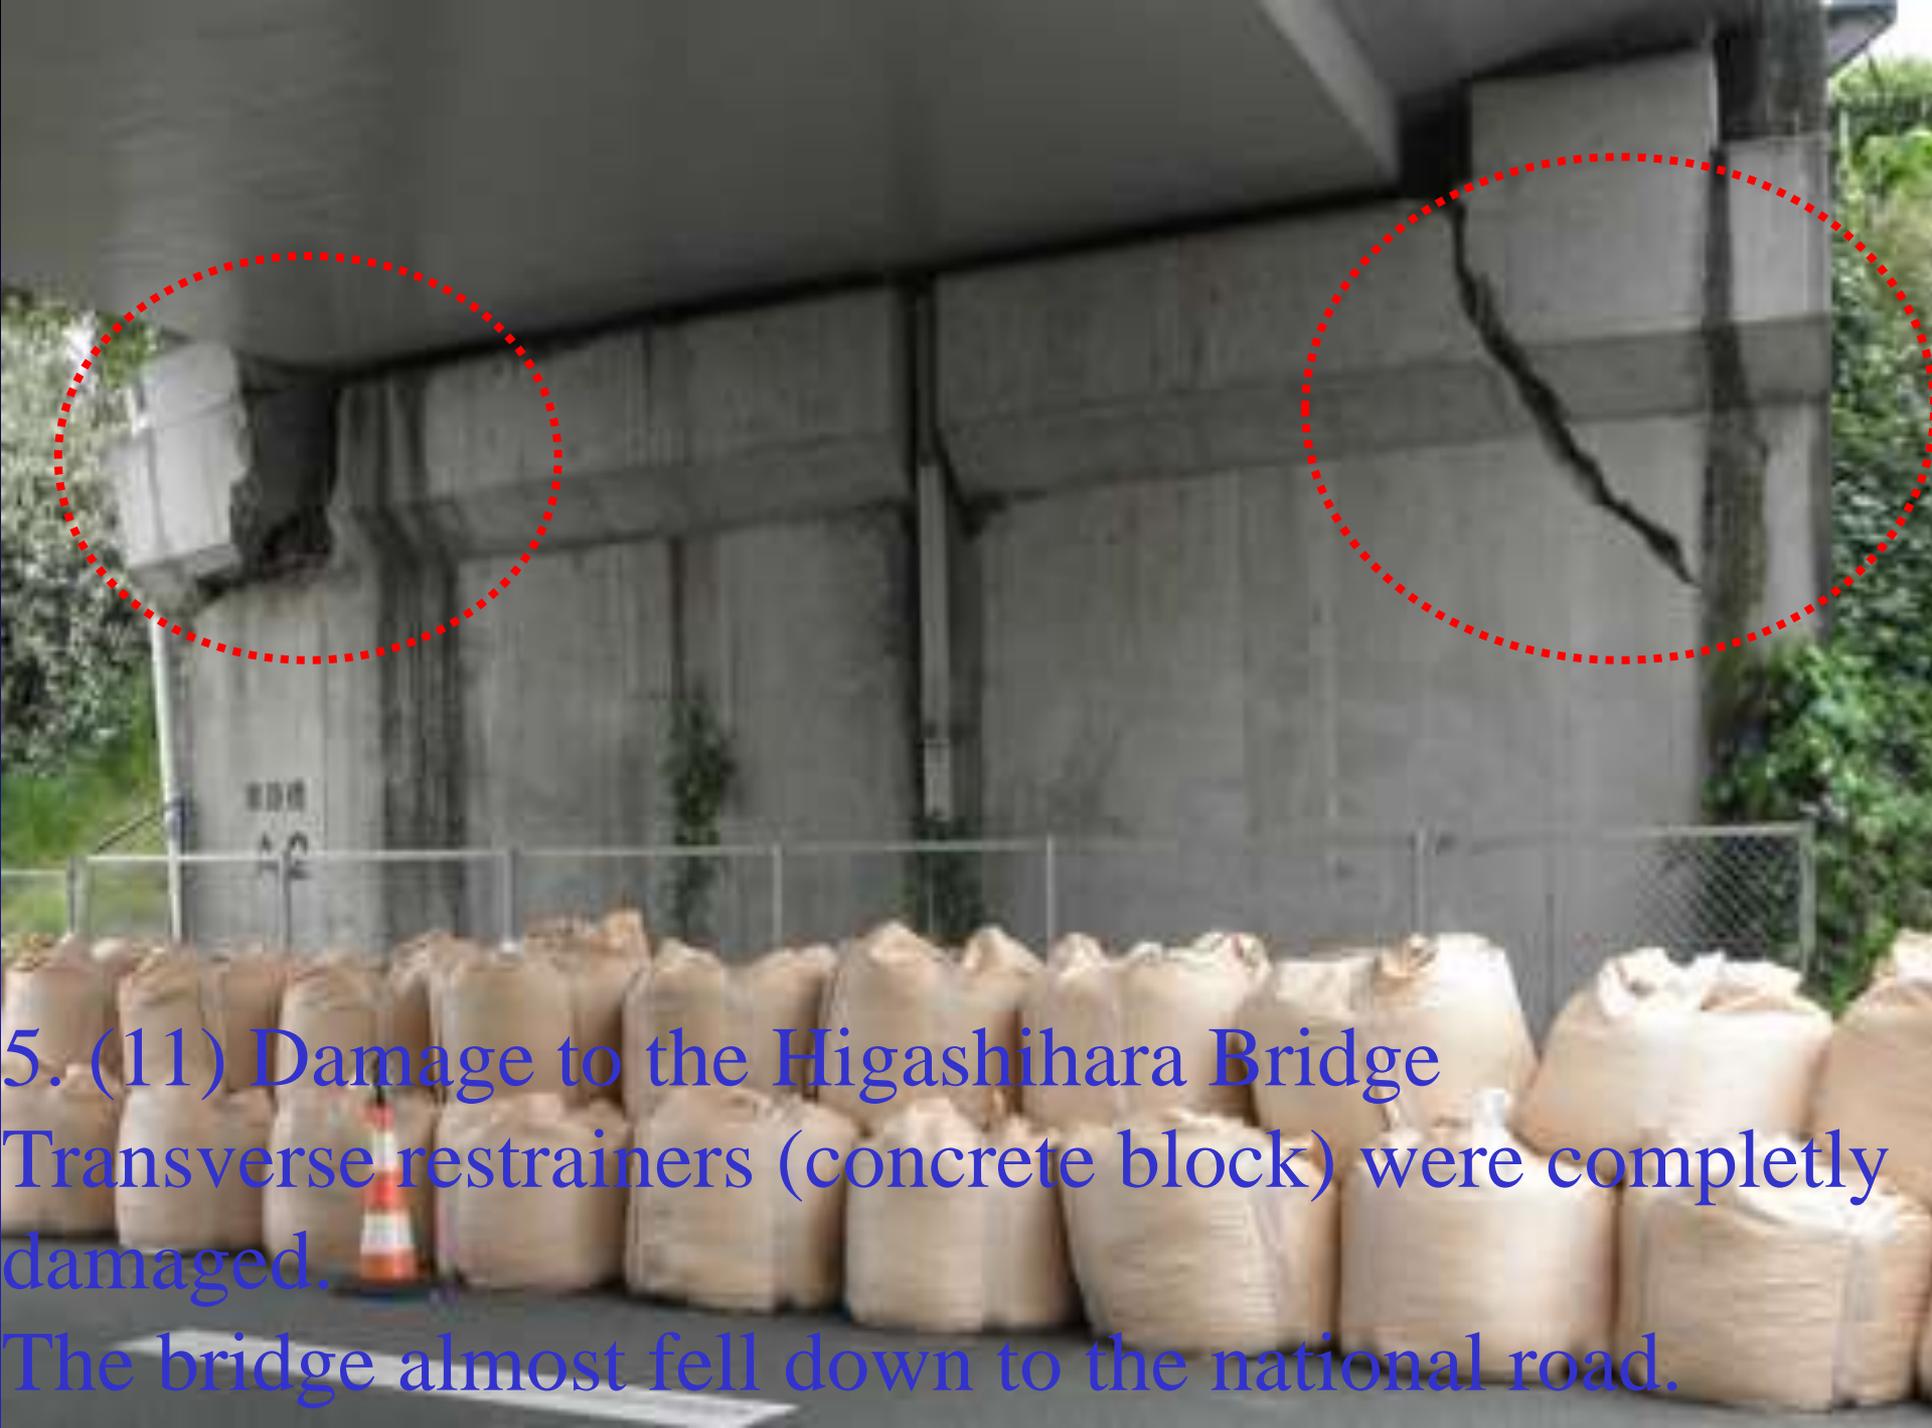
5. (10) Higashihara bridge had rocking columns at P1 and P2.

The column top moved to transverse direction about 35cm.

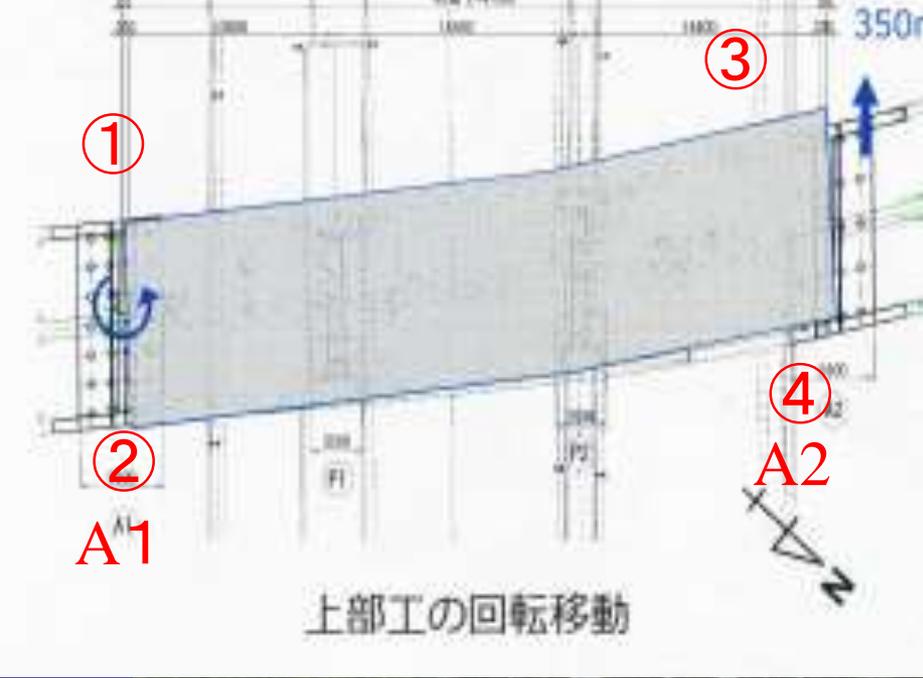
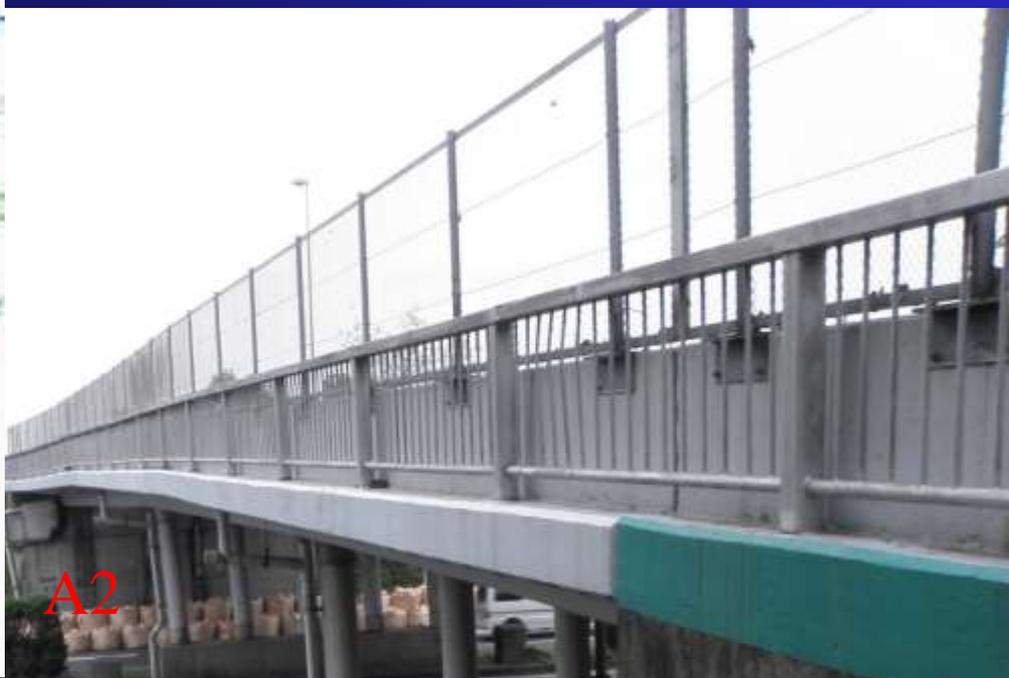
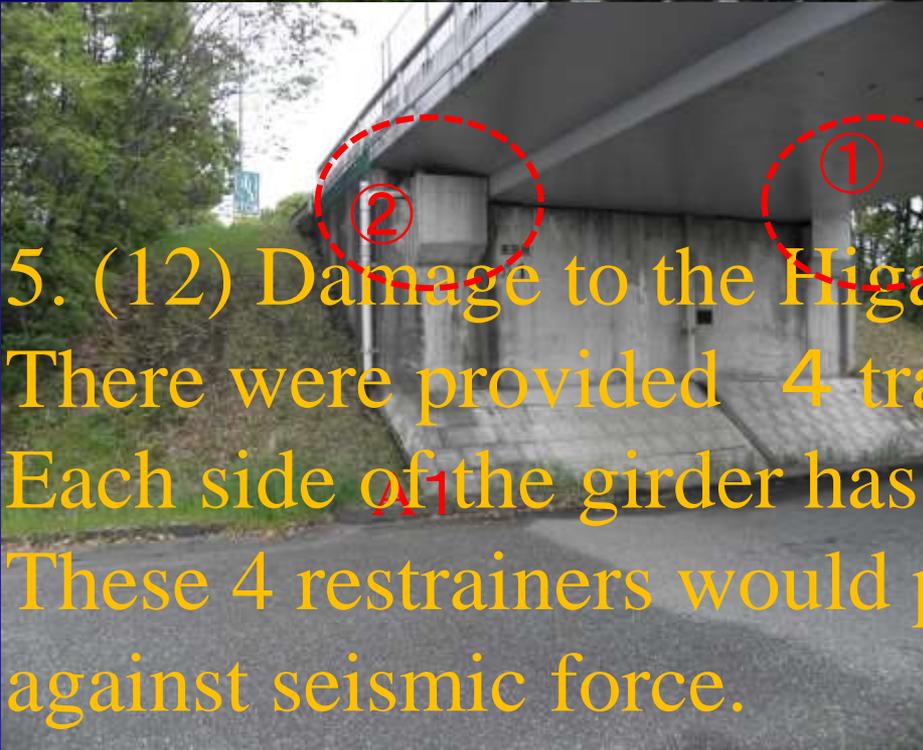
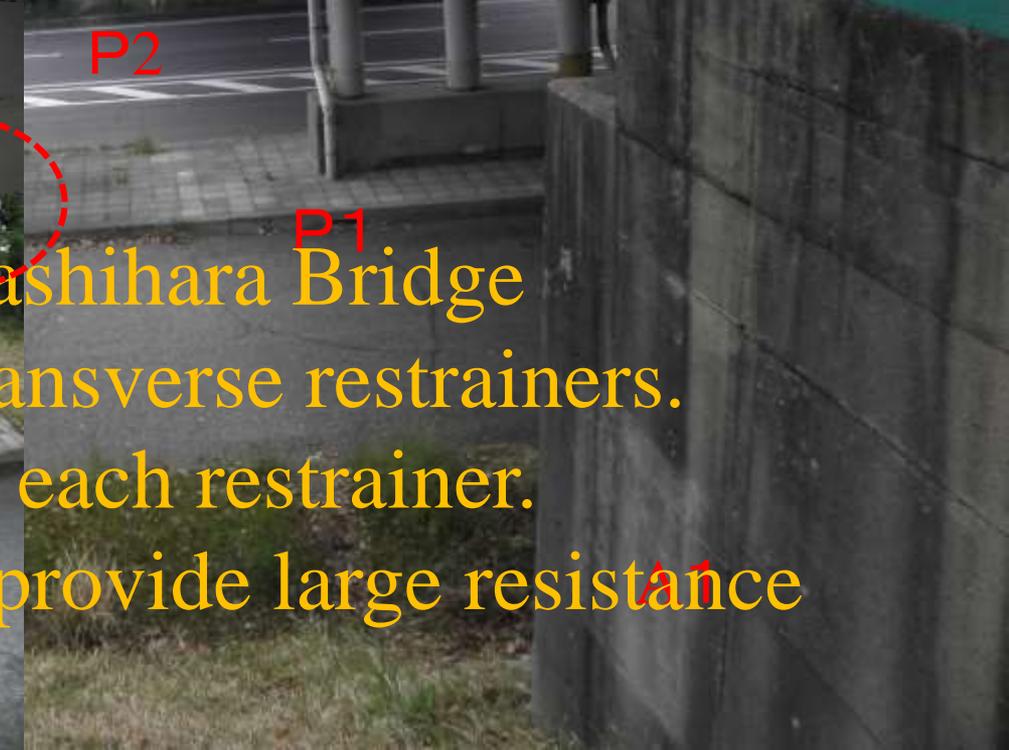
5. (11) Damage to the Higashihara Bridge
Transverse restrainers (concrete block) were completely
damaged.
The bridge almost fell down to the national road.

5. (12) Damage to the Higashihara Bridge
 There were provided 4 transverse restrainers.
 Each side of the girder has each restrainer.
 These 4 restrainers would provide large resistance
 against seismic force.

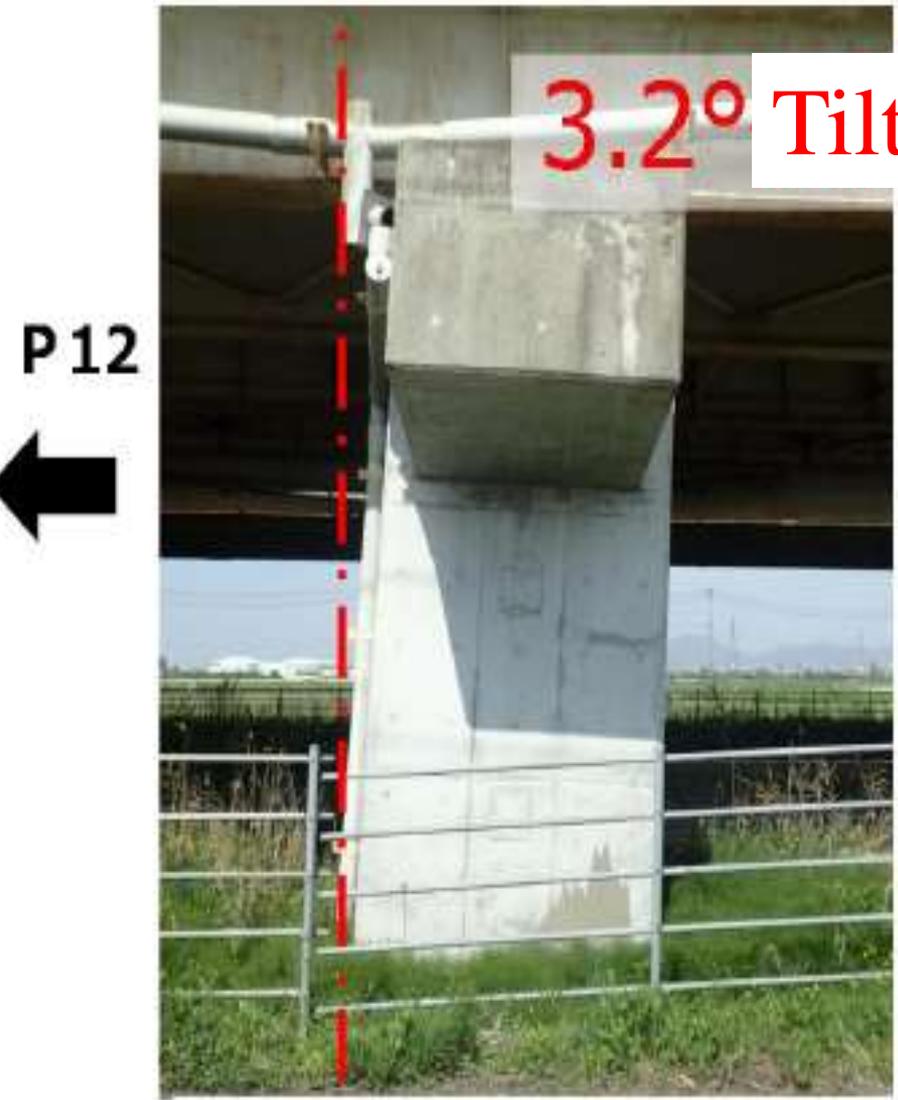
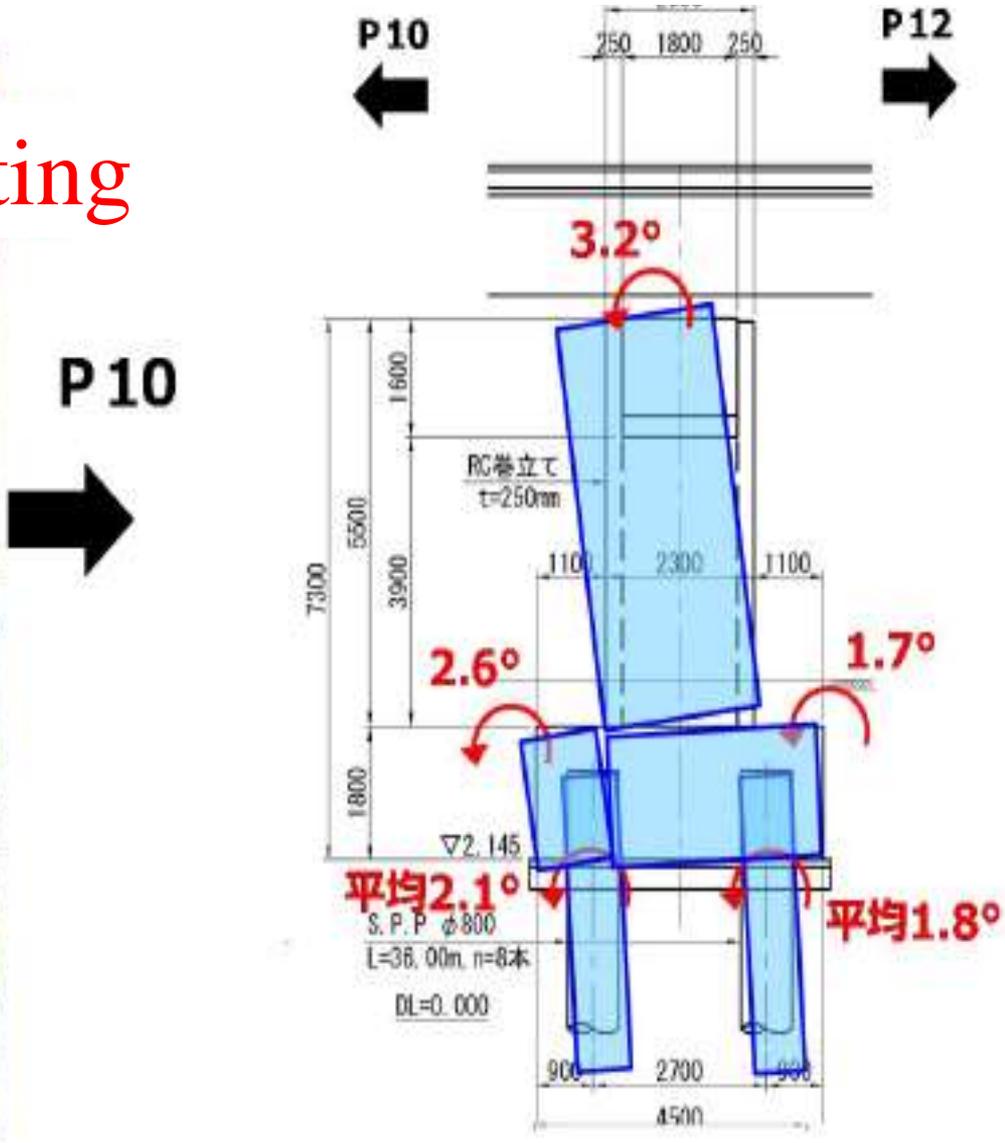
6. (2) Damage to footings in Kumamoto Earthquake

Tilting of the column (3.2°) was observed.

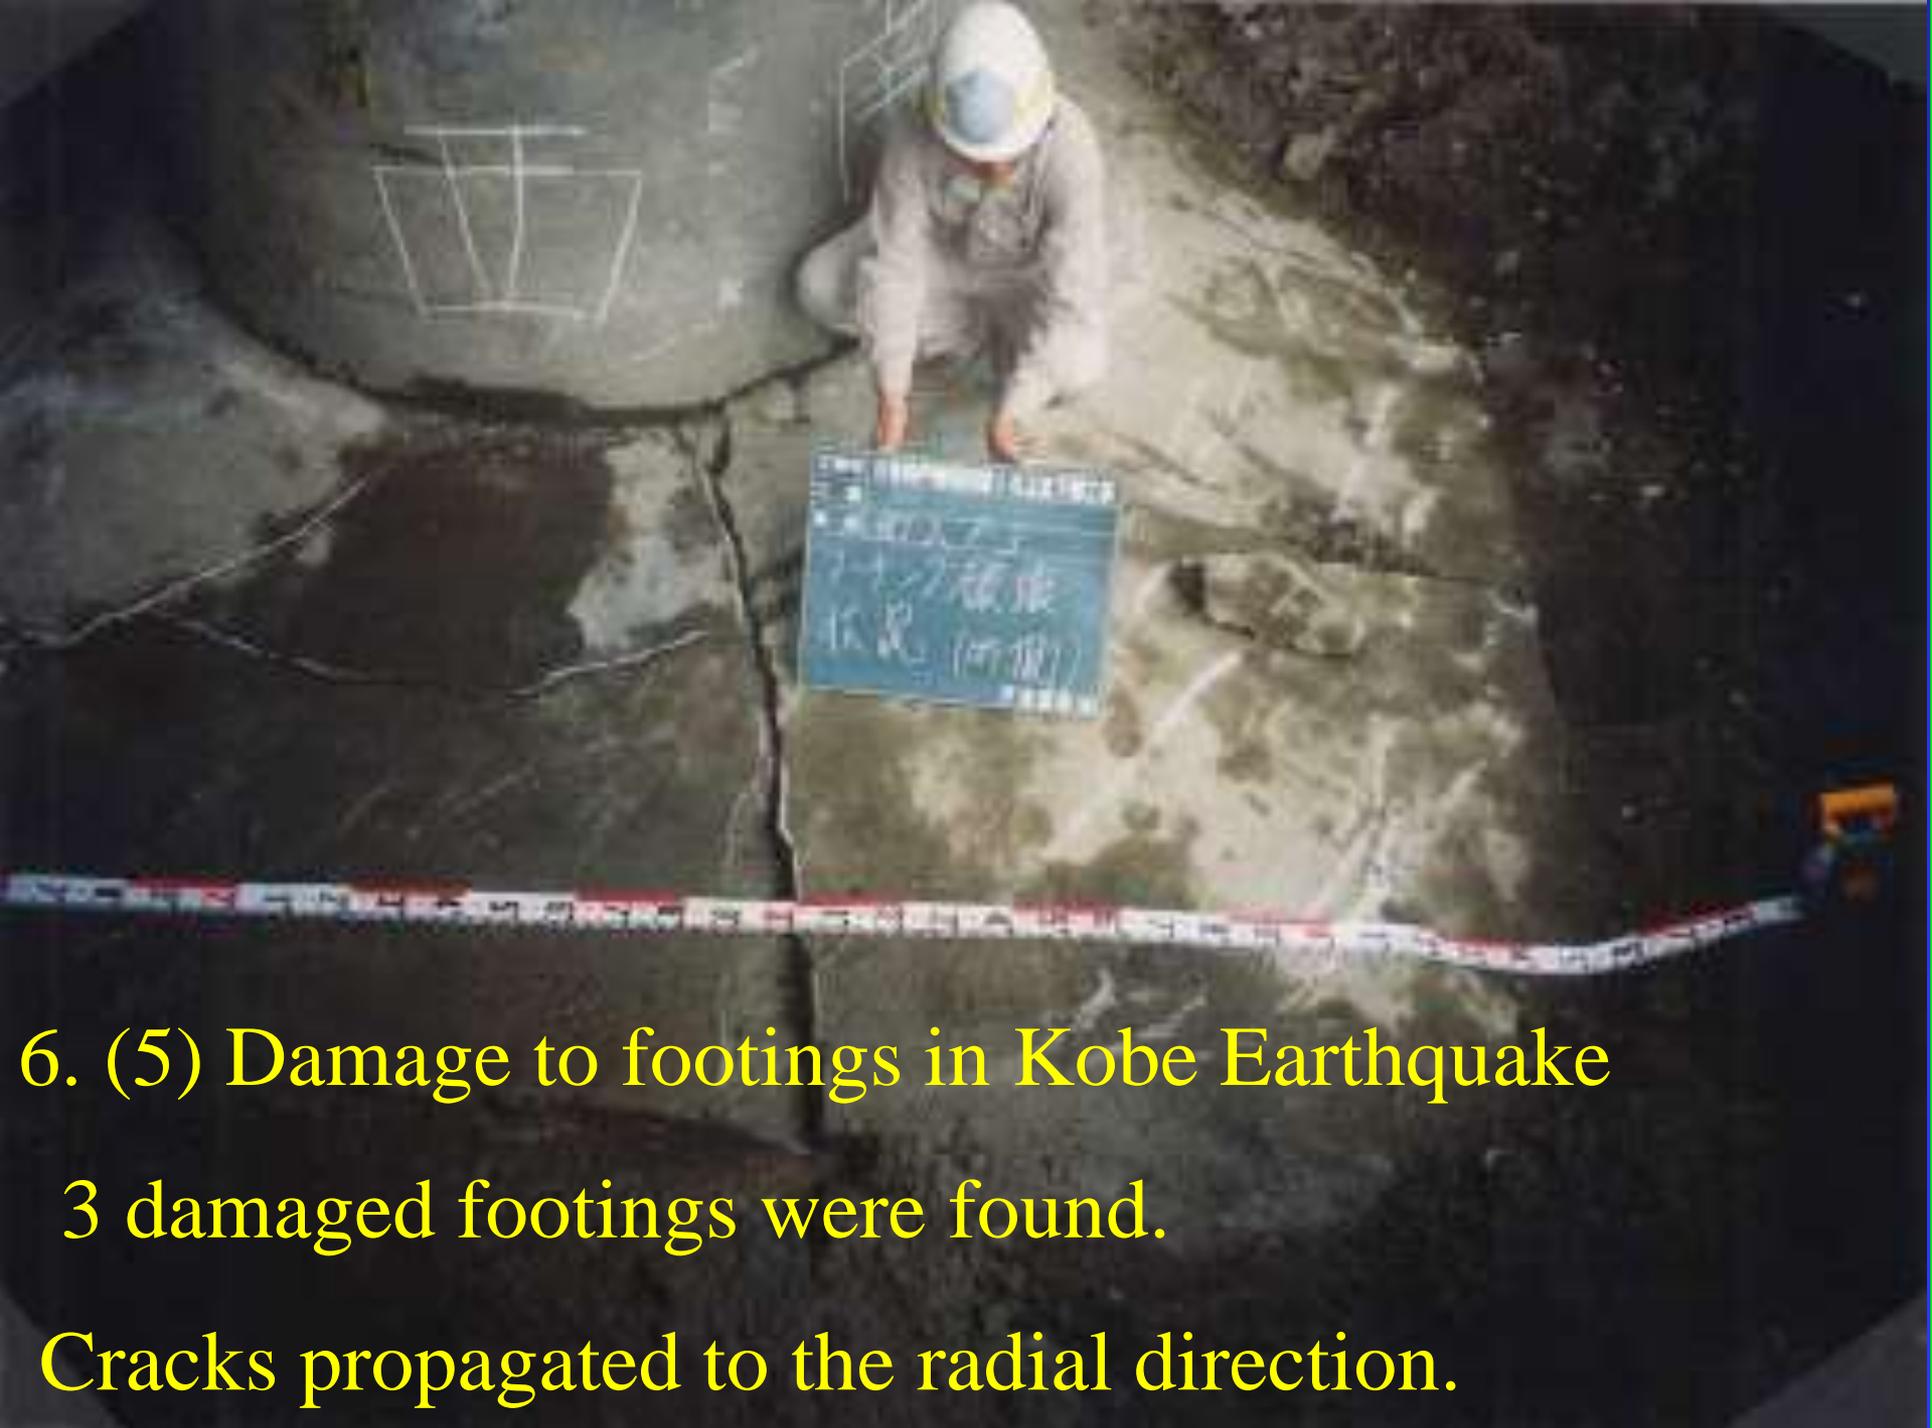
6. (4) Characteristics of damaged footing
Low main reinforcement & small sized footing
