The Third International Bridge Seismic Workshop, 3rd IBSW

Seattle, Washington, USA - October 1st to 4th, 2019

EARTHQUAKES AND SEISMIC DESIGN FOR BRIDGES IN VIRGINIA

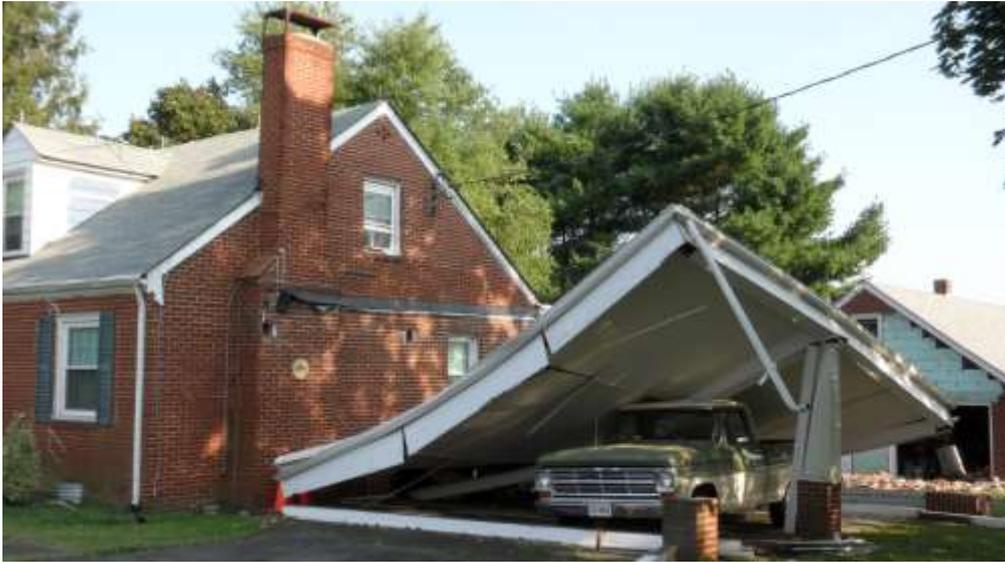
Figure 3. A Carport Collapsed near the Epicenter

Fortunately, the event was centered in a rural area and did not cause widespread severe damage or serious injuries even though the presence of a large number of old, unreinforced masonry buildings in that area. However, moderately heavy damage did occur to schools, businesses, and homes in the epicenter area, see Figure 3. Damage in Louisa County alone where the epicenter was located was estimated to be more than \$80 million.

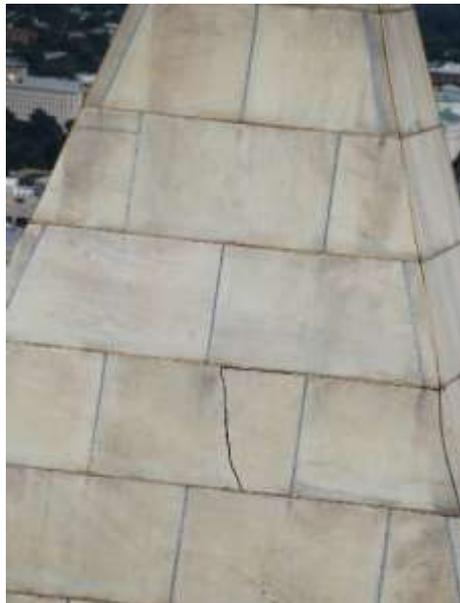
Figure 4. Crack in the Washington Monument

Widespread light-to-moderate damage occurred in the area from central Virginia to southern Maryland. In the nation's capital, there was damage to several landmarks including the Washington Monument, see Figure 4, and Washington National Cathedral. Damage to the Washington Monument and the Washington National Cathedral could cost \$40 million to repair. The Washington Monument was closed for 3 years for repair.

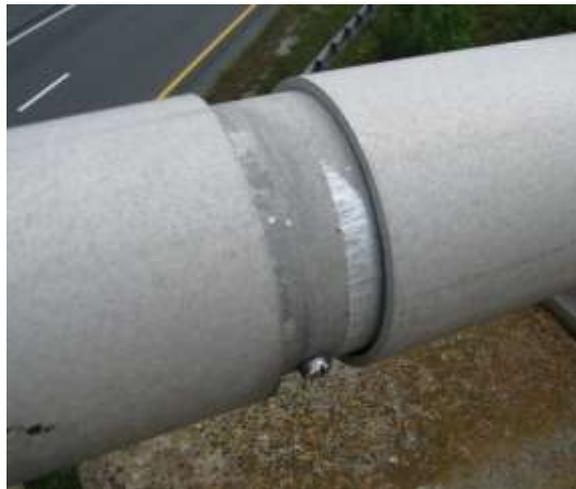
The highway bridges experienced some minor to moderate damages. No bridges or bridge components failed though some cracks or spalling occurred in several bridges, see Figure 5 to 7. It was believed that the light weight of the steel superstructure and regular layout and configuration of the bridges played a very important role for the good seismic performance.

Figure 5. Displacement of Bridge Rail

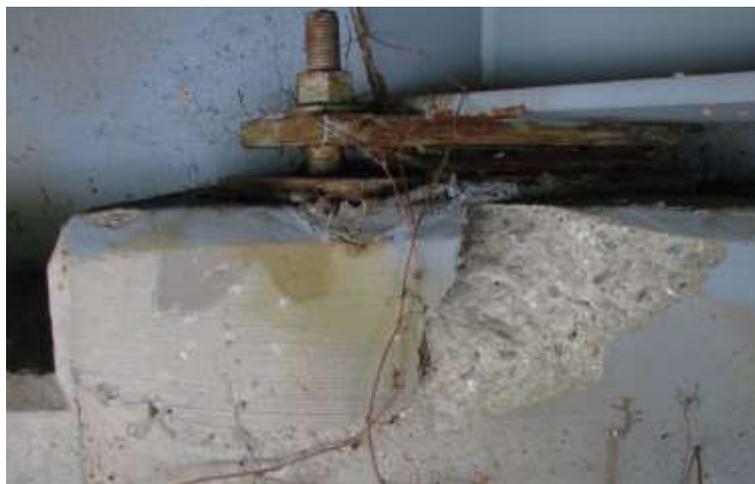
Figure 6. Damage in Bridge Seat

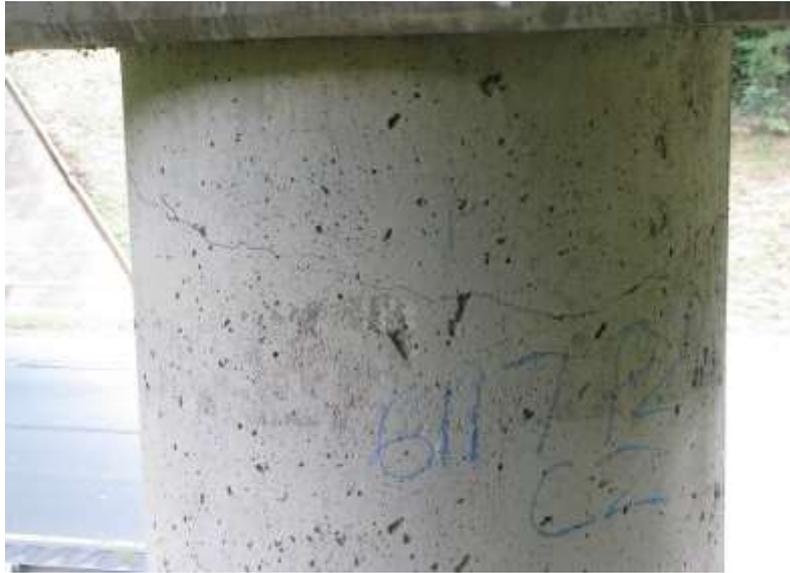
Figure 7. Crack in Column
