## FAILURE MECHANISM OF THE FURYO DAIICHI BRIDGE IN THE 2016 KUMAMOTO EARTHQUAKE

In the Kumamoto Earthquake that occurred in western Japan in 2016, the Furyo Daiichi Bridge, a 60 m-long overbridge, collapsed onto the busy Kyushu Expressway. The bridge, constructed in 1974, had a skew angle at one end of the superstructure. To confine displacements in the perpendicular direction, displacement confining devices were installed at the abutment on the skewed side of the superstructure. The two piers located on the dividing strips were rocking piers. The rocking piers had pivot bearings at both the upper and lower ends of the columns. The pivot bearings were incorporated to provide a rotating function and a vertical load support function.

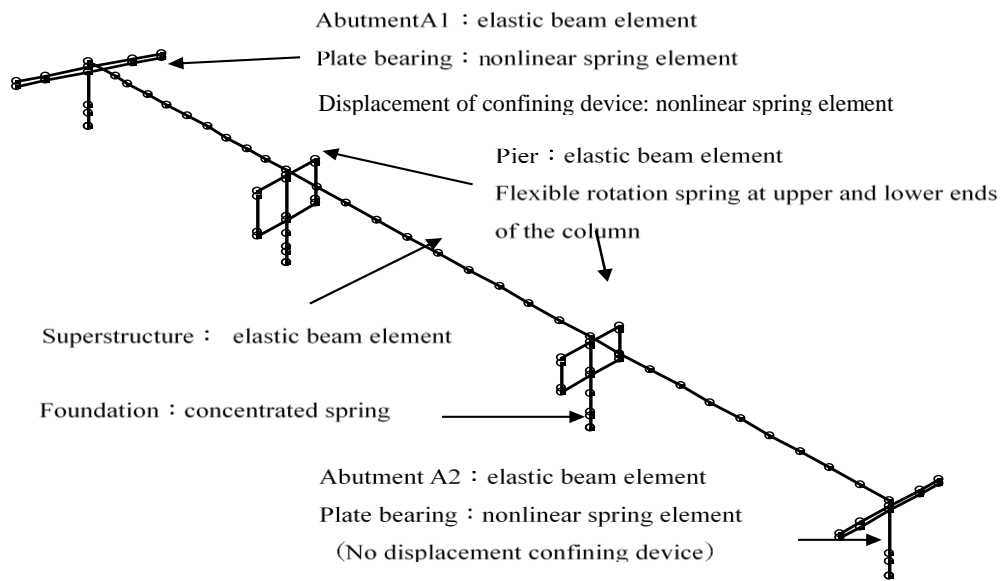
Fig. 4 Analysis model

There is a possibility that the cause of collapse of the Fuyo Daiichi Bridge was not only the rotation of the rocking piers but also the insufficient strength of the displacement confining device at Abutment A1. To investigate this possibility, we performed dynamic analysis with a focus on the strengths of the horizontal displacement confining device and the plate bearings installed at the abutment. As the input waveforms, the waveforms of the main shock recorded at the nearby Mifune Interchange were used. According to the acceleration response spectrum, large acceleration occurred around 0.5 sec and 1.0 sec. Some researchers pointed out that the acceleration response at that location was the amplified response due to the effect of the ground conditions compared with the responses at other locations [3]. A 3D nonlinear beam model shown in Fig. 4 was employed for the analysis.

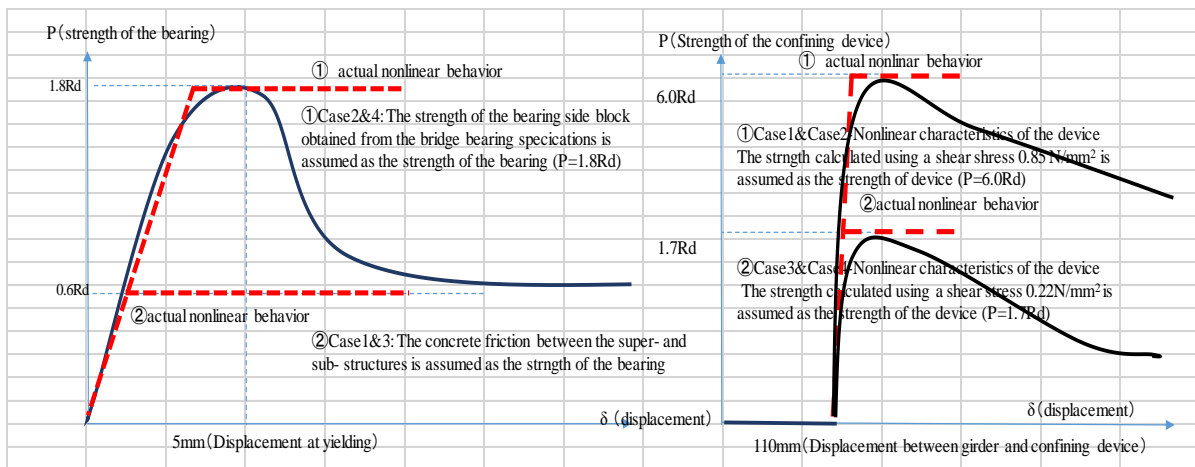
Fig. 5 Presumed relationship of plate bearing and confining device

Fig. 5 shows the presumed relationship of nonlinear characteristics vs. actual behavior for the displacement confining device and the plate bearings at the abutment. The damage to the displacement confining device was said to be the ductile failure type in which shear reinforcing steels yielded progressively [4]. The model adopted was the type that can absorb energy through hysteresis damping, and the damping constant for each member was set as 0%. We adopted this model although it was unclear how much colliding energy would be absorbed by the rubber buffer and how much energy would dissipate after the failure of the plate bearings and the displacement confining device. The plate bearing resistance at Abutment A2 was about 1.7 times larger than the plate bearing resistance at Abutment A1 because the pier span length was not equal. Also, we did not set a collision spring in the axial direction because there was no trace of the girder-parapet collision in the axial direction [5].
