FAILURE MECHANISM OF THE FURYO DAIICHI BRIDGE IN THE 2016 KUMAMOTO EARTHQUAKE

Kosa Kenji,

Kyushu Institute of Technology

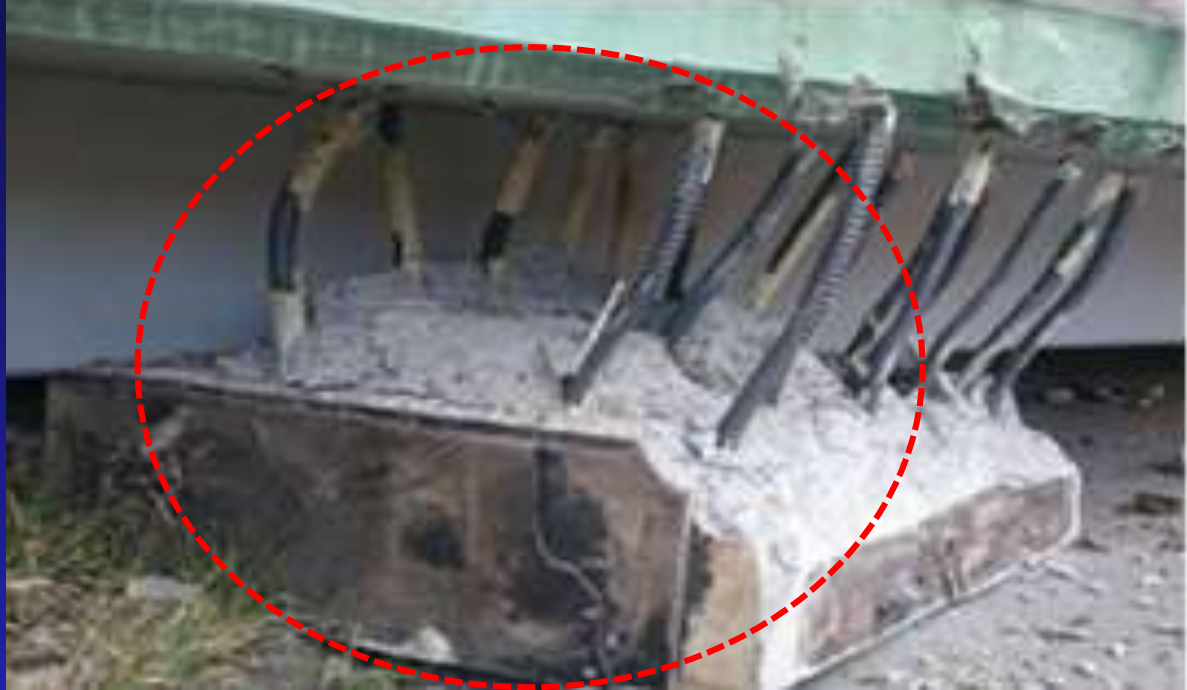
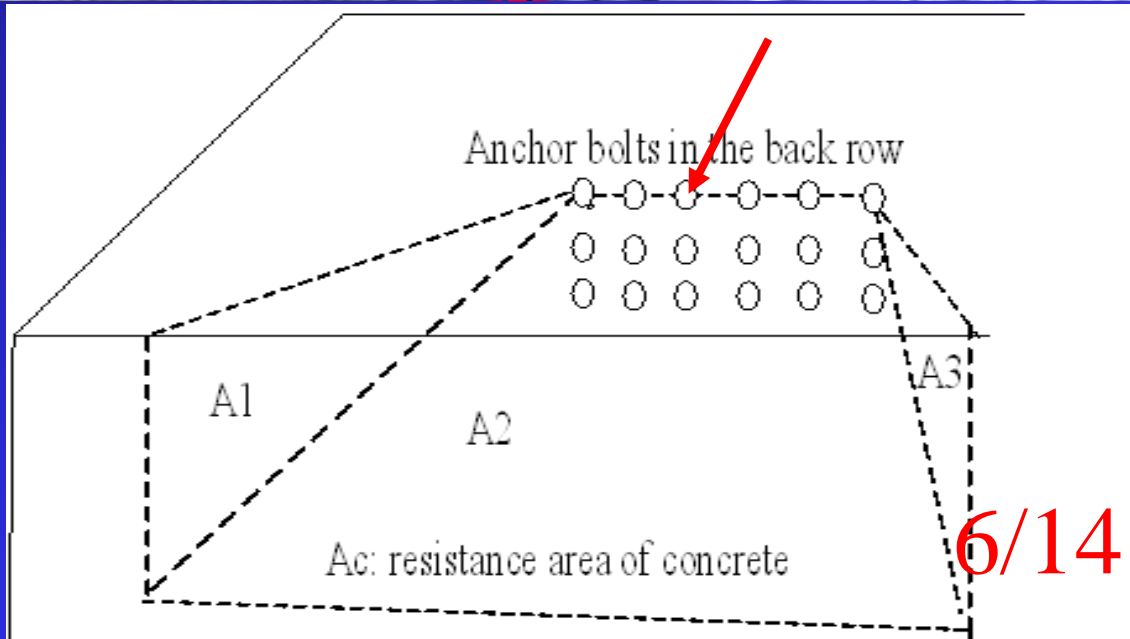
I. Punching shear resistance

$$(\tau_c : 0.22\text{N/mm}^2)$$

$$1076\text{kN}(1.7R_d)$$

II. Design seismic force

$$= 3 \cdot k_h \cdot R_d = 1554\text{kN}$$

Resistance is smaller than force.

- 1. Punching shear resistance is small.
- 2. 150mm: allowable displacement of girder
- 3. 110mm: clearance between girder and confining device.

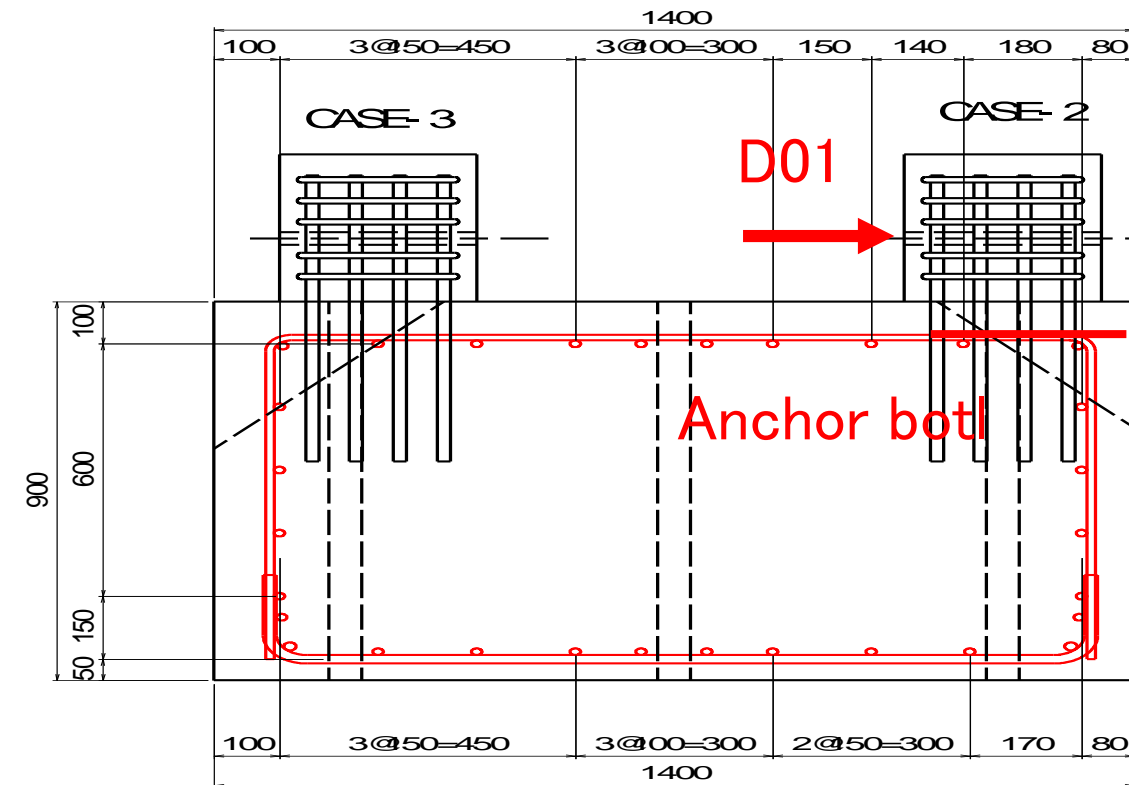
I. On going research

1. To investigate the punching shear resistance of confining device

2. Full scale punching shear test was conducted.

3. Monotonic load is applied.

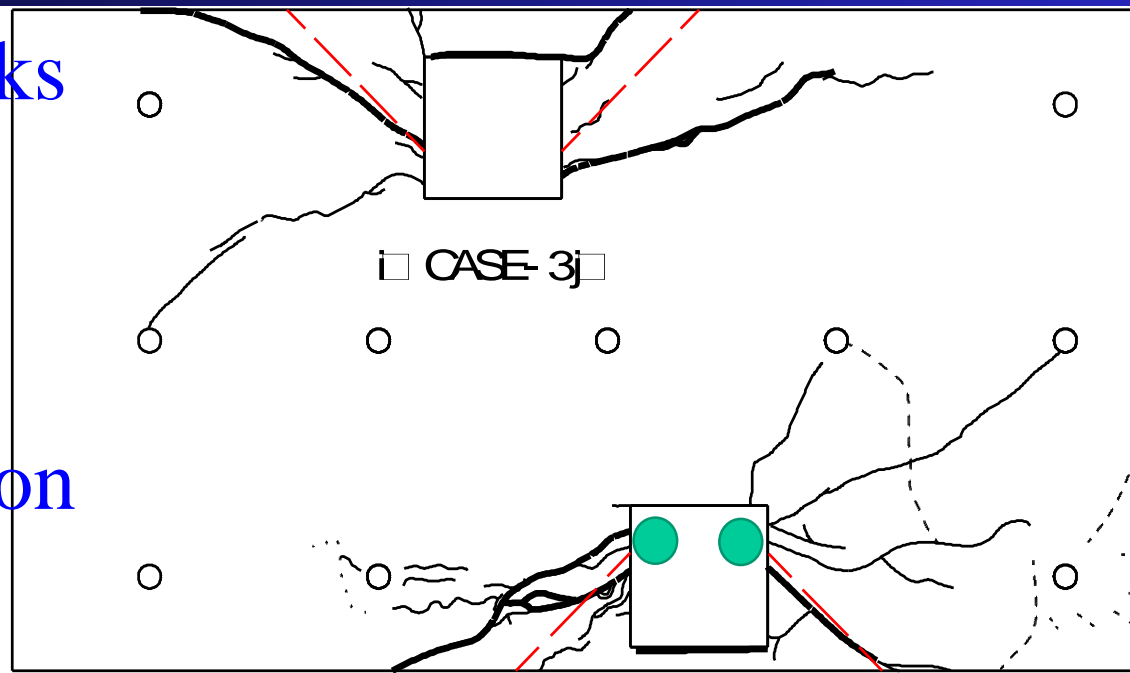
CASE-2 ($\frac{1}{2}$ - \hat{E})

CASE2

1. Fig. shows the cracks at the maximum load at the maximum load

2. Cracks starts from the anchor bolt position of cross section of cross section.

3. Cracking angle is 45°
