Damage of Bridges due to kumamoto Earthquake

Kenji Kosa

Kyushu Institute of Technology

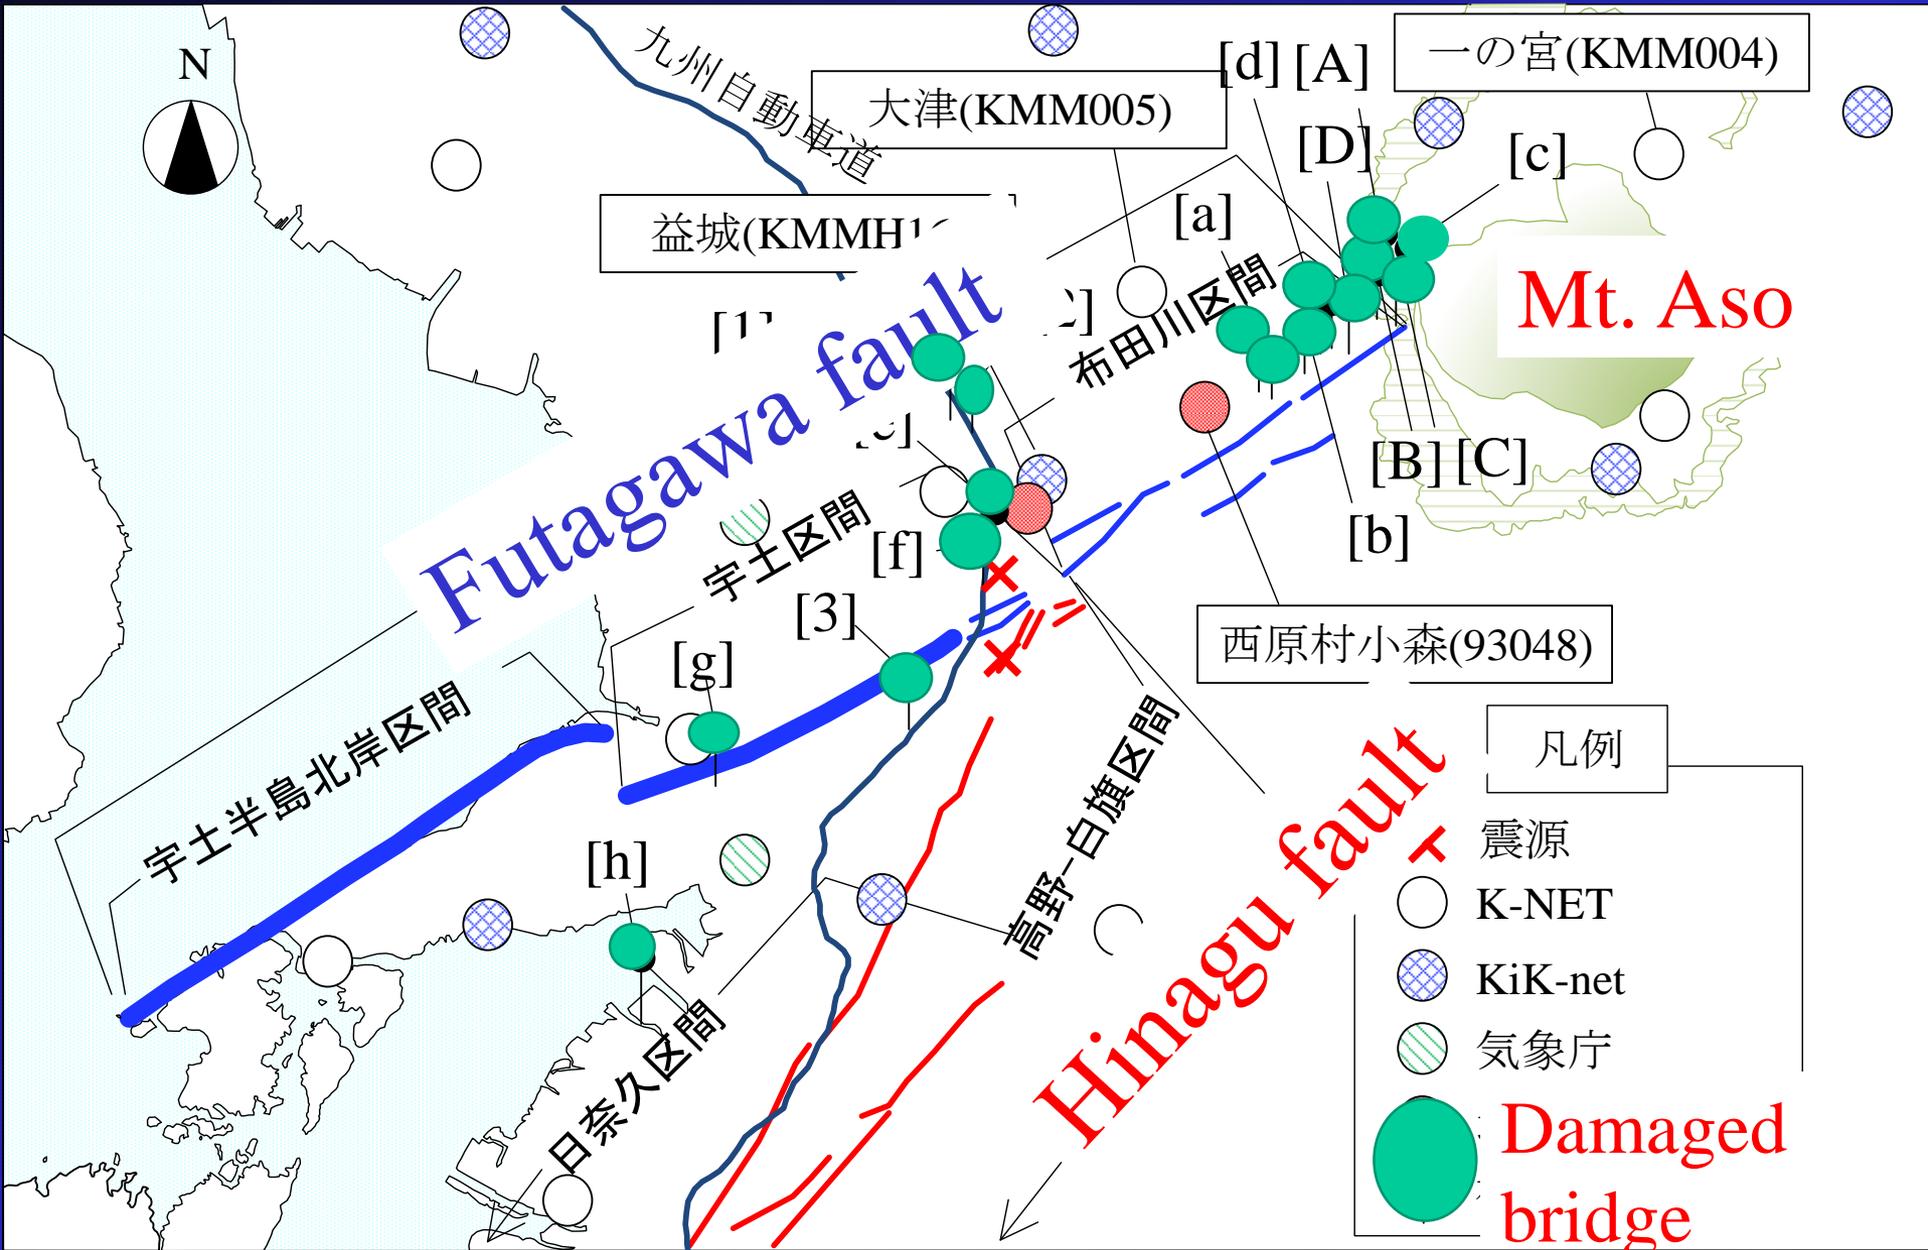
1.(1) Bridges were damaged along Hinagu and Futagawa faults. Damage was caused by ground motion and ground movement.

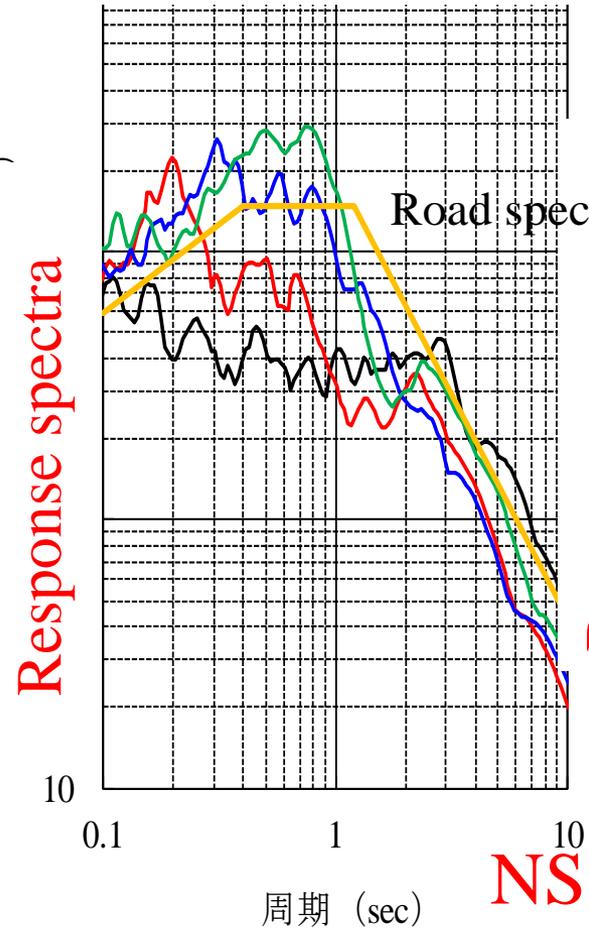
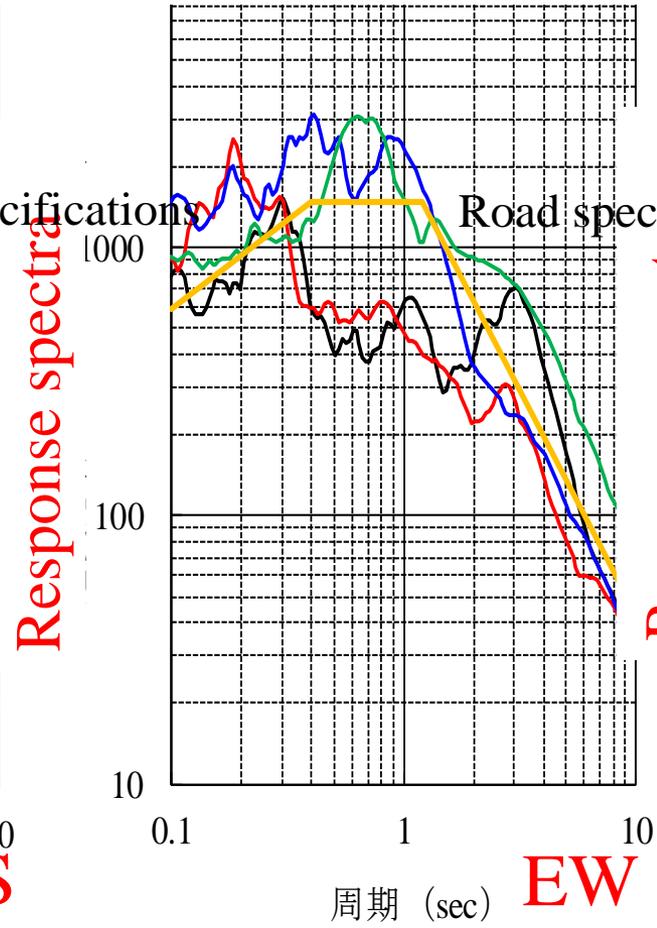
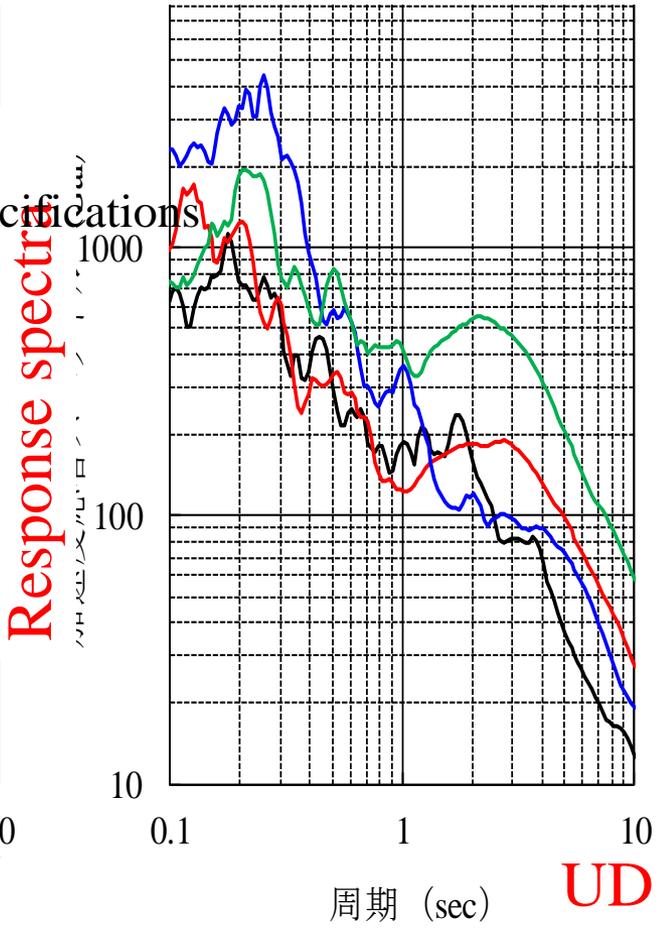
Acceleration response spectra of Kumamoto Earthquake

1.(2) Kumamoto spectra exceeds stad. spectra by Road Spec.

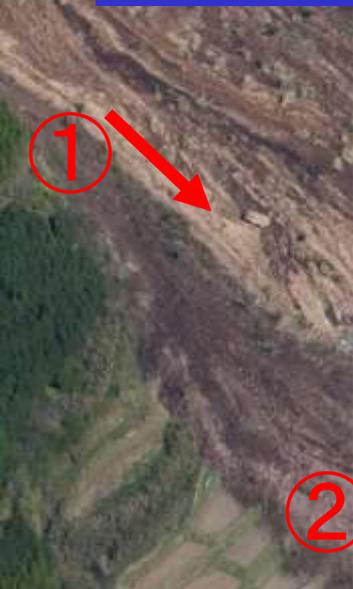
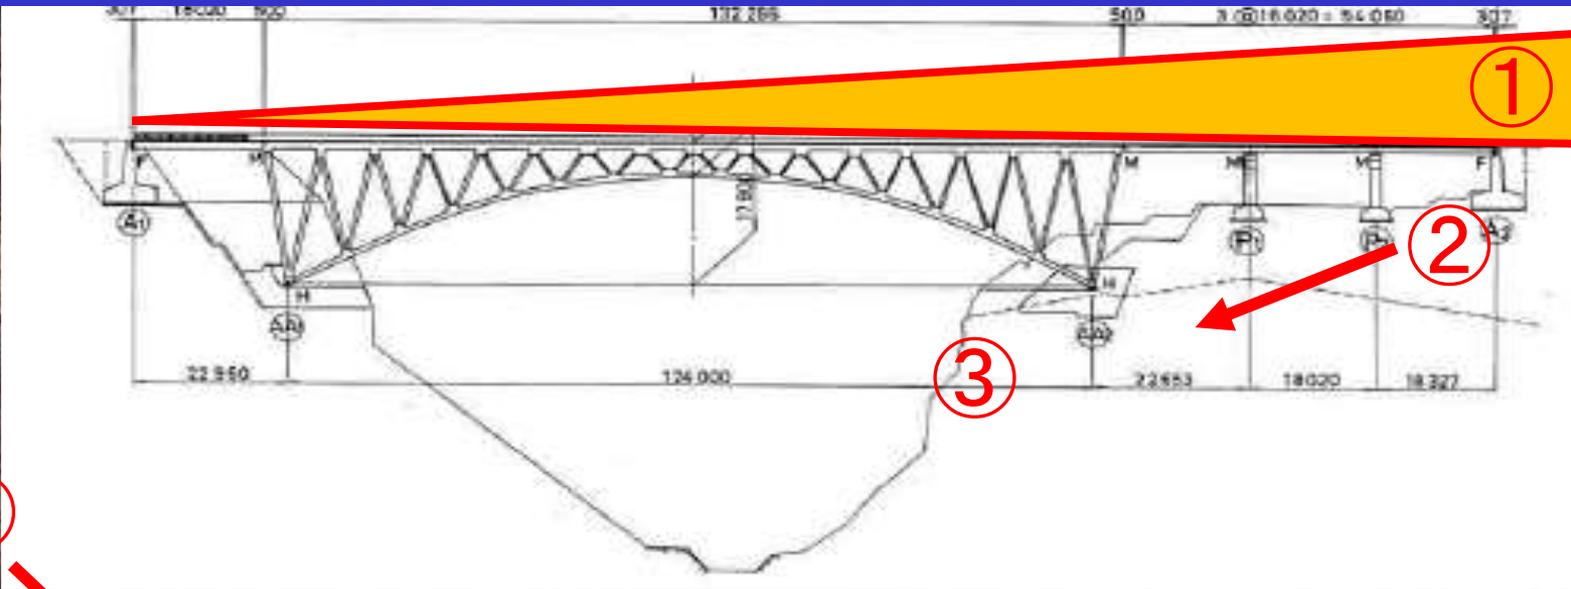
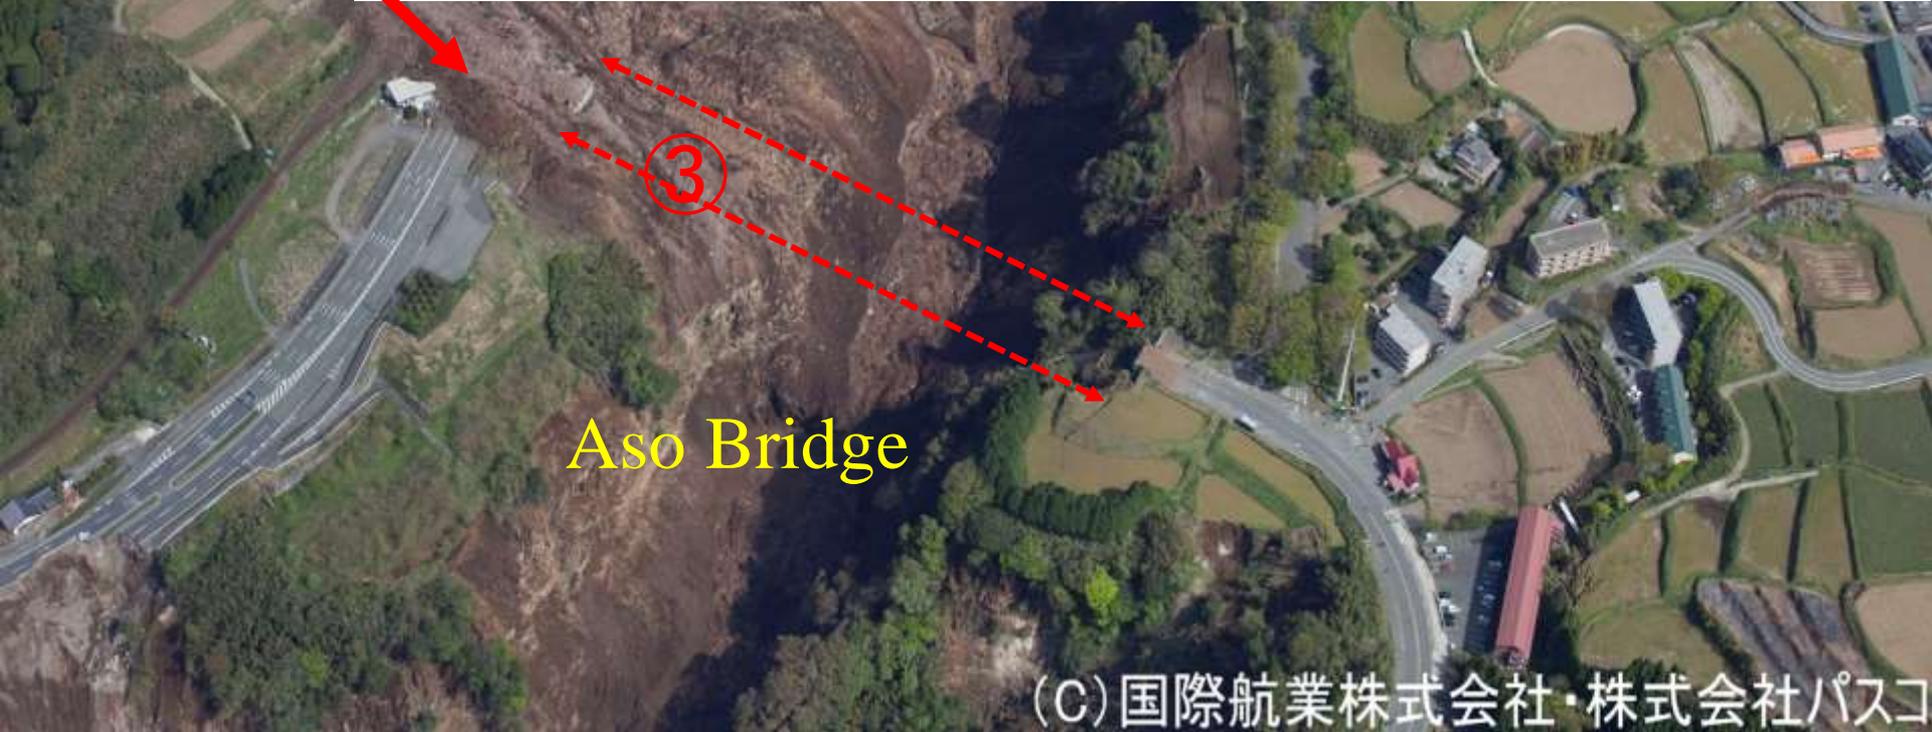
3. (5) Possible cause of bridge collapse: ①, ② or ③

- ① Accumulated soil by the first landslide
- ② Movement of soil by the second landslide, or
- ③ Displacement of abutment (Fault effect?)

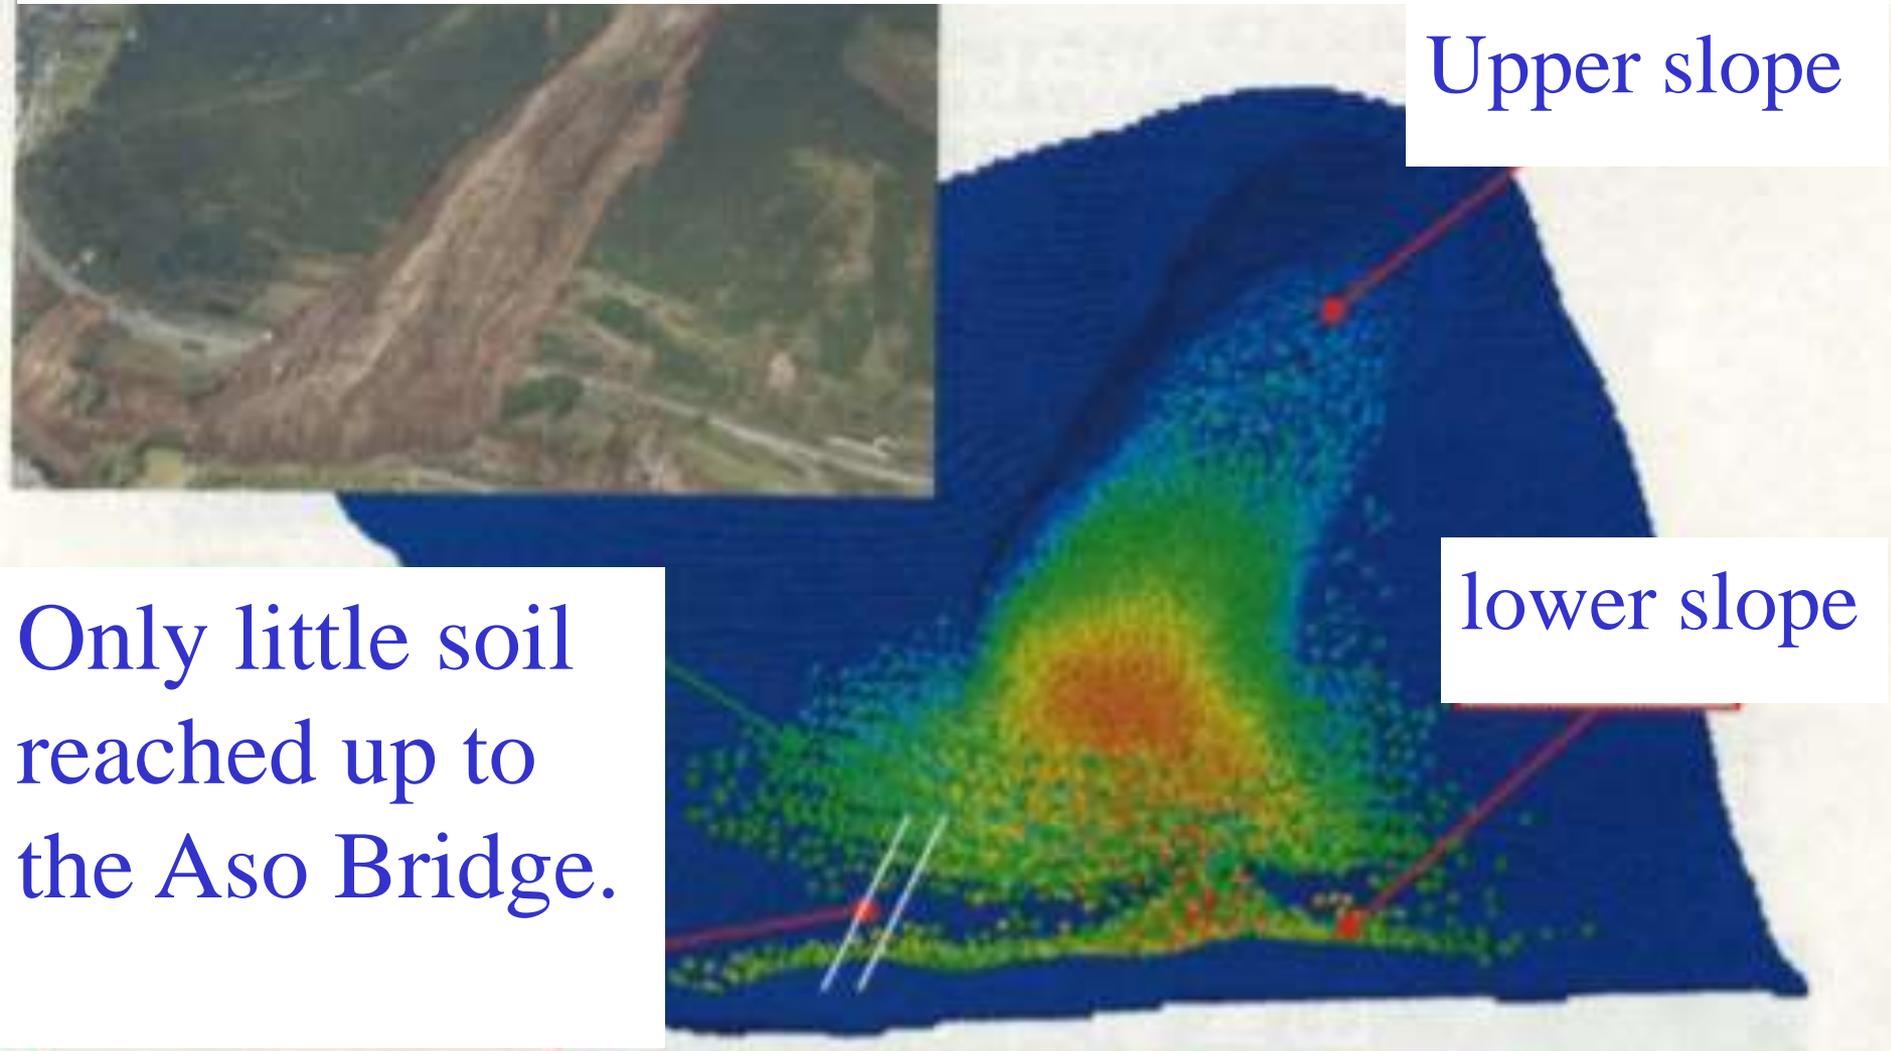
3. (6) To investigate Cause①, SPH(smoothed particle hydrodynamics) method was applied (Kiriya)

Little possibility as to Cause① (first landslide)

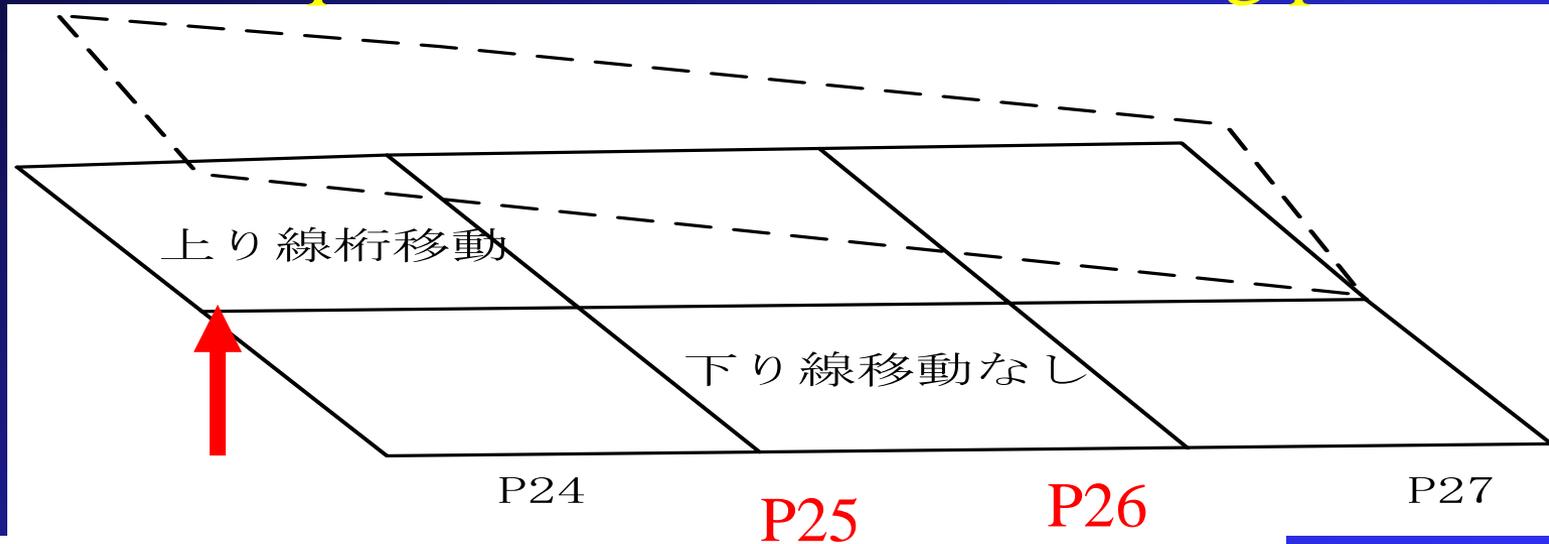
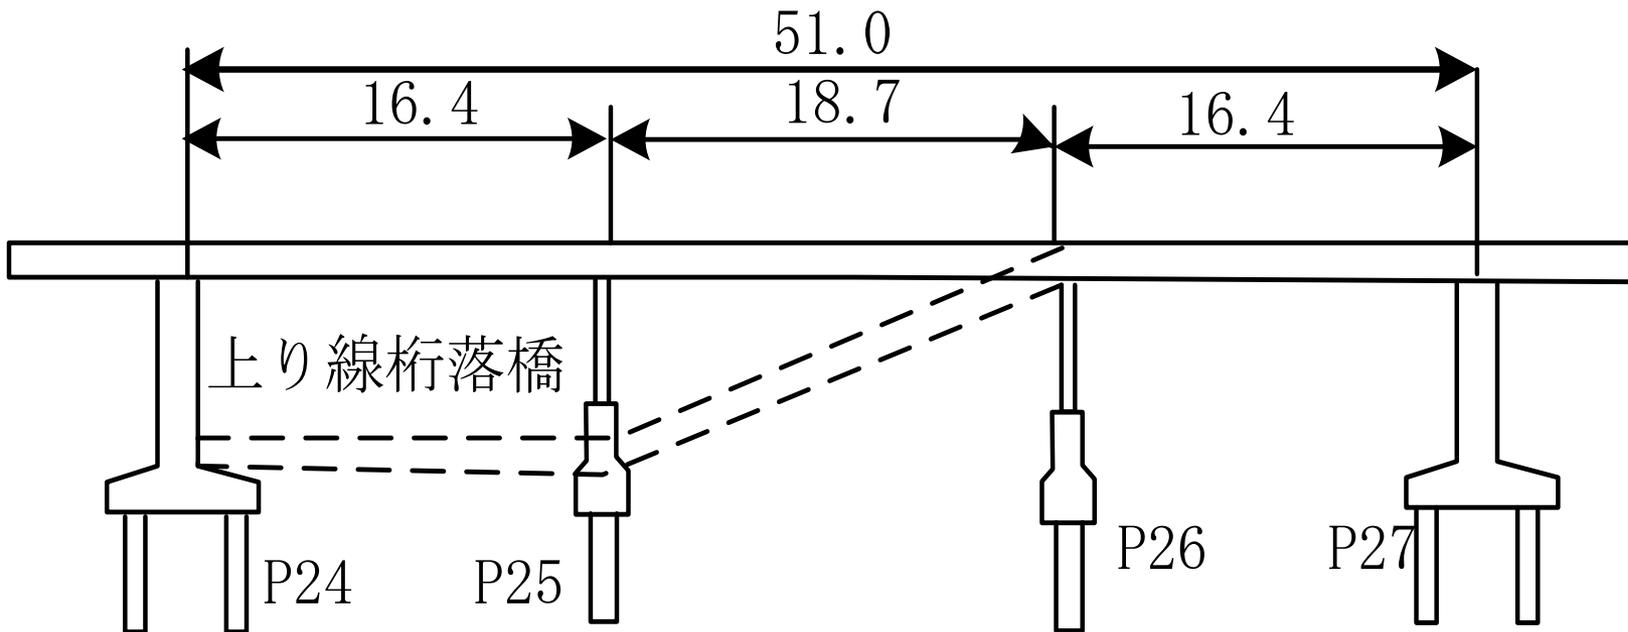
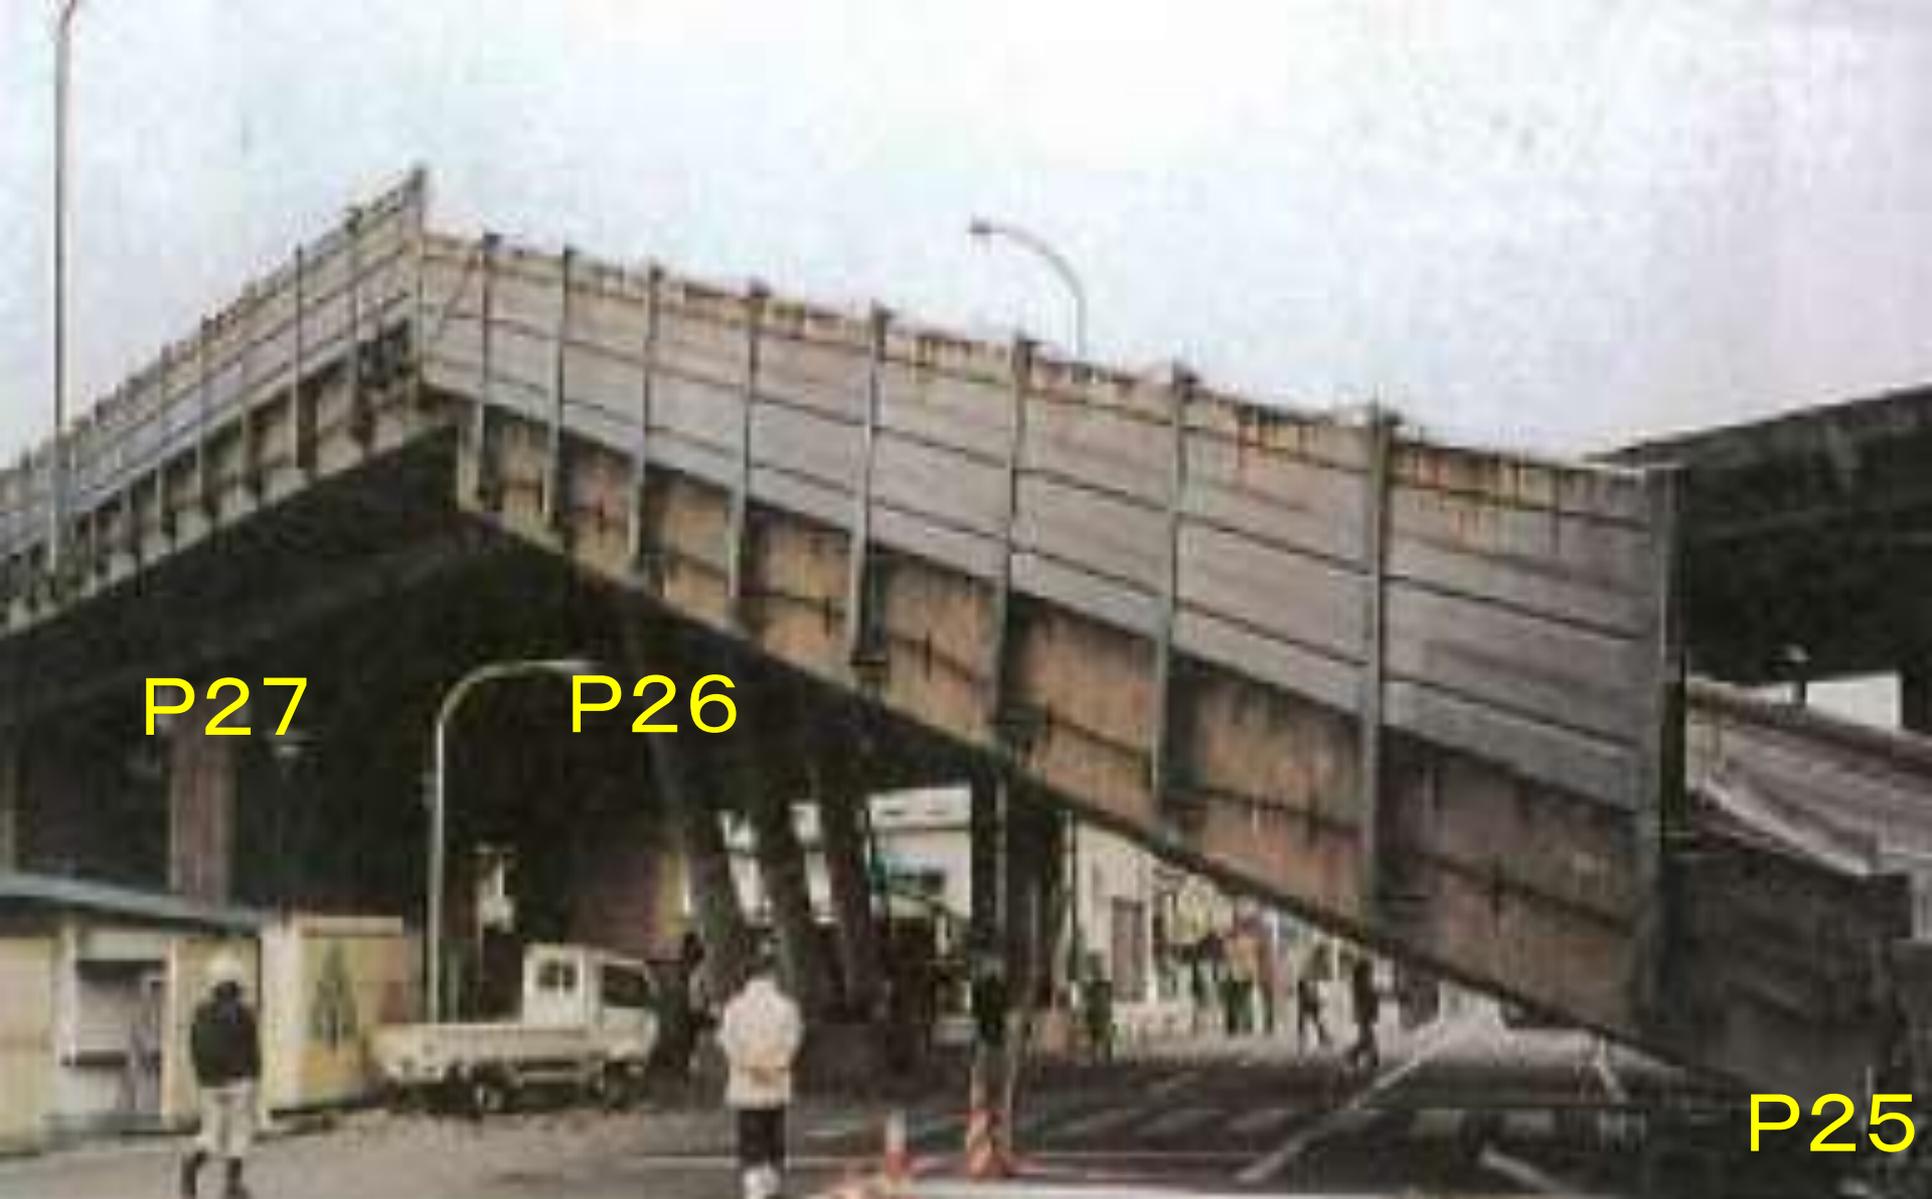
5. (2) One rocking pier (Kawaragi) was collapsed during Kobe earthquake. P25, 26 were rocking piers.

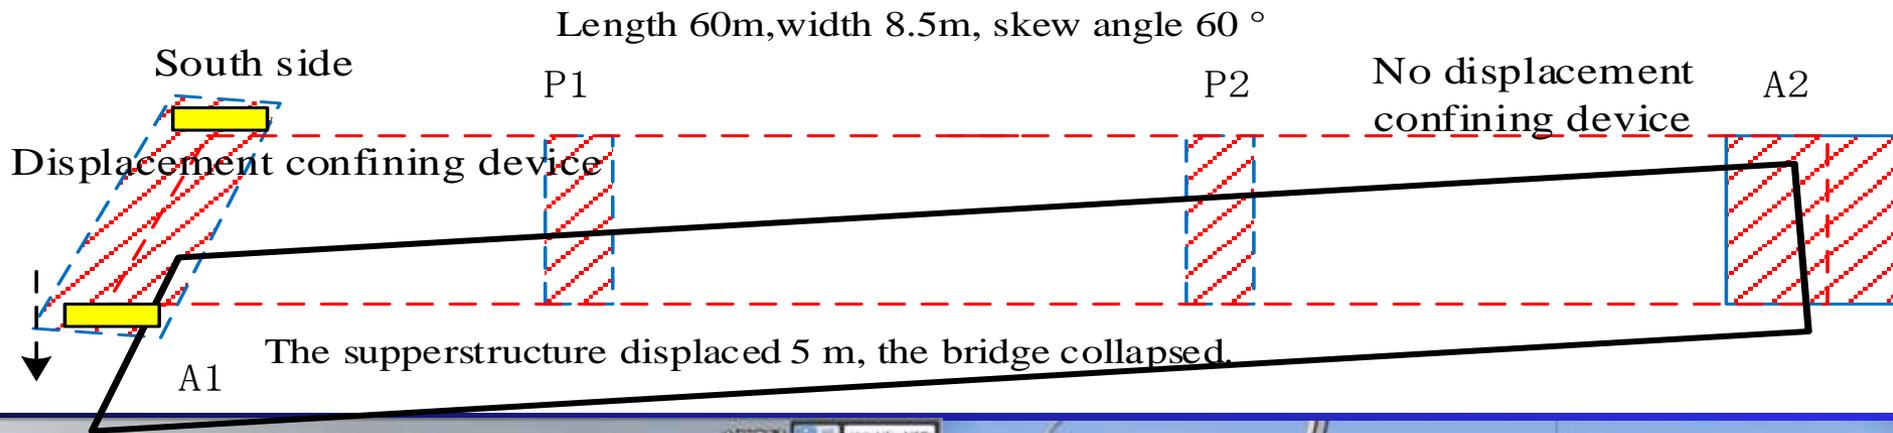
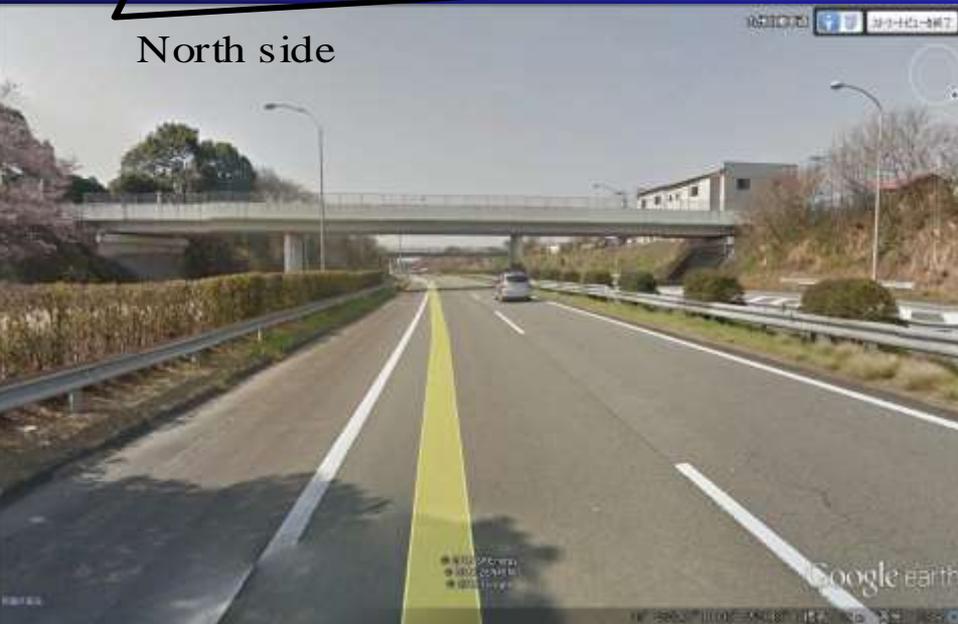
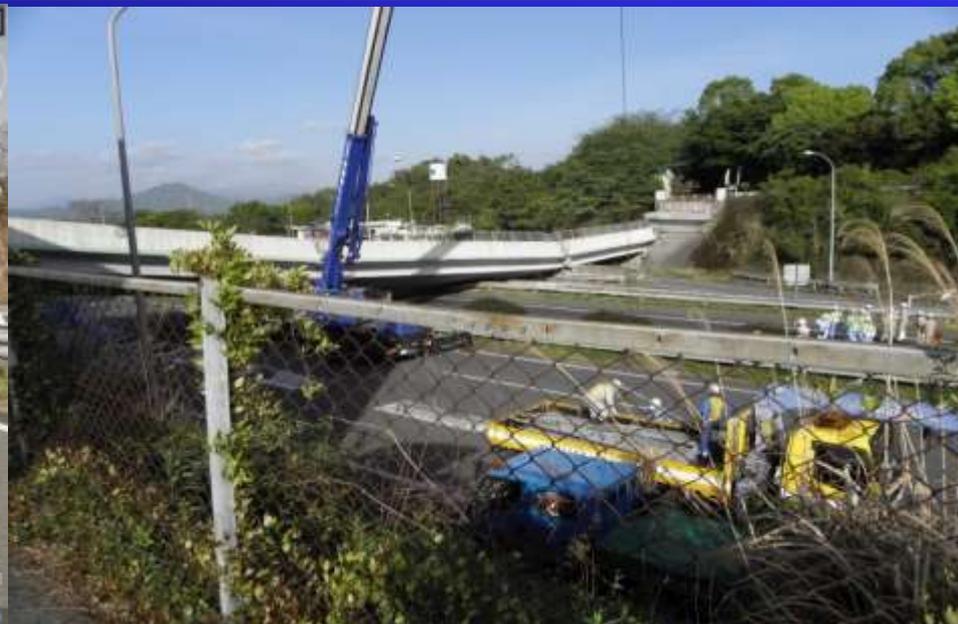
5. (3) Skew girder rotated and fell down in the 1995 Kobe Earthquake.

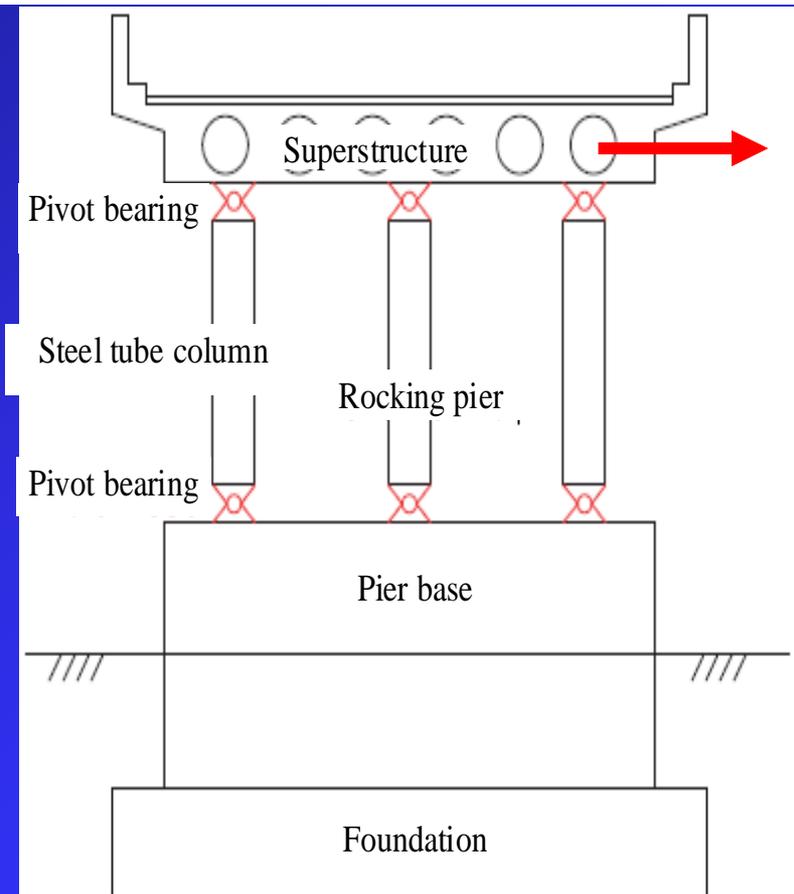
1. Girder moved to the transverse direction.
2. Pivot type bearing was used.
3. When the rotating angle was over 0.06 rad, pivot bearing collided with plate, and leads to the collapse of the bearing.

Pivot bearing is used at lower and upper ends.

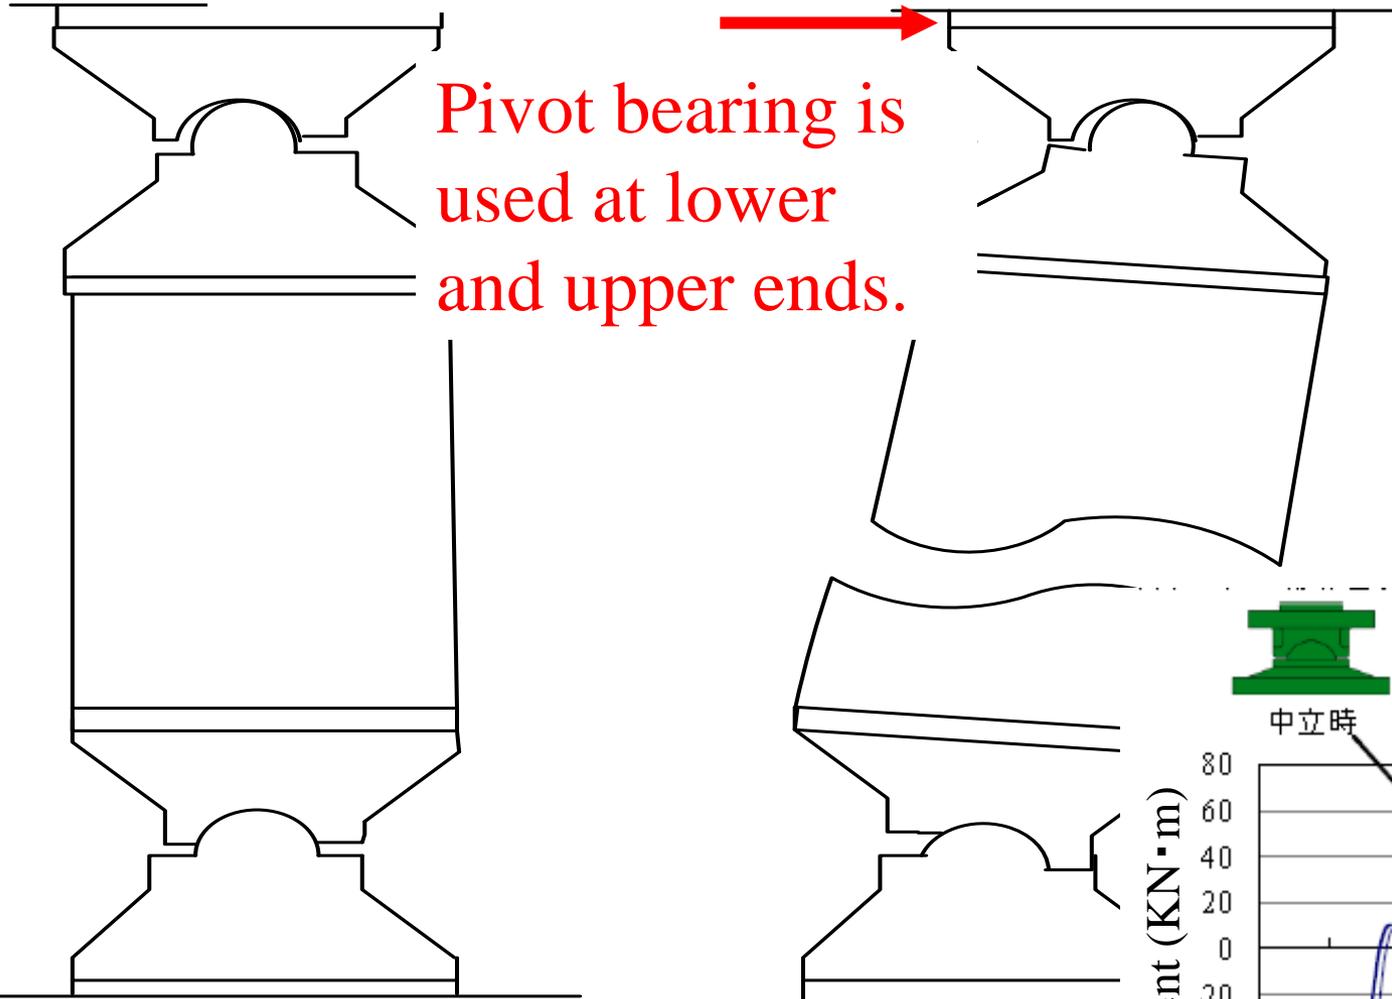
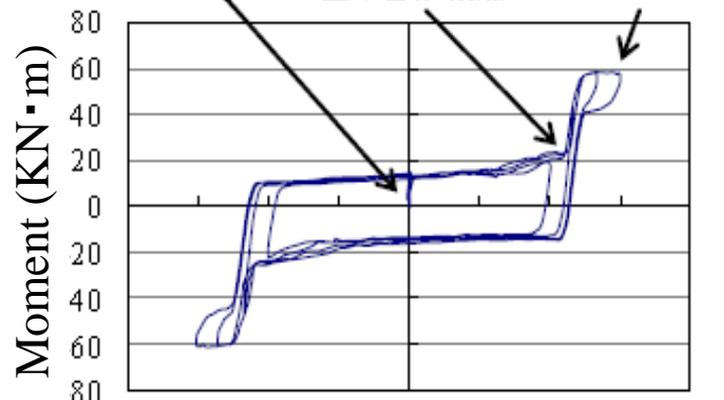
5.(7) Bearings were damaged due to large rotation.

Collide with plate and move up

5.(8)1. When rotational angle of column was 0.06rad, this value is the limit angle of pivot bearing.
2. As the restrainers were completely collapsed, the pivot bearings rotated over 0.06rad, and the bridge collapsed.

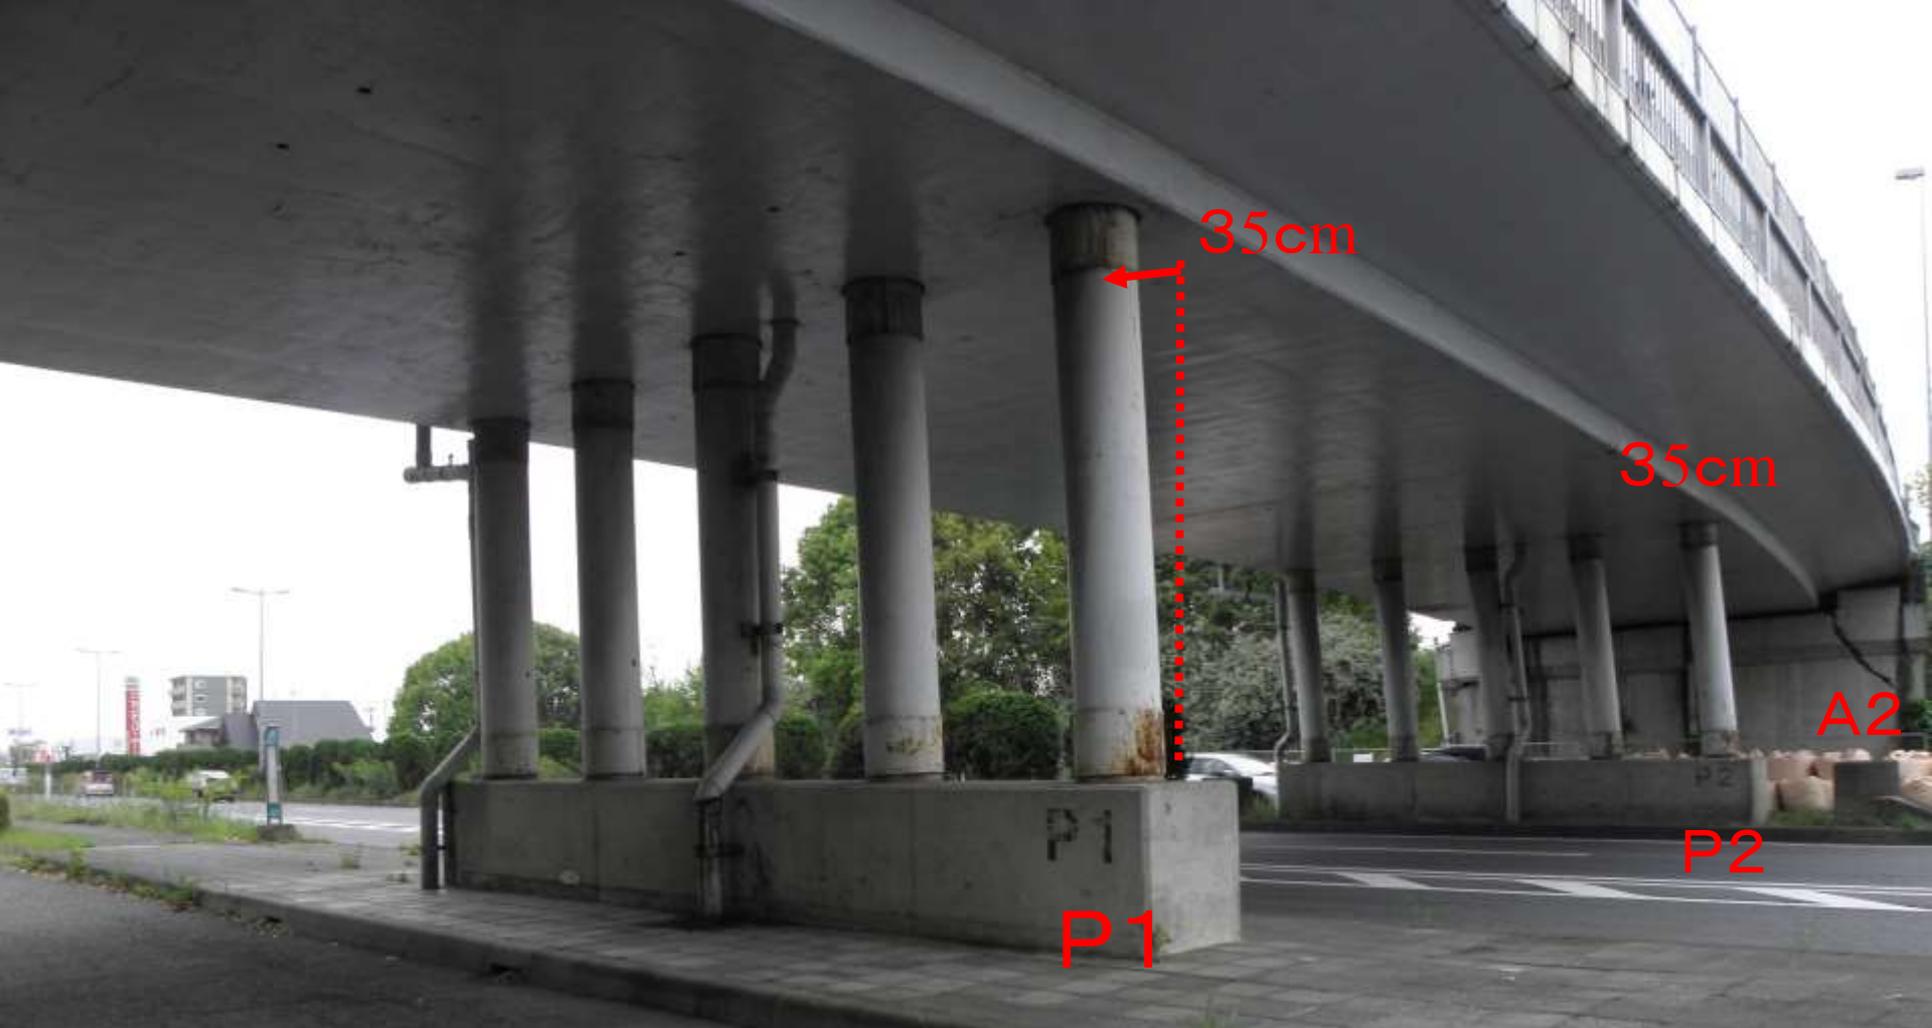
5. (9) Design problems of Furo Daiichi Bridge

1. P1, P2 were rocking columns. There was not installed for longitudinal restrainers.

There was installed for transverse restrainers to protect rotation of girder.

$$F = 3kh \cdot R_d = 1554 \text{ kN}$$

3. Actual applied acceleration would be larger than $3kh$ (about $0.75G$).

4. Punching shear resistance = 1076 kN

5. Resistance is smaller than the acted force.

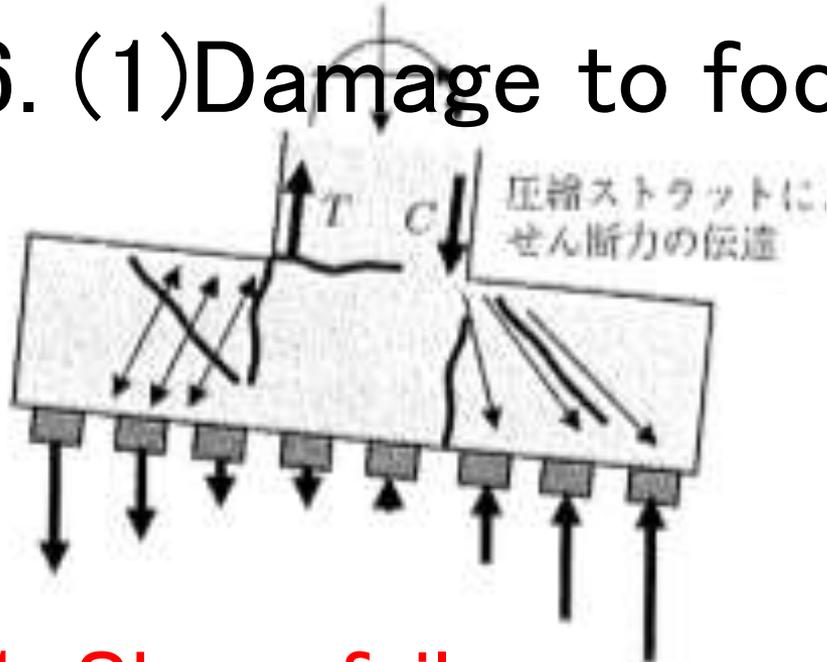
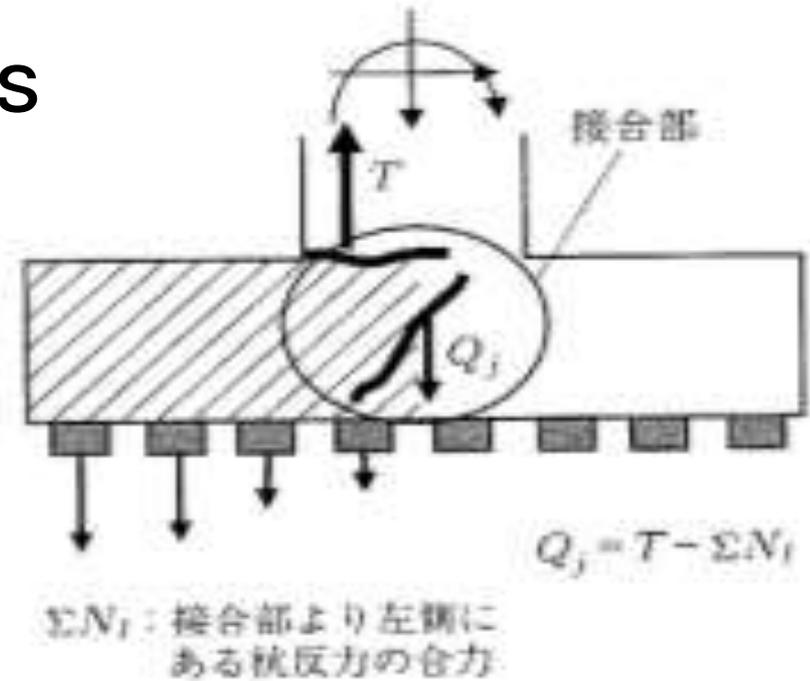
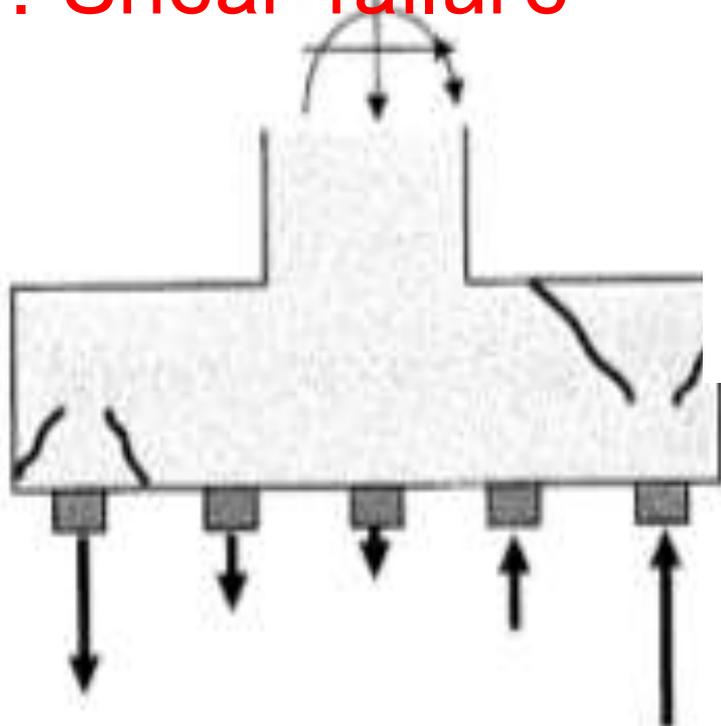
1. Shear failure

2. Shear failure at joint

3. Punching shear
