Damage of Bridges due to kumamoto Earthquake

Kenji Kosa

Kyushu Institute of Technology

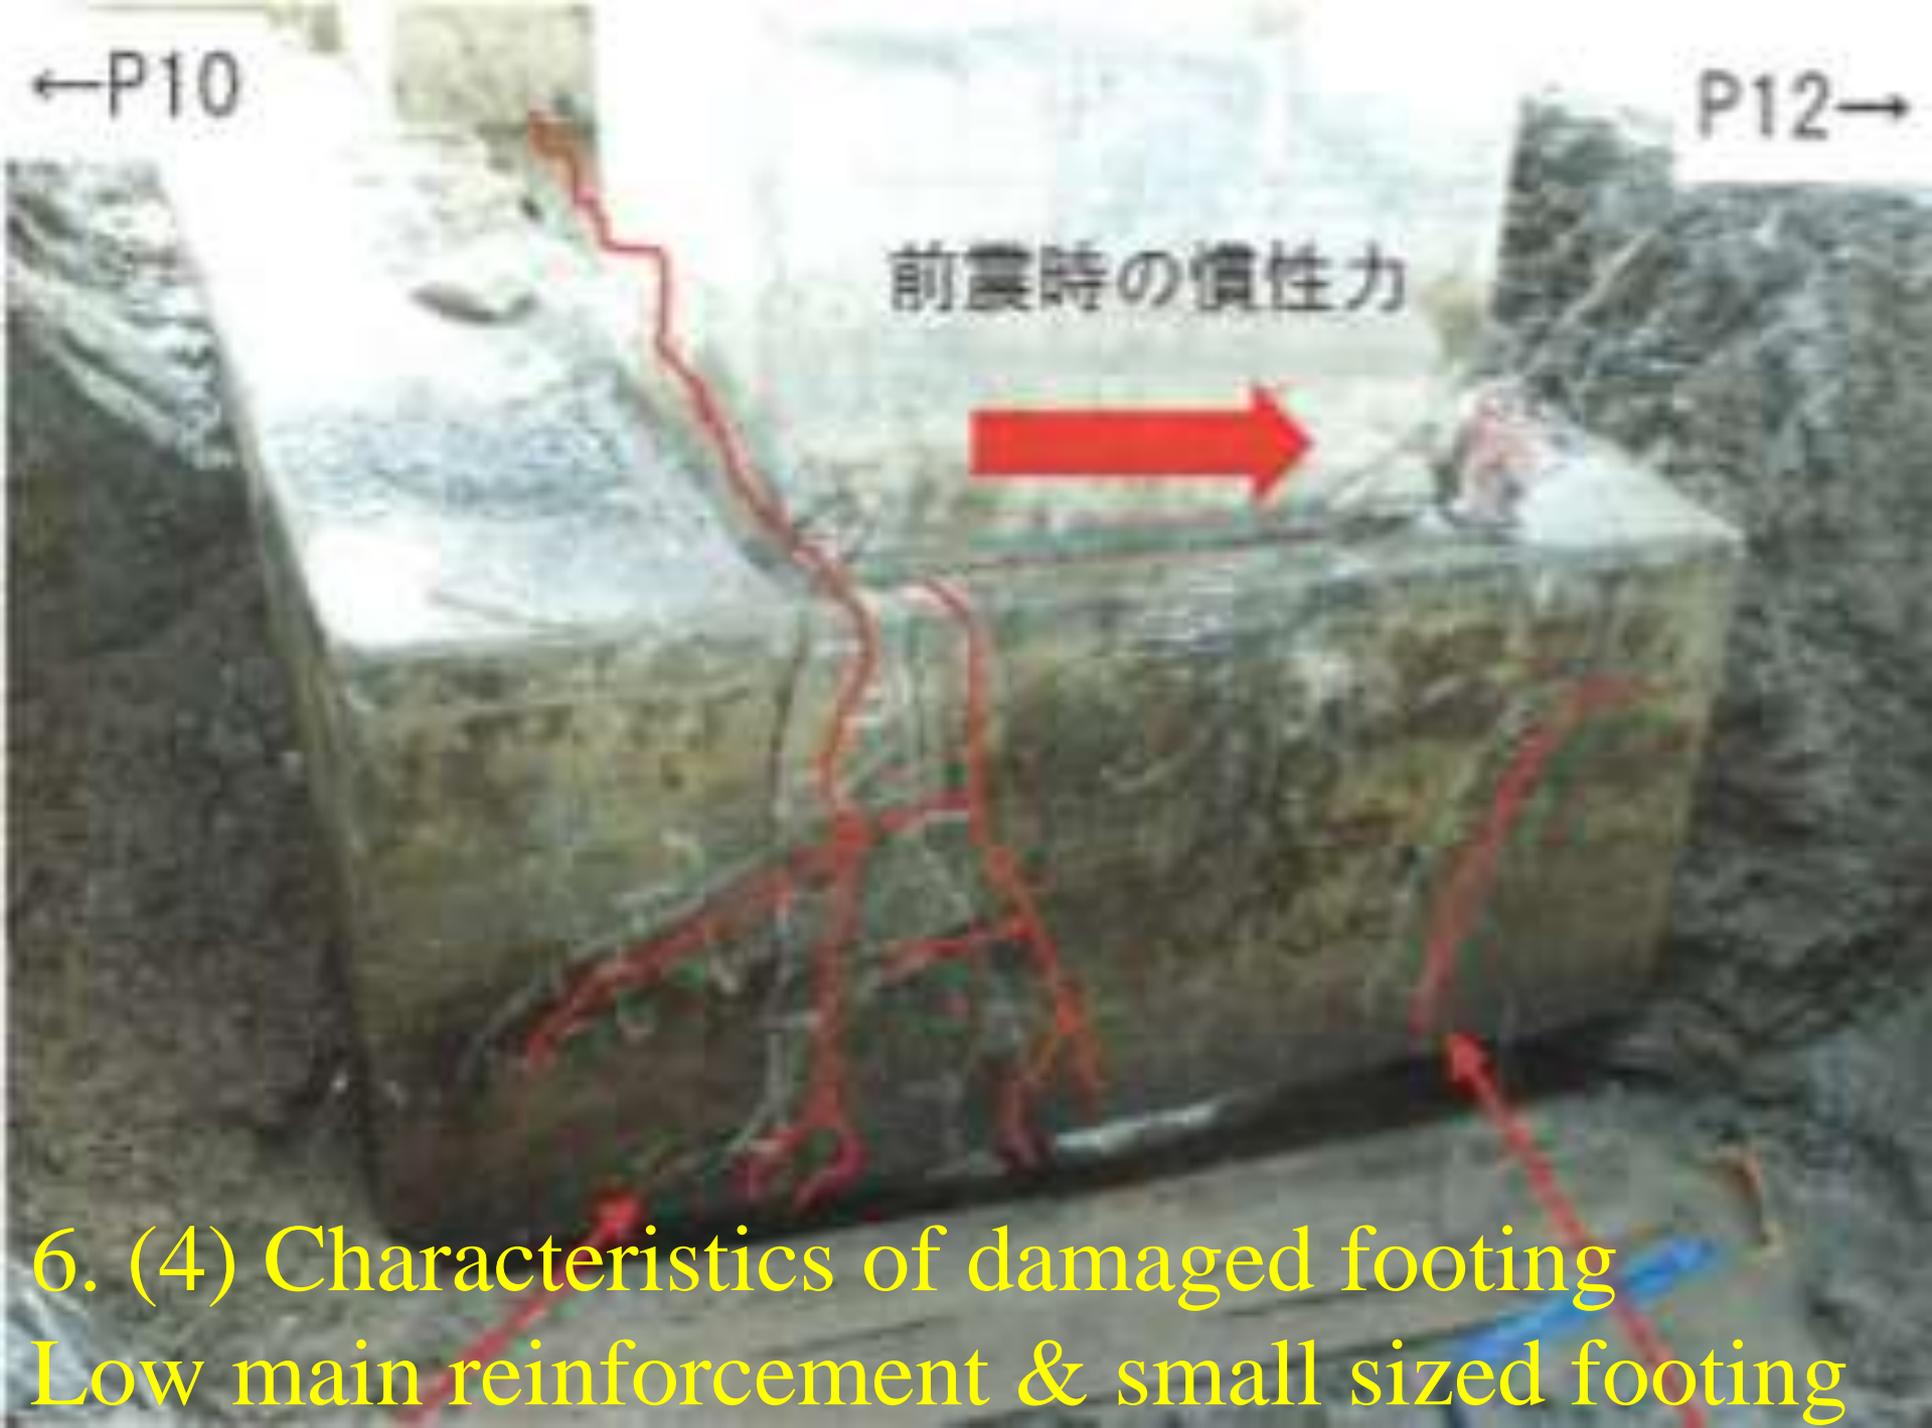
6. (4) Characteristics of damaged footing
Low main reinforcement & small sized footing

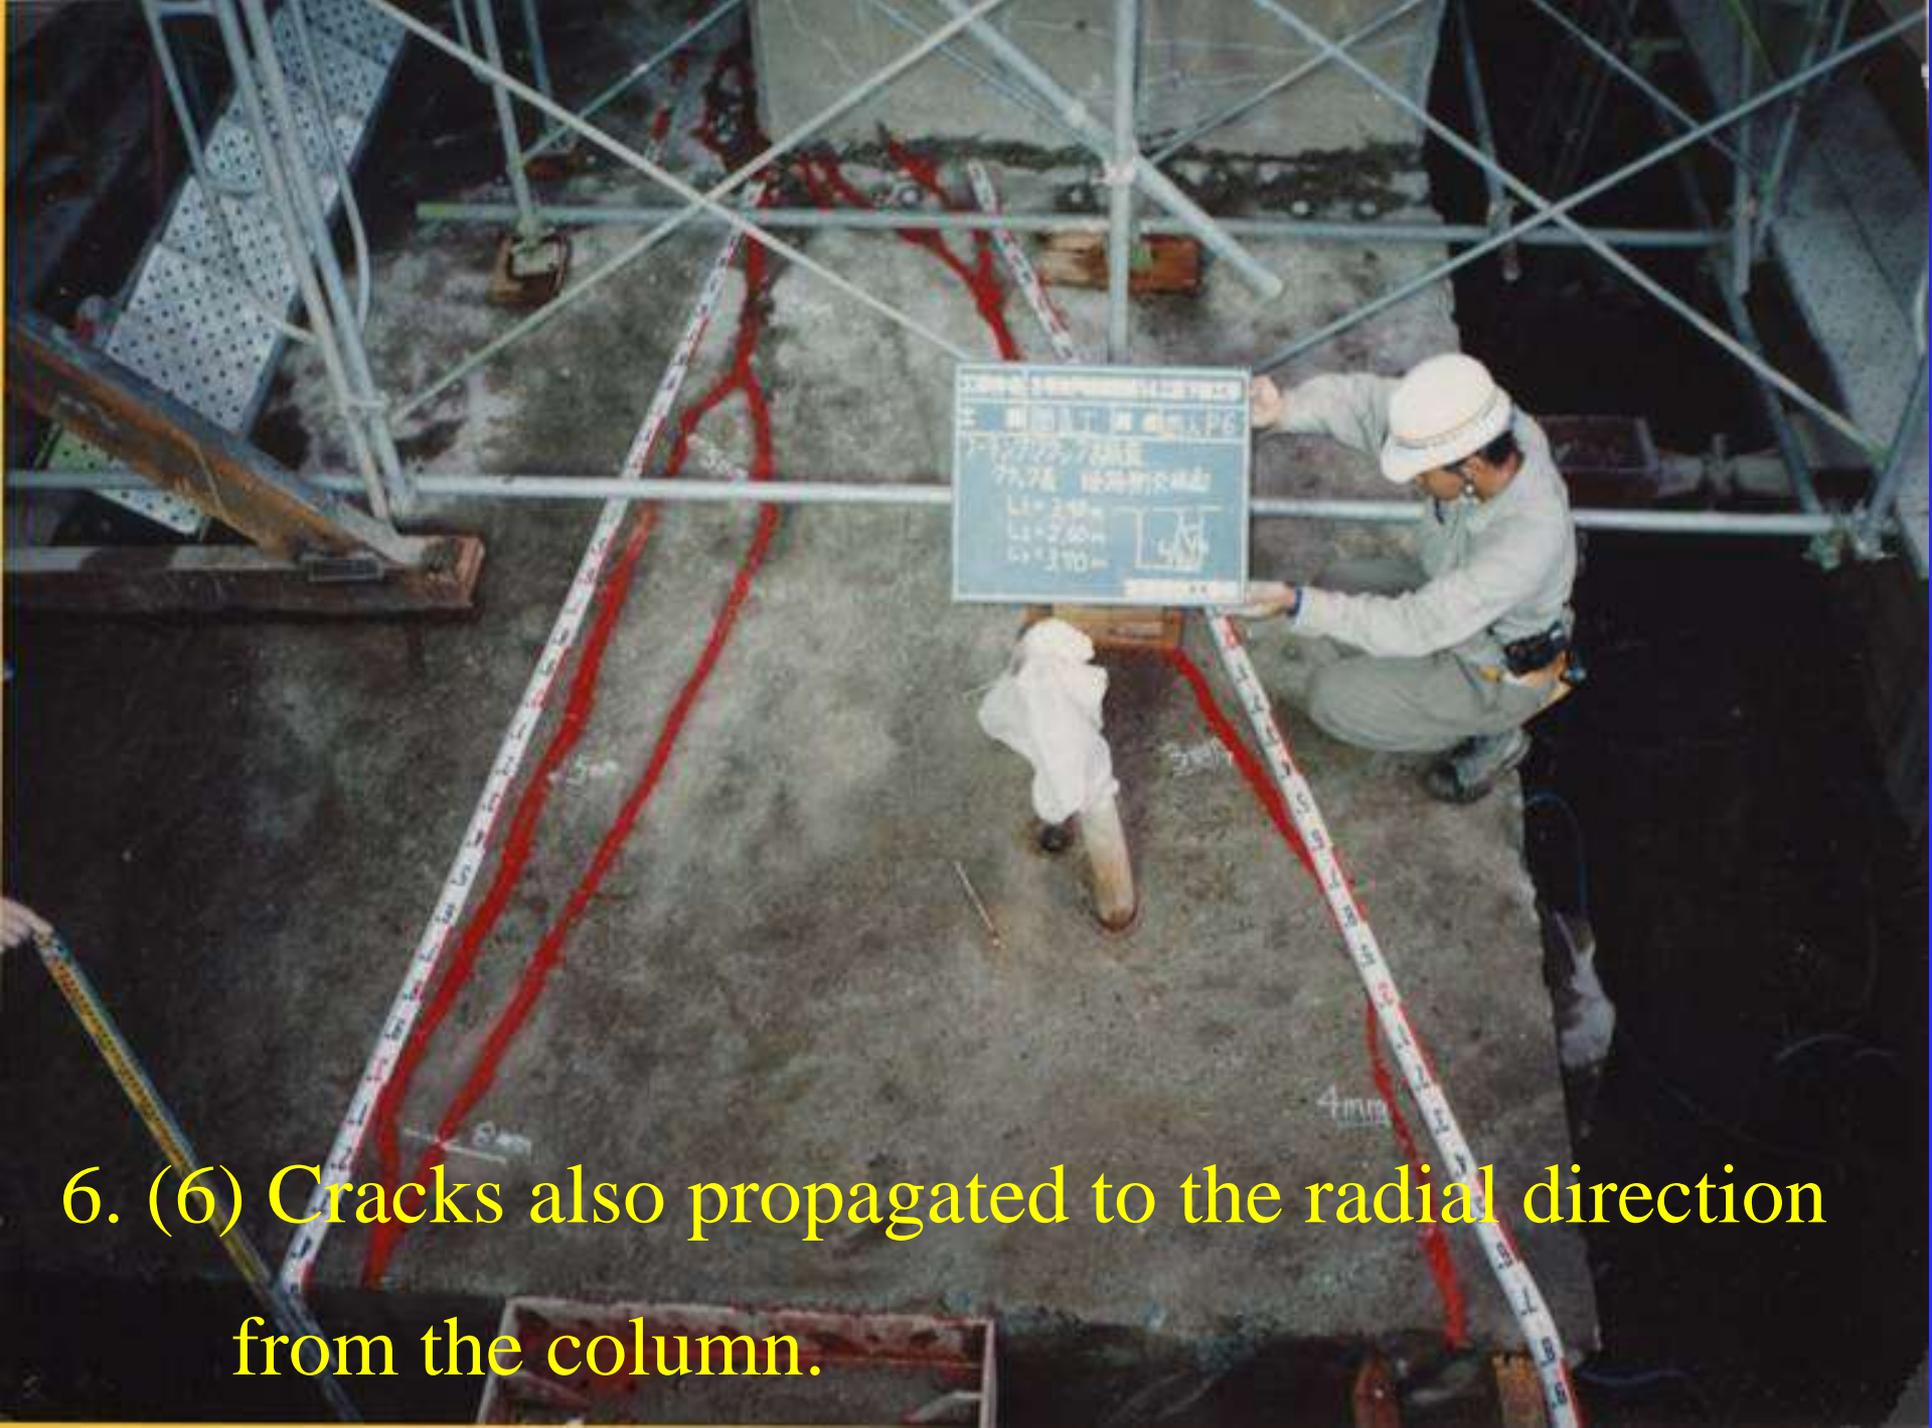
6. (6) Cracks also propagated to the radial direction from the column.

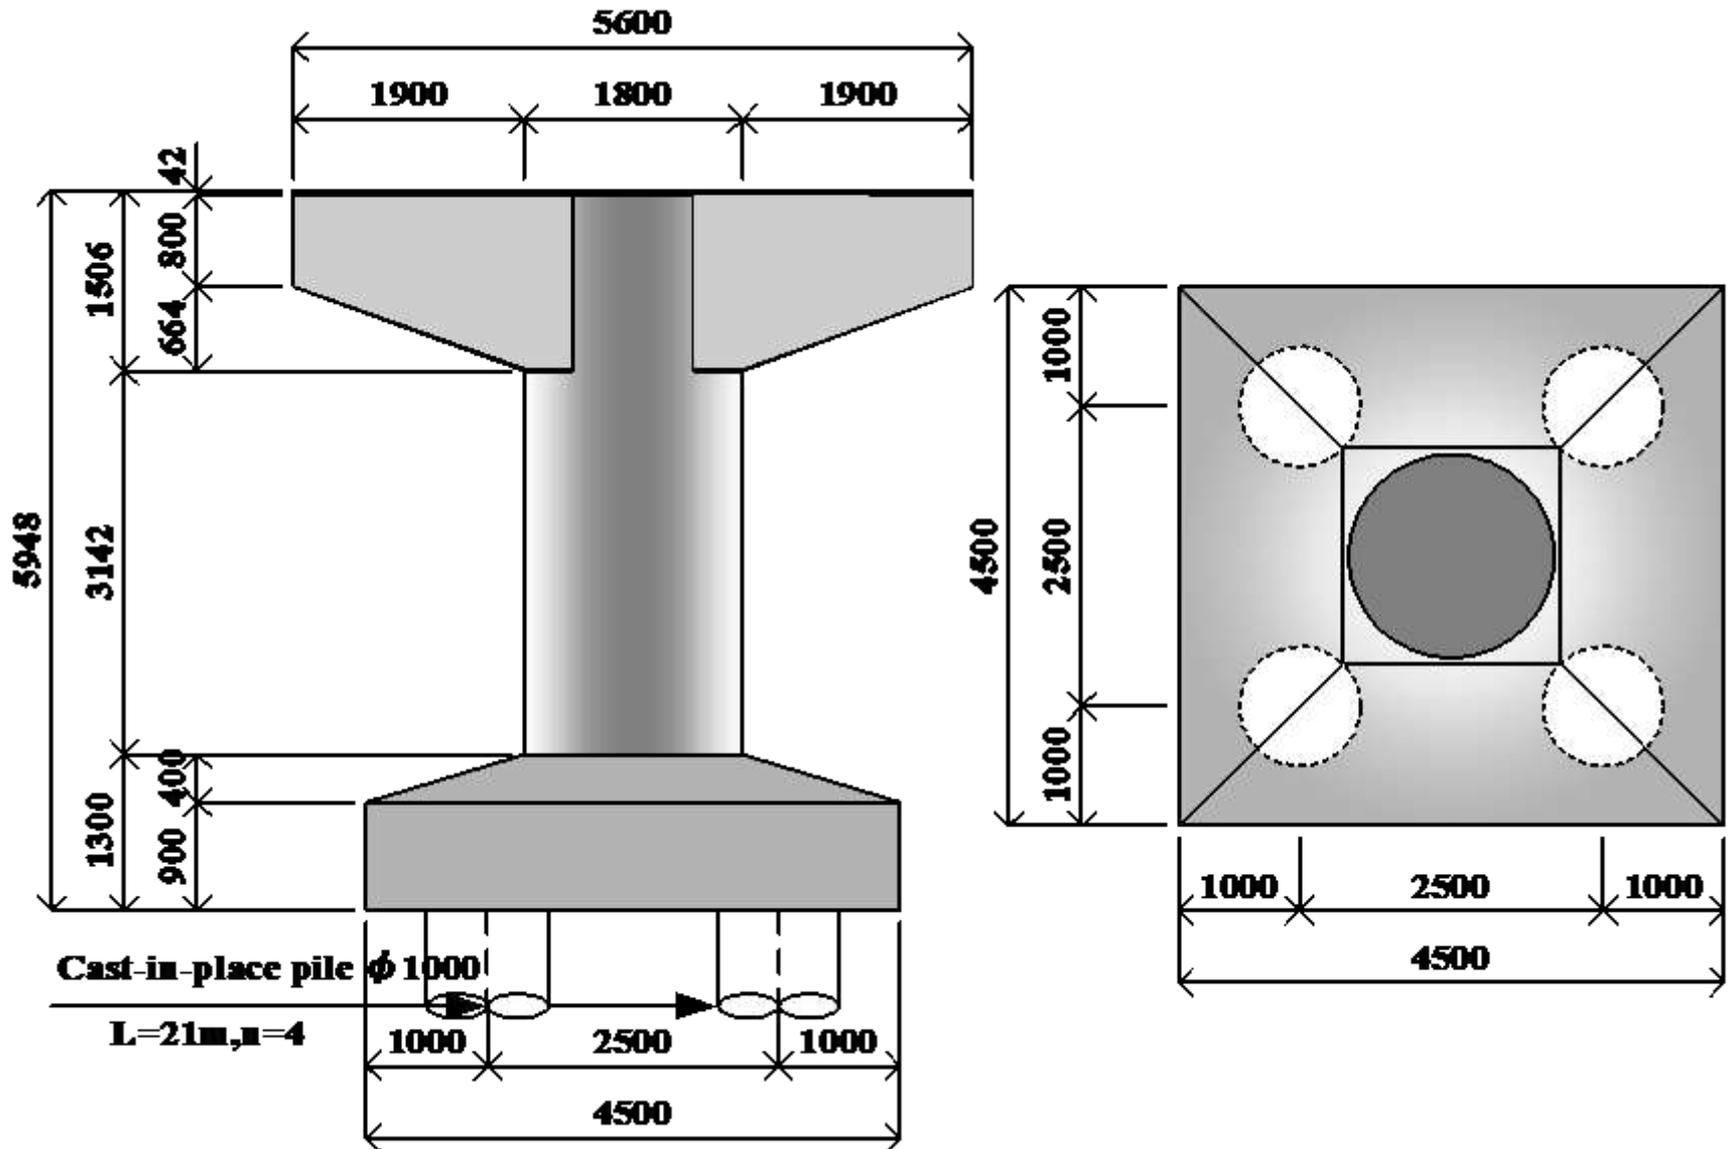
6. (7) Fig. General structure of the damaged footing

Maximum crack width 20 mm, average crack width 7mm. Proto-type (50 % scale) test was conducted.

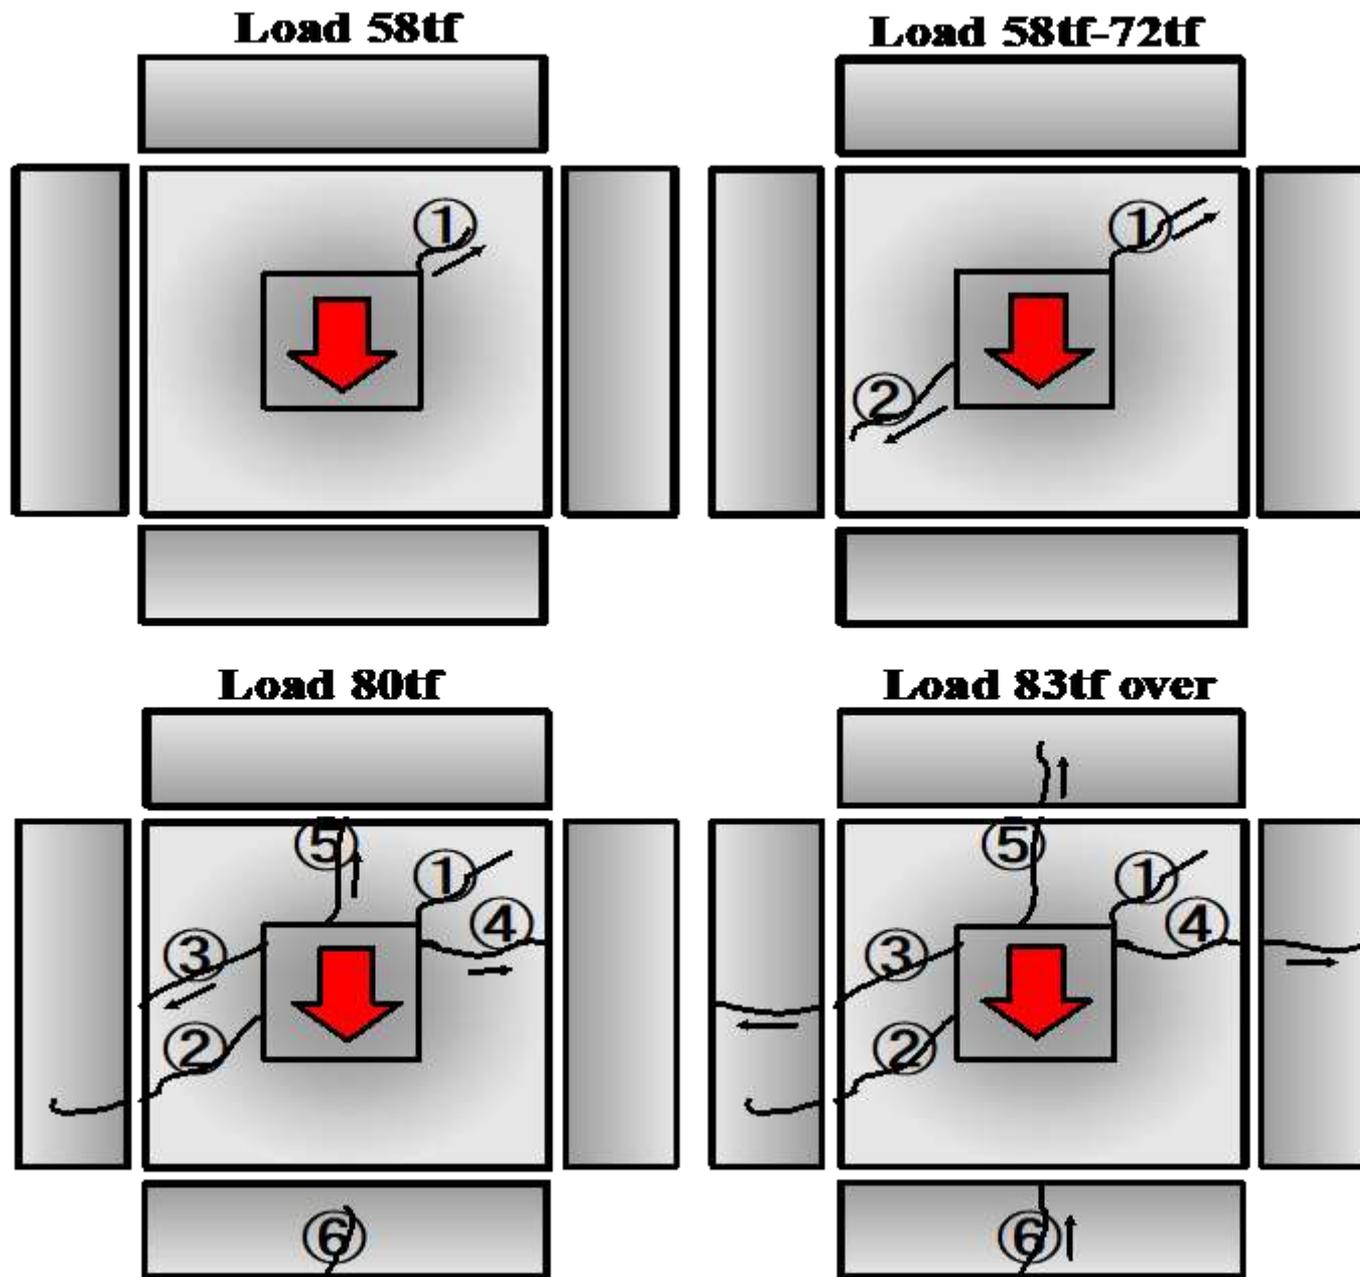
6. (11) Fig. Propagation of cracks under loading

Upper concrete started to rise, and a cone-type failure was generated.

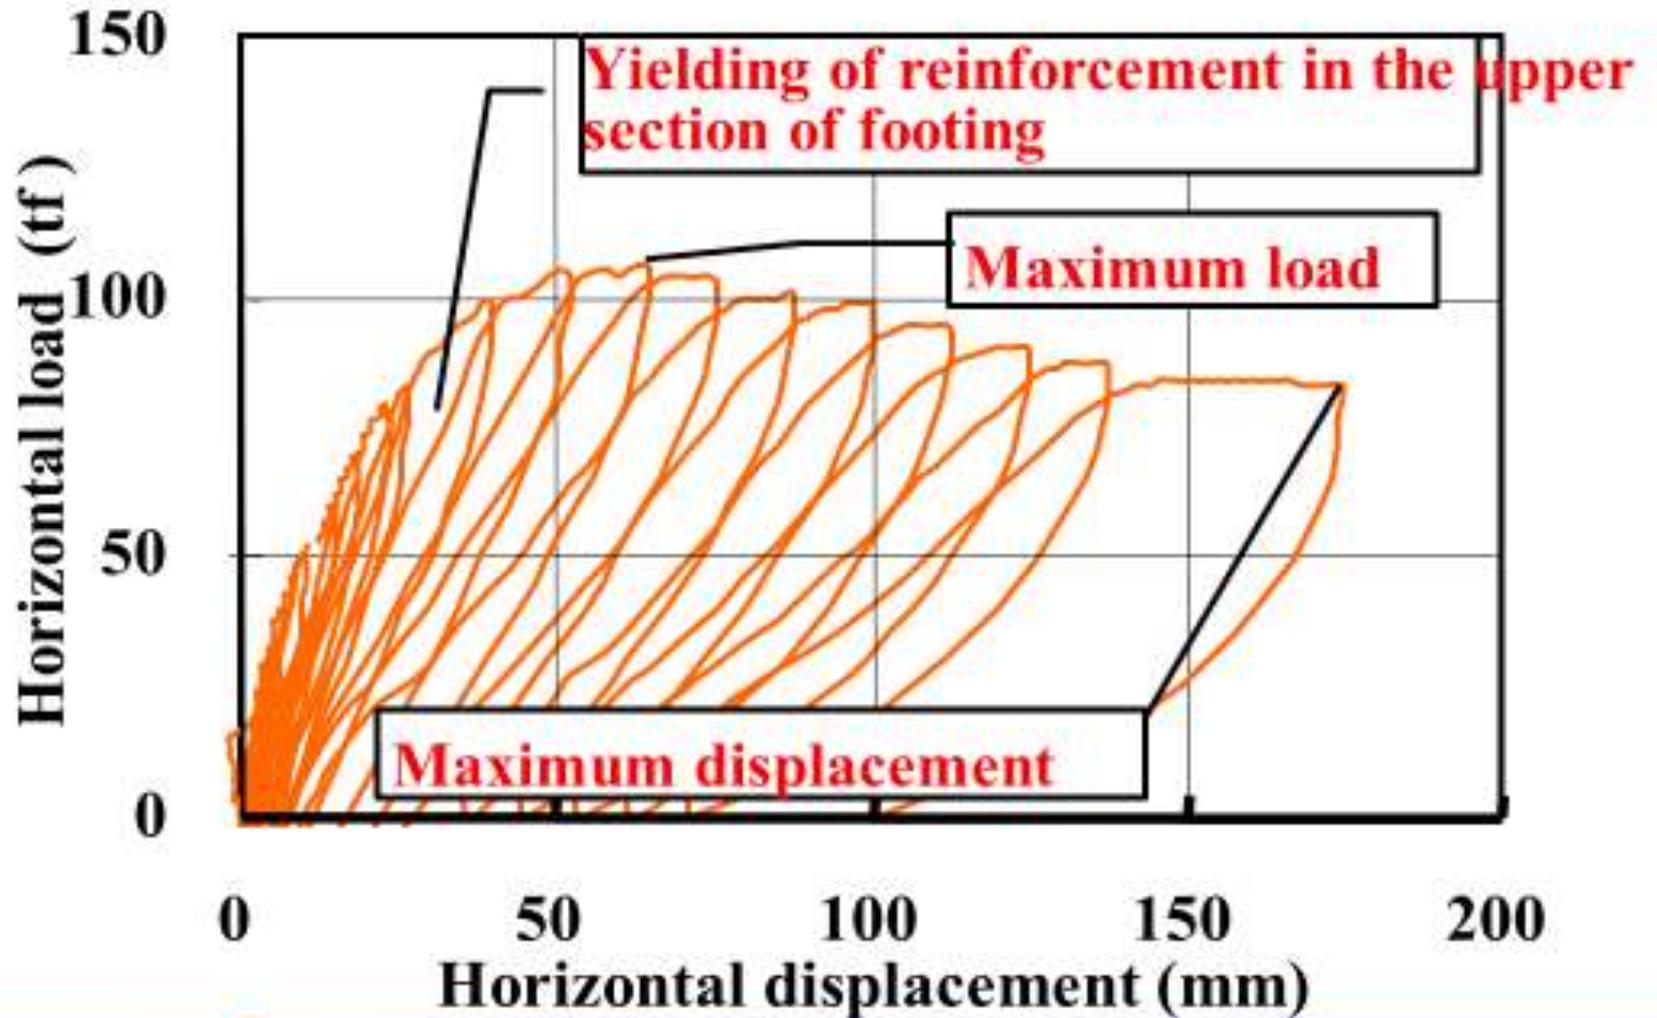
6. (13) Fig. Load-displacement relationship taken at the column top

1. Cracks appeared at the column-footing connection.
2. Damage that determines the maximum load is the yielding of the upper reinforcement.
3. Reinforcement in the upper area of the footing is effective to increase the bearing capacity.
