UNILATERAL CYCLIC LOADING TESTS ON REPAIRED 0.2-SCALE RC COLUMN MODELS USING SHCC

This study investigates failure mechanism of repaired RC columns using SHCC based on unilateral cyclic loading tests of 0.2-scaled RC column models that have been compared with a full-scaled RC column model with regarding to strength, ductility and so on in authors' previous studies in order to minimize the size effect of scaled column models. Following the authors' previous studies, this study repaired damaged 0.2-scaled RC columns which were tested in the authors' previous studies and carried out their cyclic loading tests. For repairing, this study used a spraying cement mortar with the 2 % volume of polyvinyl alcohol fiber having 40.0 μm diameter and 12 mm length after removing cover concrete of the damaged columns.

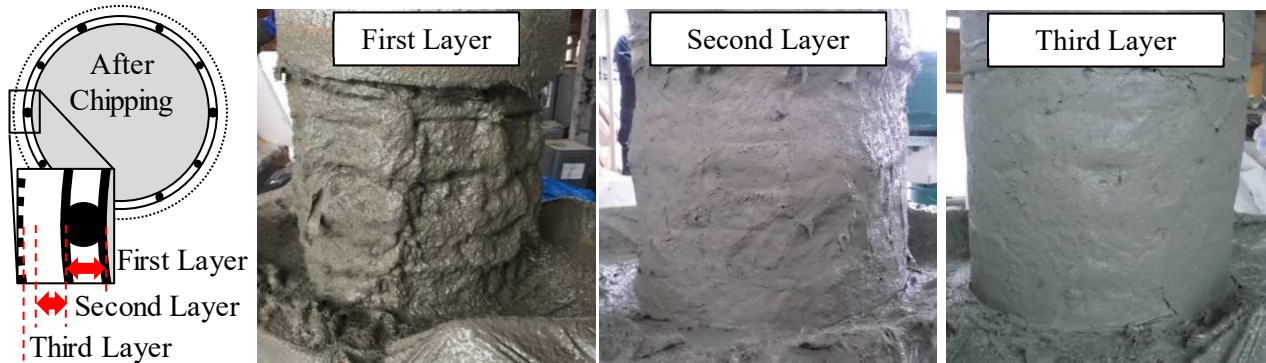
Figure 5. Spraying SHCC (1R)

broken. The broken ties were repaired by using new same tie. Buckling longitudinal bars were not repaired. Figure 5 shows the method of the spraying SHCC. The SHCC was sprayed dividing into 3 layers. First layer was sprayed at the area of longitudinal bars. Second layer was sprayed at the area of cover concrete. Third layer was sprayed as finishing. The SHCC was a cement mortar with the 2 % volume of polyvinyl alcohol (PVA) fiber having 40.0 μm diameter and 12 mm length. Water-binder ratio and unit water amount was 40 %, 335 kg/m^3 . Figure 6 shows SHCC strength based on cylinder tests. Cylinder tests performed at 14 days curing. The average of compressive strength was 23.1 N/mm^2 . On the other hand, the average of tensile strength was 4.5 N/mm^2 .

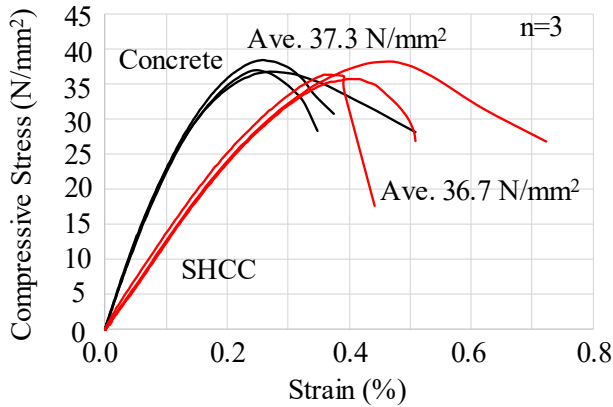
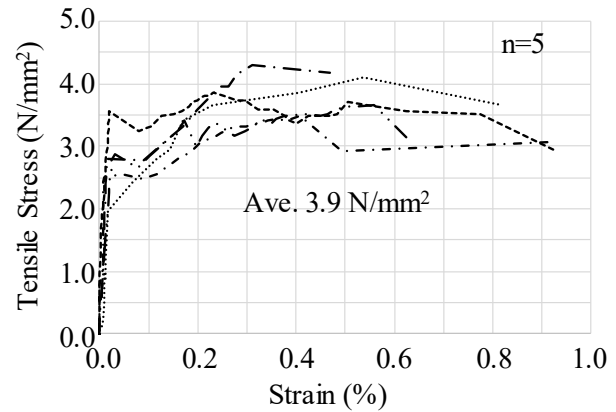
(a) Compressive

(b) Tensile

Figure 12. Material strength (3R)

Figure 10 and Figure 11 shows the repair area and the chipped area of the 3R models. In 3R models, additional bars and ties were inserted at the area of the fracture of longitudinal bars. Method of the spraying was same as 2R models. The cover concrete of the damaged models chipped from the base to the height of 600 mm. The chipped depth was around 30 mm from the longitudinal bars back. Inserted additional bars were fixed by welding. Figure 12 shows SHCC strength based on cylinder tests. Cylinders tests performed at 14 days curing. The average of compressive strength was 36.7 N/mm². On the other hand, the average of tensile strength was 3.9 N/mm².

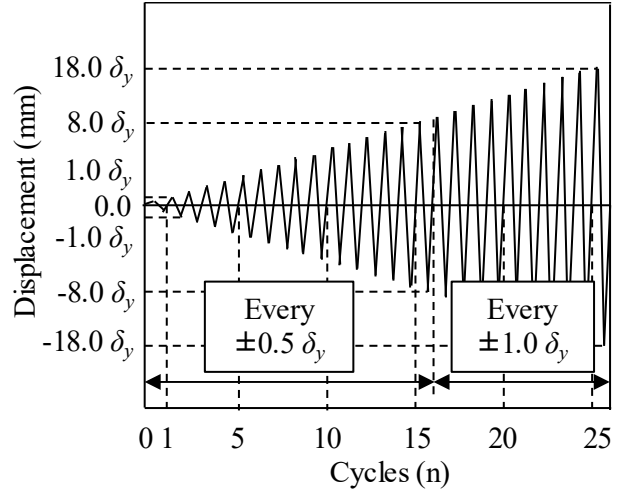
linear slider. Figure 14 shows loading sequence. Yield displacement (δ_y) was the same value in authors' previous study [7,8]. A loading-controlled testing was conducted until yield displacement. After the yield displacement, a displacement-controlled testing on the lateral direction with an axial load was conducted.

Figure 14. Loading sequence

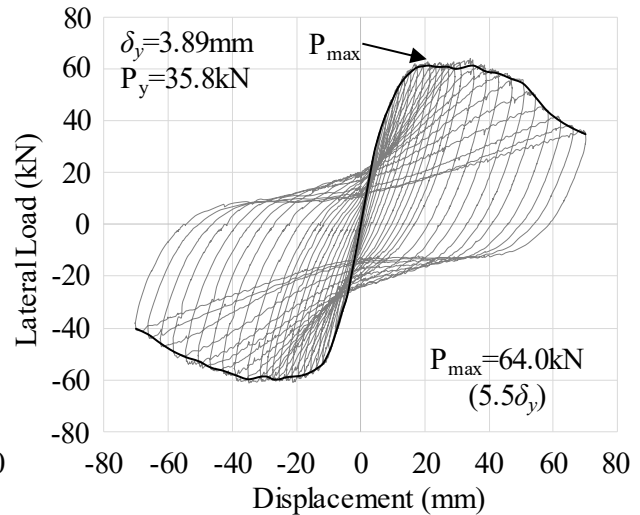
Figure 15 shows hysteresis curves of D10-150-1R model and D13-150-1R model. In the D10-150-1R model ($\delta_y=4.44$ mm, $P_y=32.3$ kN), horizontal cracks and multiple fine cracks were observed before $\pm 3.0 \delta_y$ ($\delta=13.3$ mm). The maximum strength reached 62.5 kN at $\pm 3.5 \delta_y$ ($\delta=15.5$ mm). After the maximum strength, the strength gradually decreased. Break of the tie was observed at $5.5 \delta_y$ ($\delta=24.4$ mm). Break of the longitudinal bar was observed at $-13.0 \delta_y$ ($\delta=57.7$ mm). The cyclic loading test finished at $\pm 16.0 \delta_y$ ($\delta=71.0$ mm) because the strength reached 50% strength of the maximum strength. In the D13-150-1R model ($\delta_y=3.89$ mm, $P_y=35.8$ kN), the maximum strength reached 64.0 kN at $\pm 5.5 \delta_y$ ($\delta=21.4$ mm). After the maximum strength, the strength gradually decreased. Break of the tie was observed at $+10.0 \delta_y$ ($\delta=38.9$ mm). The cyclic loading test finished at $\pm 18.0 \delta_y$ ($\delta=70.2$ mm) because the strength reached 50 % strength of the maximum strength. 1R models

(a) D10-150-1R

(b) D13-150-1R

Figure 15. Hysteresis curves (1R)

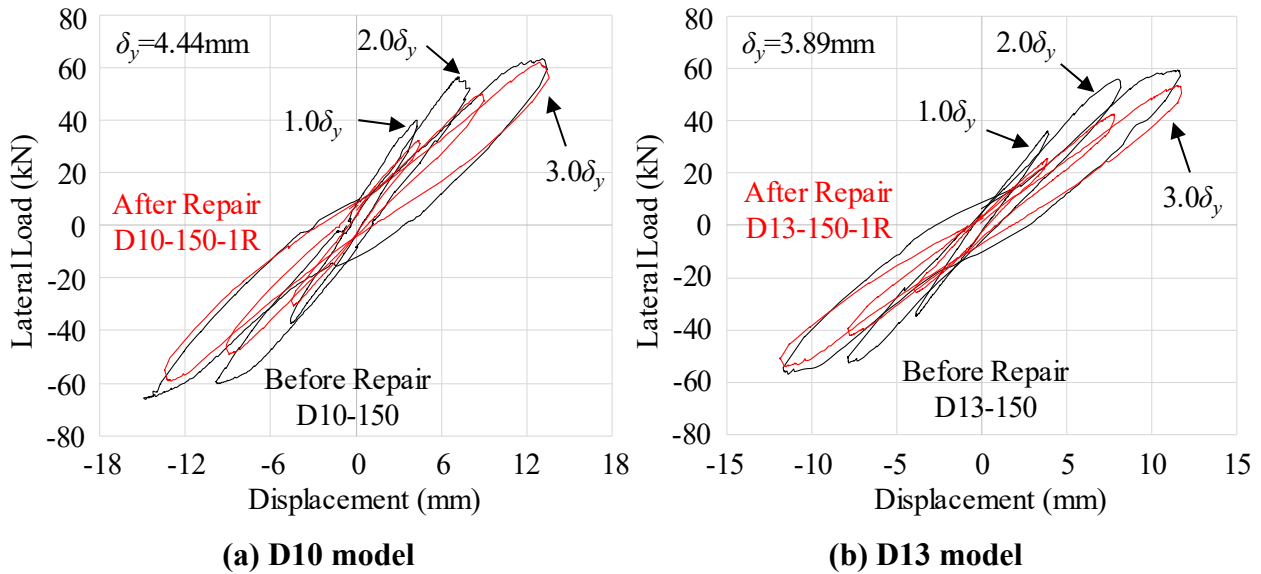
Figure 18. Hysteresis loops in the $1.0 \delta_y$, $2.0 \delta_y$ and $3.0 \delta_y$
